PROCEEDINGS

OF THE MARINE SAFETY COUNCIL

April 1978

Barge Blast Kills Four

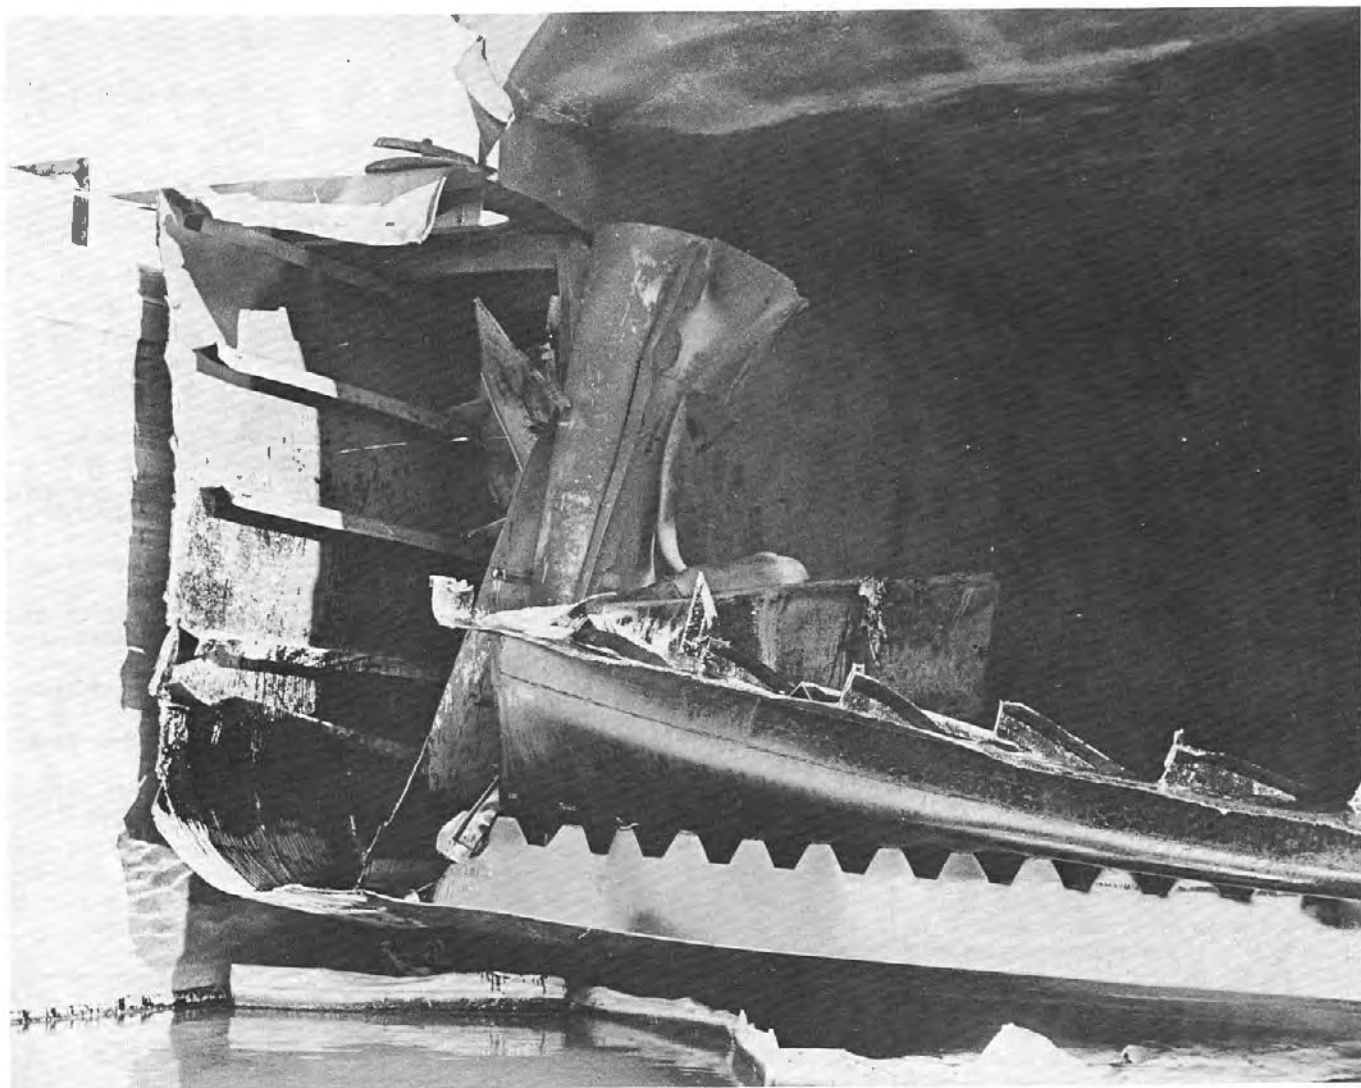
The burned-out shell of the double-skin tank barge B-924. Four lives were lost in an explosion and fire 2 years ago at a Mississippi River repair yard where the barge was undergoing welding repairs.

Pictured are the No. 1 starboard cargo tank and starboard wing void. At the time of the explosion, welding was being done to repair a crack in the bulkhead between the tank and the void. The firewatch in the void space escaped when cargo residue ignited, but the four men in the tank - including the marine chemist who had certified the barge safe for hot work - perished.

The initial flames spread quickly and touched off an explosion that ripped away the entire forward rake and blew in the forward bulkheads of both No. 1 cargo tanks. Fire engulfed the barge, and it required the efforts of the local fire department as well as a Coast Guard cutter which was on the scene to extinguish the blaze about 2 hours later.

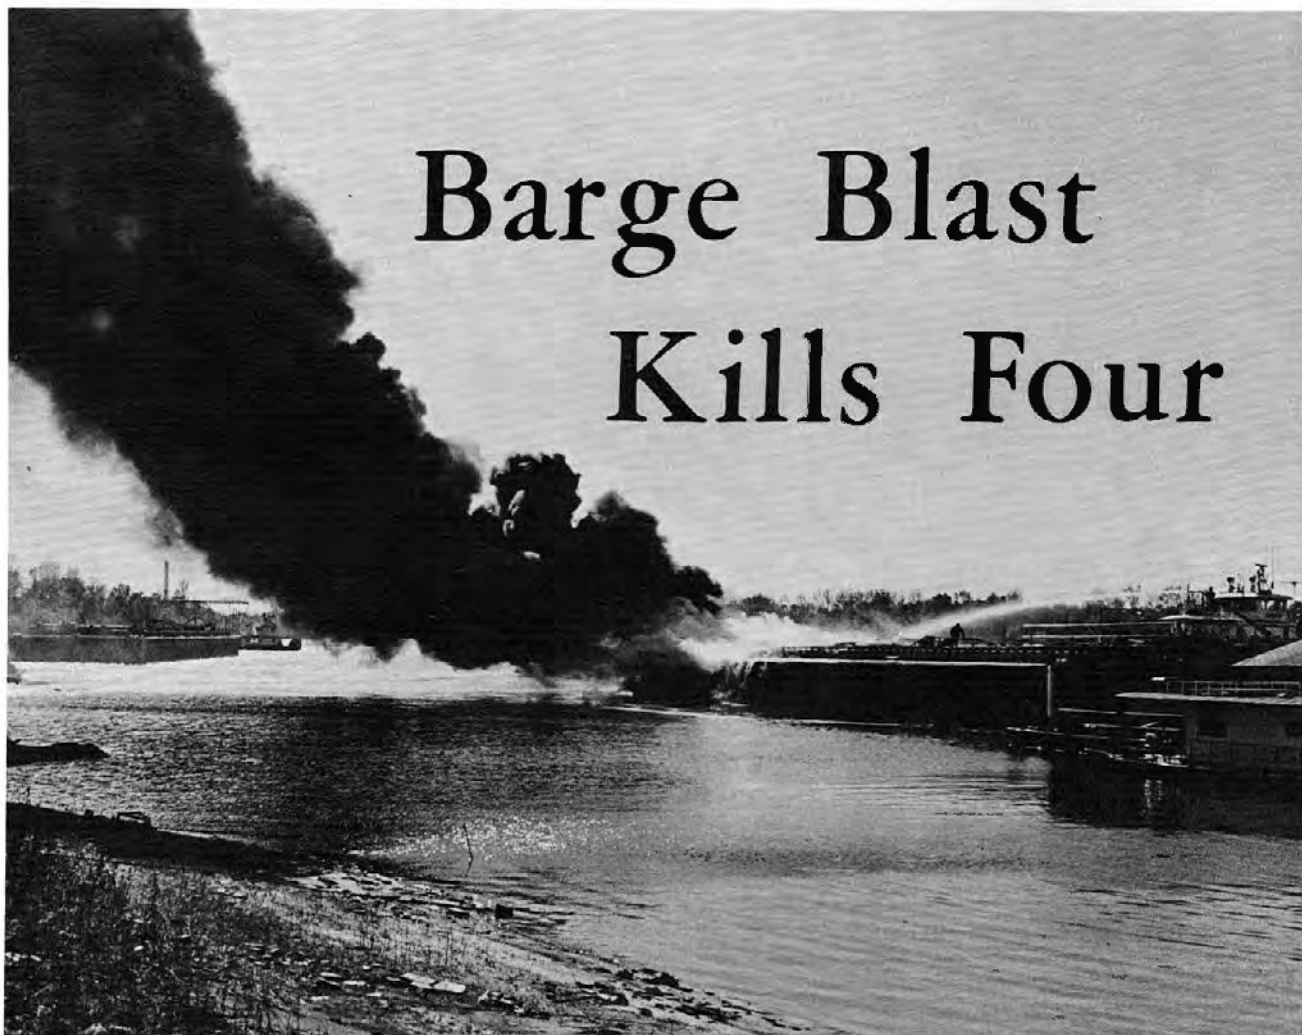
On 13 November 1975, the tank barge B-924 exploded and burned during welding repair work at the Brent Towing Company repair facility, Greenville, Mississippi. Four people were killed and two

The blast ripped away most of the rake in three sections, one of which was deposited on a roadway more than 500 yards from the site. Both forward No. 1 wing bulkheads were forced forward, and both cargo tank forward bulkheads were forced aft by the explosion. The forward section of the B-924 was immediately engulfed in flames.

pairs being undertaken on a tank barge that was not gas free. This resulted in the ignition of vapors from cargo and cargo residue in the No. 1 starboard wing void which spread fire throughout the forward section of the vessel and ignited volatile vapors causing an explosion. The disregard for federal regulations and unsafe practices on the part of the marine chemist and the owners of the vessel resulted in this fatal accident.

The Commandant concurred with the Marine Board's recommendation that the Coast Guard review standards relating to detailed procedures and responsibilities for the completion and handling of marine chemists' certificates. The Coast Guard will also conduct a complete review of the certification of marine chemists and their equipment, and the maintenance of related records.
