# Proceedings

of the Marine Safety Council

June 1986

# Disaster Strikes When Natural Gas Vapors Migrate

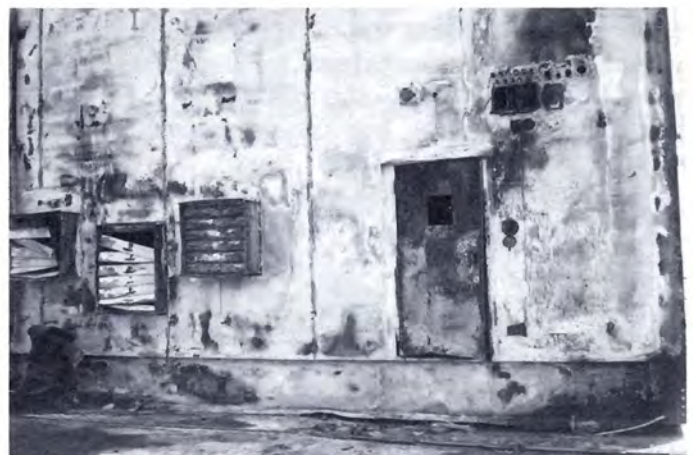
*The intensity of the explosion and fire caused this damage to the generator wall facing the living quarters. (All photos are from U.S. Coast Guard files)*

The most probable cause of this casualty was the contamination of the living quarters unit and generator shelter with flammable gases or vapors which migrated from the platform's common drain sump, through the com-

mon drainage system, and into spaces beneath the quarters unit and generator shelter. The gas was then ignited from an undetermined source. The source of ignition could not be adequately determined due to the degree of damage to the living quarters and associated equipment, although the most probable source of ignition was an electrical spark or discharge originating from the switch contact of the air conditioning or heating equipment located in the living quarters. It is unknown if the opening of the galley door contributed to the explosion by allowing vapors to come into contact with the ignition source.

The drainage system on a platform can provide a hazardous path for the migration of natural gas. Owners, operators, and safety inspectors (industry and Coast Guard) should be highly aware of this potential. From the safety standpoint, buildings should not be placed over existing drains, and drains should not be installed under buildings. If the Coast Guard encounters this particular situation during an inspection of the platform and determines the condition to be hazardous, the drains should be ordered removed or plugged. The present system can be made safer. Standard plumbing "P" traps should not be installed in drains under buildings where they tend to fill up with dirt. The American Petroleum Institute states in API RP 14E that consideration should be given to minimizing bends and flow restrictions in gravity drains and in no circumstances should up-slopes be permitted.

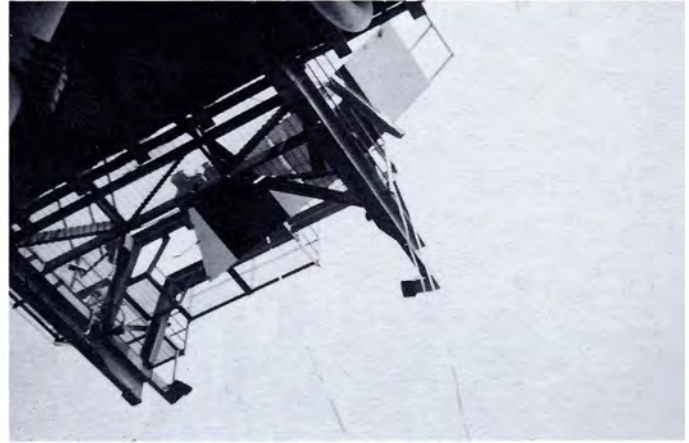
The U.S. Coast Guard investigating officer reported that, during the attempted evacuation, the releasing mechanism on the Whittaker Survival Capsule failed to release the capsule from its launching cable. Close examination of the releasing mechanism revealed possible disuse and some minor corrosion to the come-along, the mechanism that rotates the hook and releases the capsule from its launching cable. The investigating officer stated in his report that a stronger spring on the take-up reel pawl would have allowed the come-along on the releasing mechanism to operate properly, and release the launching cable.

*A portion of the helo deck was blown into the life capsule support frame by the explosion.*

fied and eliminated by safe means. Assigned personnel are required, by 33 CFR 146.15, to thoroughly inspect all lifesaving equipment periodically, making sure that all equipment is in good working order. This includes operating it as necessary. Good operating practices require replacement of expended equipment, as well as periodic renewal of those items which have a limited period of effectiveness. In addition, 33 CFR 146.125 requires drills to be conducted on a regular basis by the person in charge of the manned facility. This individual shall instruct personnel as necessary to ensure that all persons are familiar with their duties and stations.

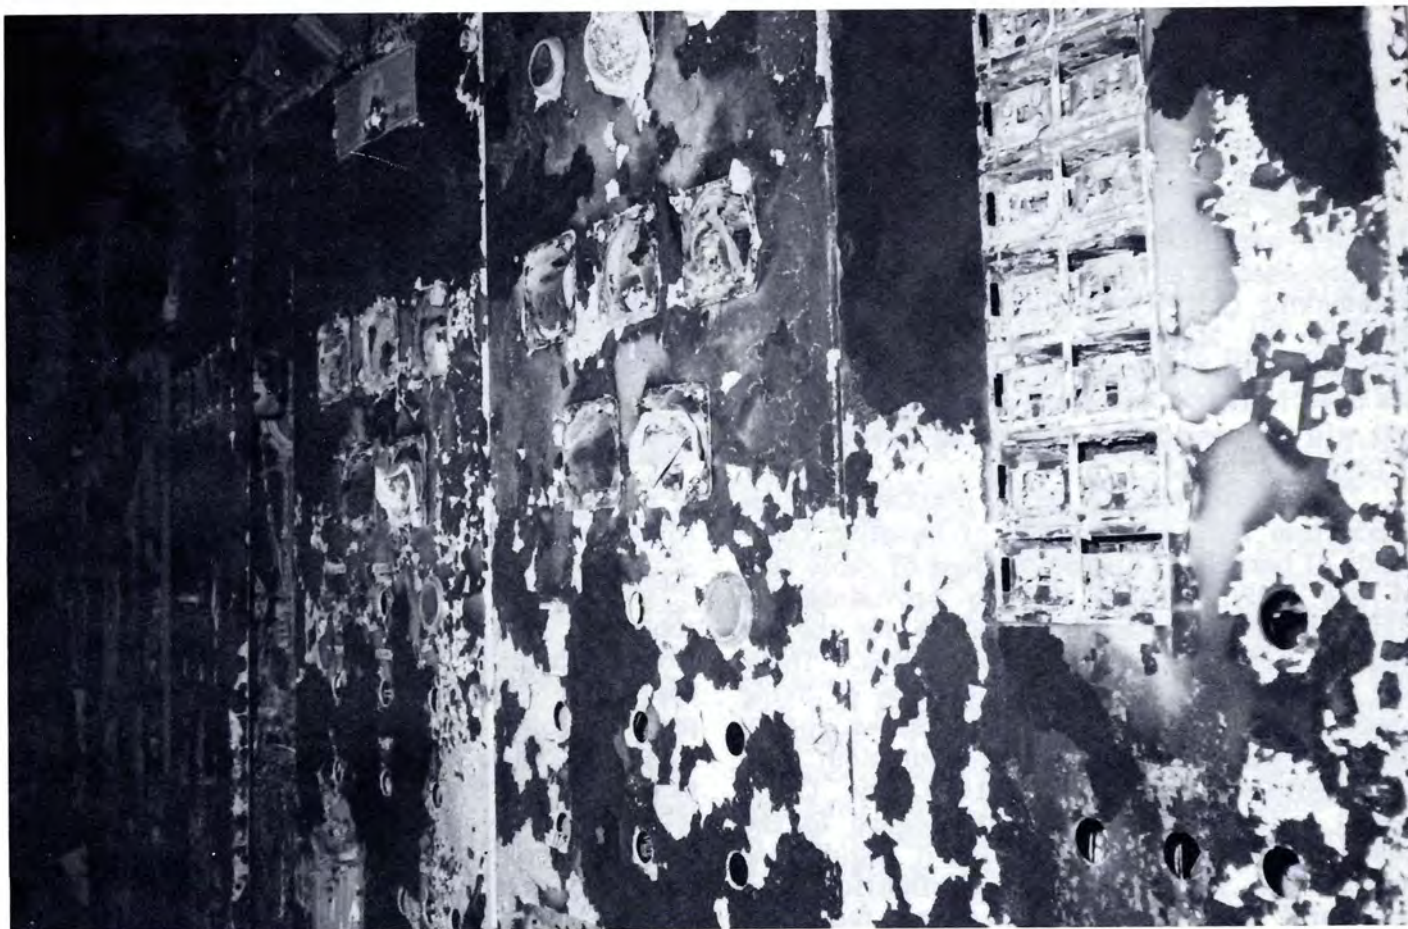
*The gauge board inside the generator room bears mute witness to the fire's severity.*

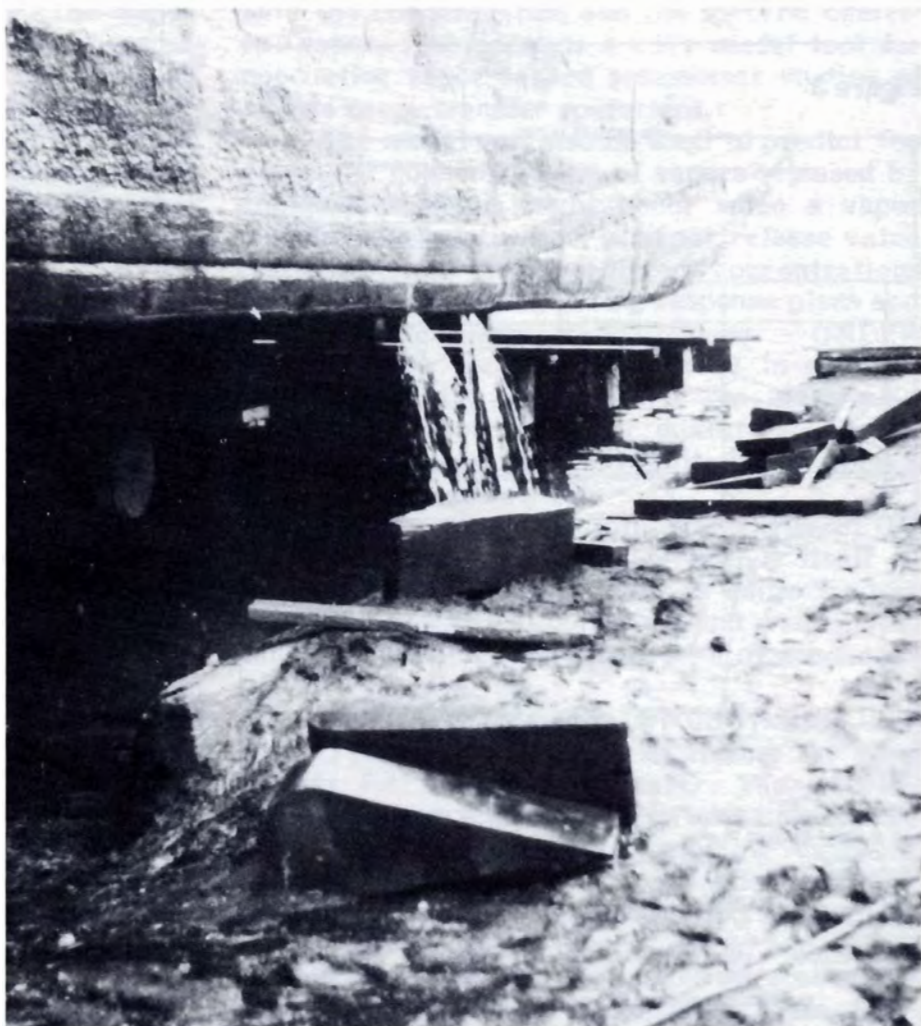
*"When the barge was lifted on the drydock, water poured out of the starboard side in four places." (Official U.S. Coast Guard photo)*

Two marine surveyors examined the underwater body of the barge for damage caused by the grounding and for any pre-existing deterioration. One of the surveyors took a small inspection hammer and pushed it by hand through the hull at the bilge turn and, with very little effort, ripped open a 12-inch hole. The surveyors determined that the hull deterioration had been present for quite some time and that the grounding and subsequent salvage effort had not caused this damage.
