Proceedings

Vol. 44, No. 10

November 1987

- 251 Fire and Explosion on the Letitia Lykes**
Oxygen bottles began to explode, throwing
shrapnel thousands of feet in all directions
LCDR Christopher Walter

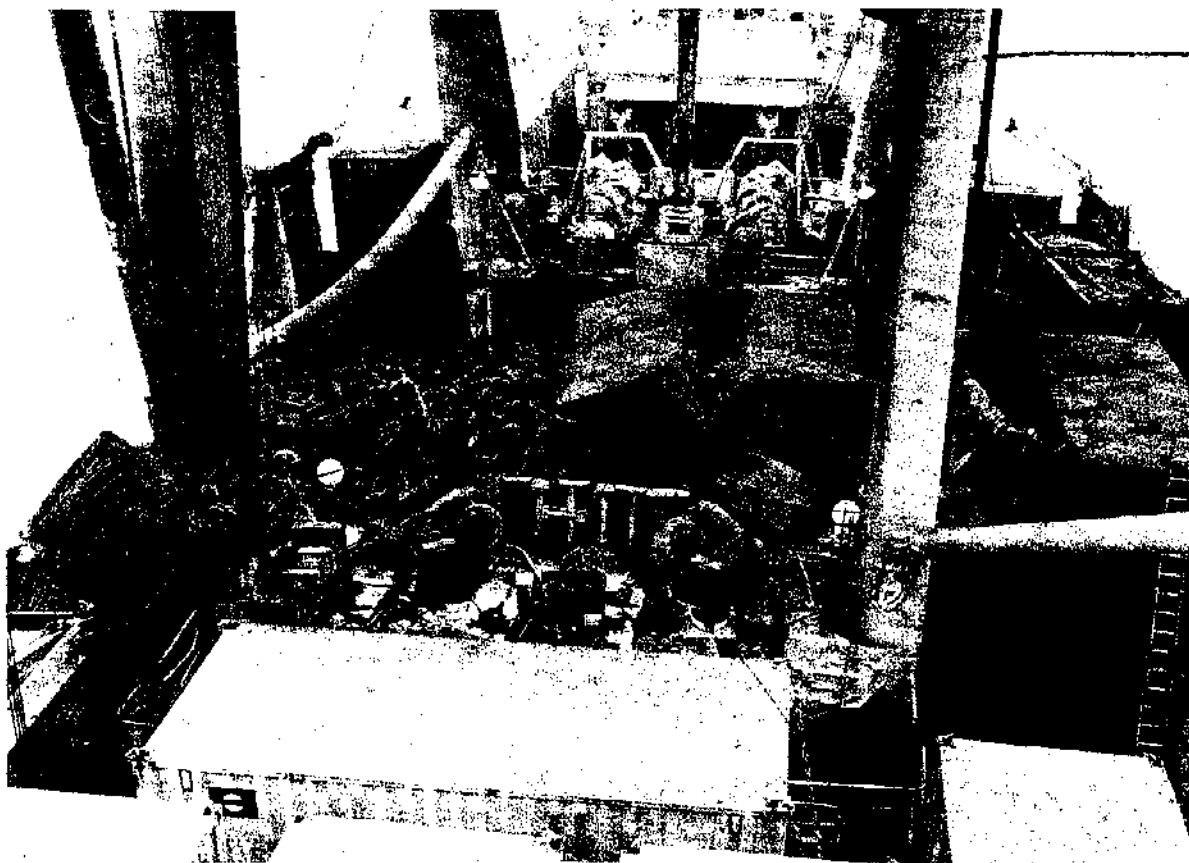
Fire damage to cargo gear and containers on main deck of *Letitia Lykes* in way of Nos. 2, 3, and 4 cargo holds. Majority of damage is over No. 3 hold. (Official U.S. Coast Guard photo by LT William J. Uberti)

Containers with 126 tons of oxygen bottles were completely destroyed. This tremendous release of pure, medical oxygen fed the fires which ravaged the vessel for 10 hours. All 41 tons of nitrous oxide were destroyed. Containers with 19 of the 49 tons of acetic acid were badly damaged or demolished. Containers with compressed nitrogen, liquefied propane, organic peroxides, silver nitrate, chloroform, flammable liquids, and poisons were also damaged or destroyed.

All 26 containers in way of the No. 3 hatch were destroyed. Three on No. 2 hatch were destroyed as well as three on No. 4. Thirty-two containers were a total loss; 9 others were badly damaged or scorched. The containers on No. 5 and 6 holds, which were aft of the house, were not damaged. They were, however, cluttered

While still at Diego Garcia and under the supervision of a marine inspector from Marine Safety Office Hampton Roads, temporary repairs were made to the ship's fire main and main deck, and a sturdy wood and tarpaper temporary hatch cover was fabricated for No. 3 hold. The *Letitia Lykes* discharged her cargo in Guam and proceeded to a repair yard in Japan where permanent repairs were completed on July 25, 1985, under the supervision of marine inspectors from Marine Safety Office Honolulu. The *Letitia Lykes* then returned to Preposition Group One in Diego Garcia and settled into a much quieter routine than it experienced on the eighth and ninth of May 1985.

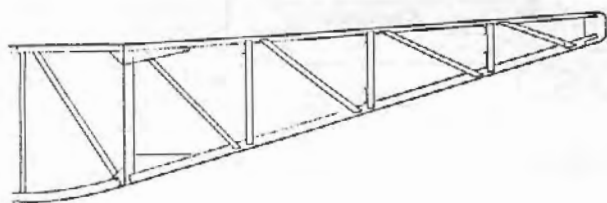
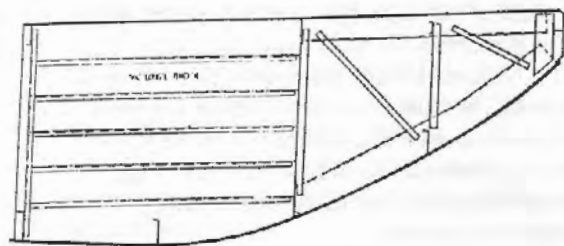
- Any vessel is in danger of pounding, even at low speeds, if it is light by the head. For long voyages, or if bad weather can be expected during the voyage, barges should be ballasted to keep the bow from coming out of the water.
- The long, spoon-bill rake has poor seakeeping properties. Although a heavy load or proper ballasting can improve the situation somewhat, there is no way to keep this type of bow from pounding in a seaway. While the spoon-bill is typical and adequate for river service, it is not the best shape for ocean service.

Inboard profile of a spoon-bill bow (top) and an ocean barge bow (bottom).
