Final Report

Auger Lifeboat 6 Incident

Shell Oil Company
Houston, Texas, USA

Report No.: O-AP-FINV / BPADG (10165575)
July 9, 2020

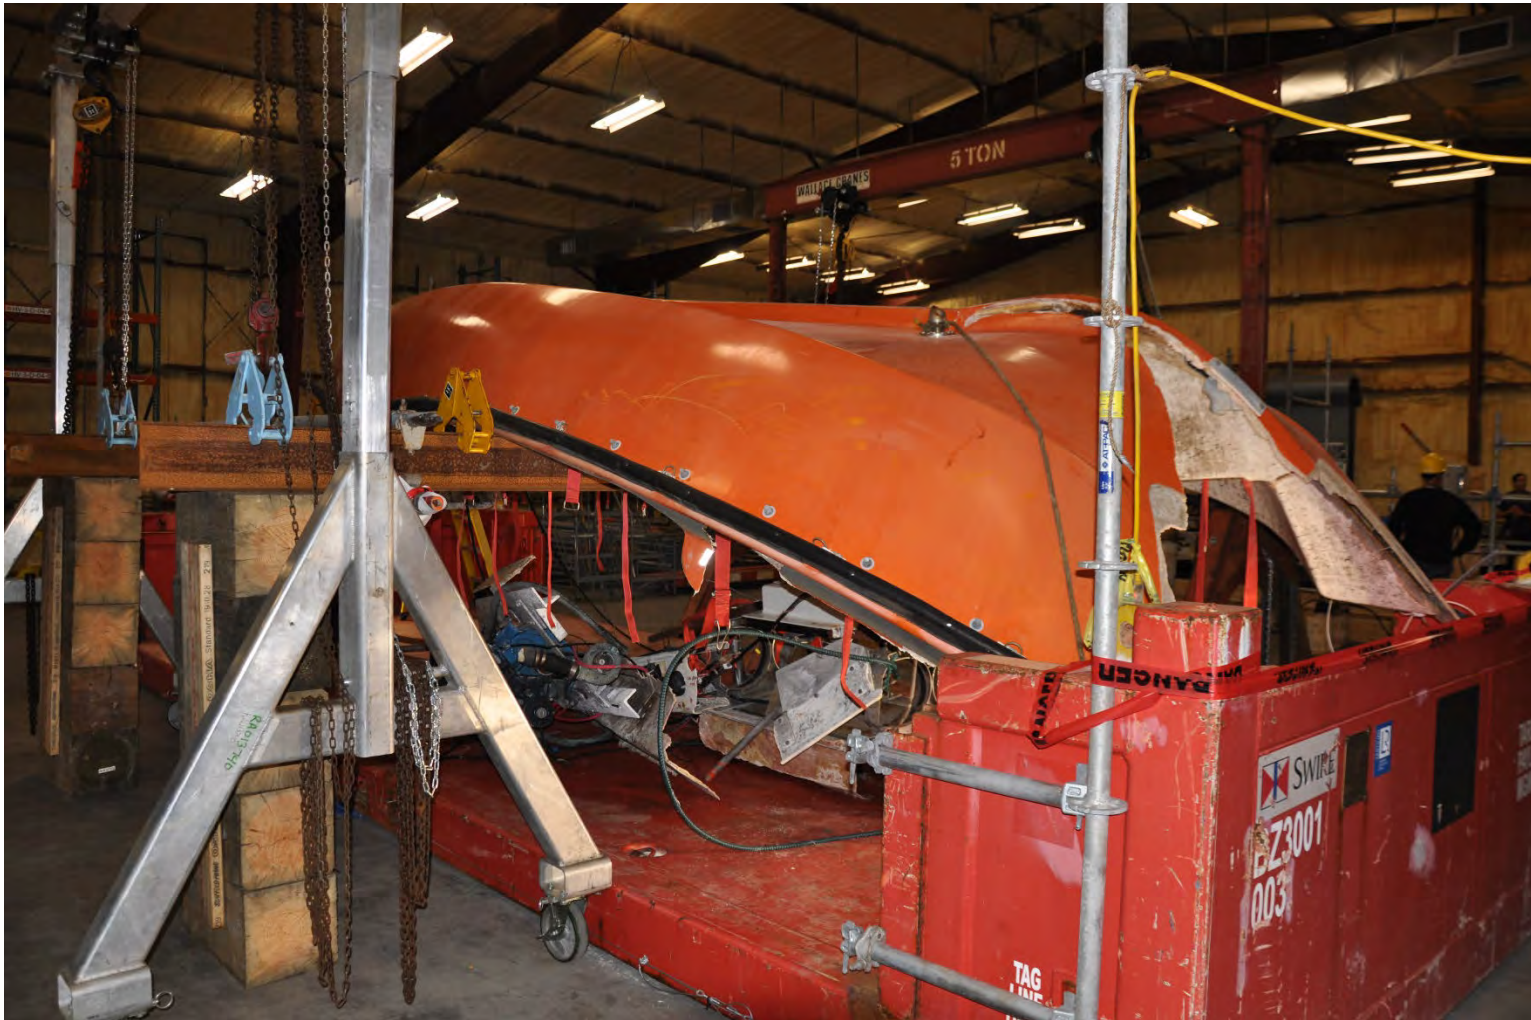
Figure 8. Photograph showing the condition of Lifeboat 6 in Harvey Terminal after the incident, as viewed from the forward, port side.

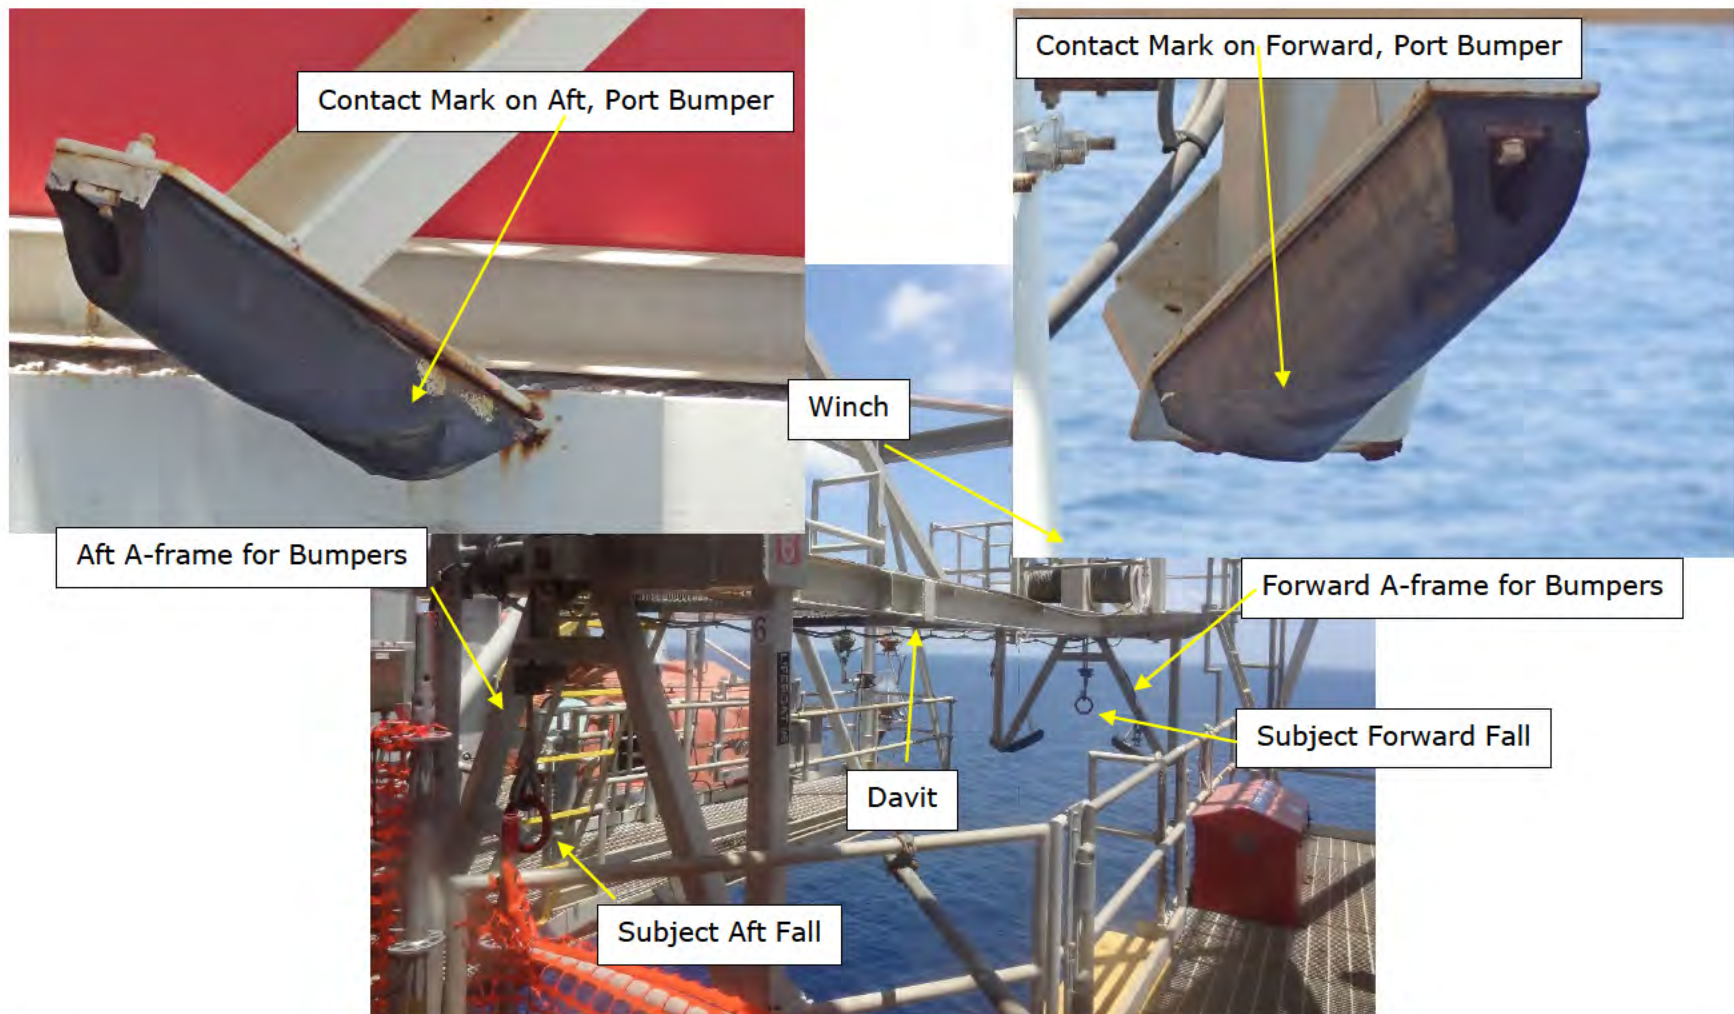
Figure 10. Photographs showing the condition of the davit and port bumpers after the incident. Photograph provided by SOI.

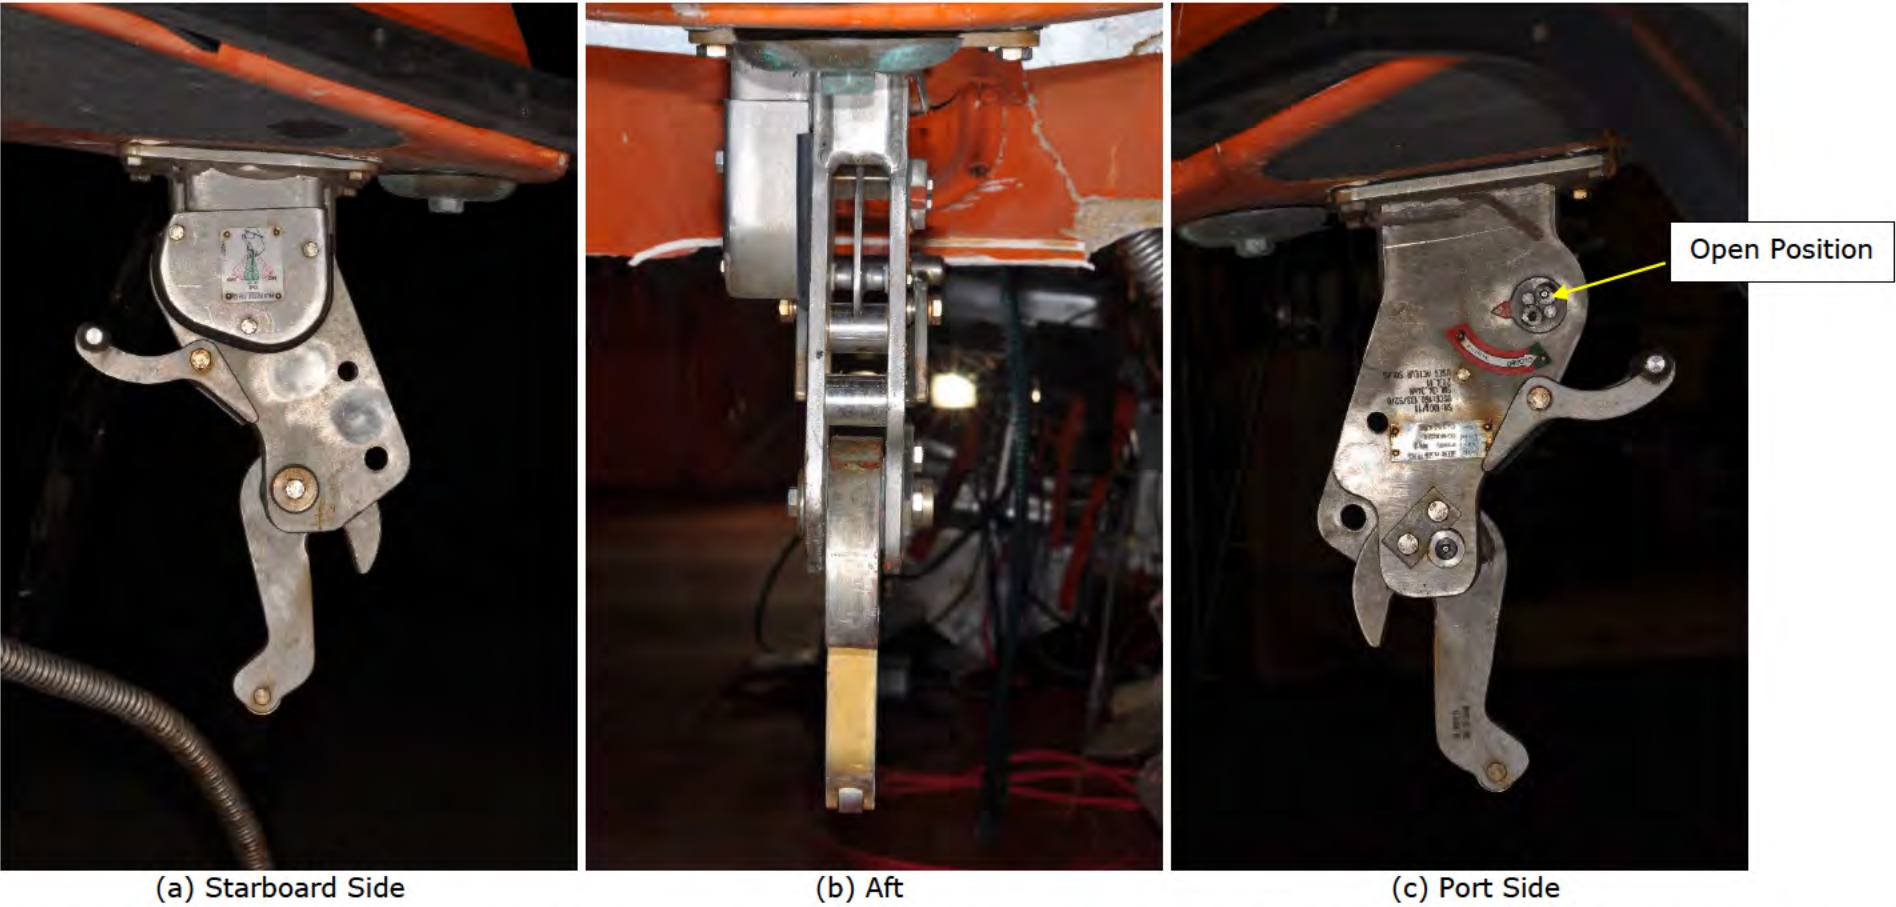
Figure 18. Photographs showing the aft of Lifeboat 6 and the as-found condition of the Subject Aft Hook as viewed from (a) the starboard side, (b) the stern, and (c) the port side.

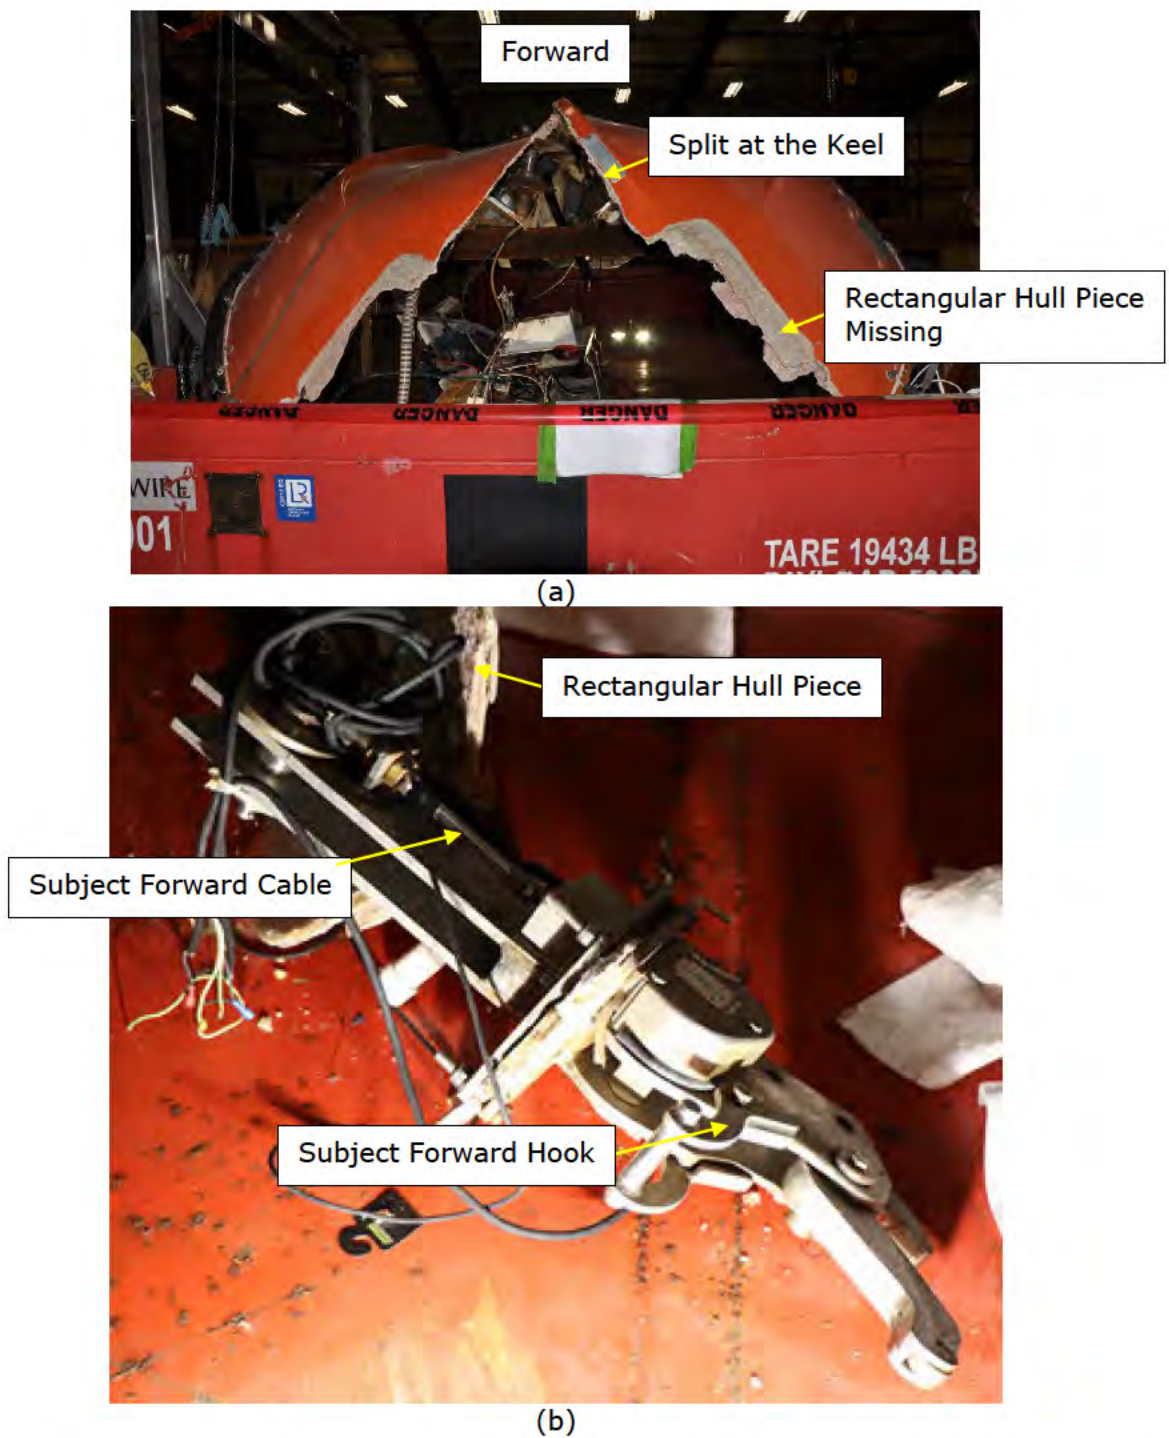
Figure 21. Photographs showing (a) the bow of Lifeboat 6 and (b) the as-received condition of the Subject Forward Hook at Harvey Terminal. Photograph in (b) provided by USCG.

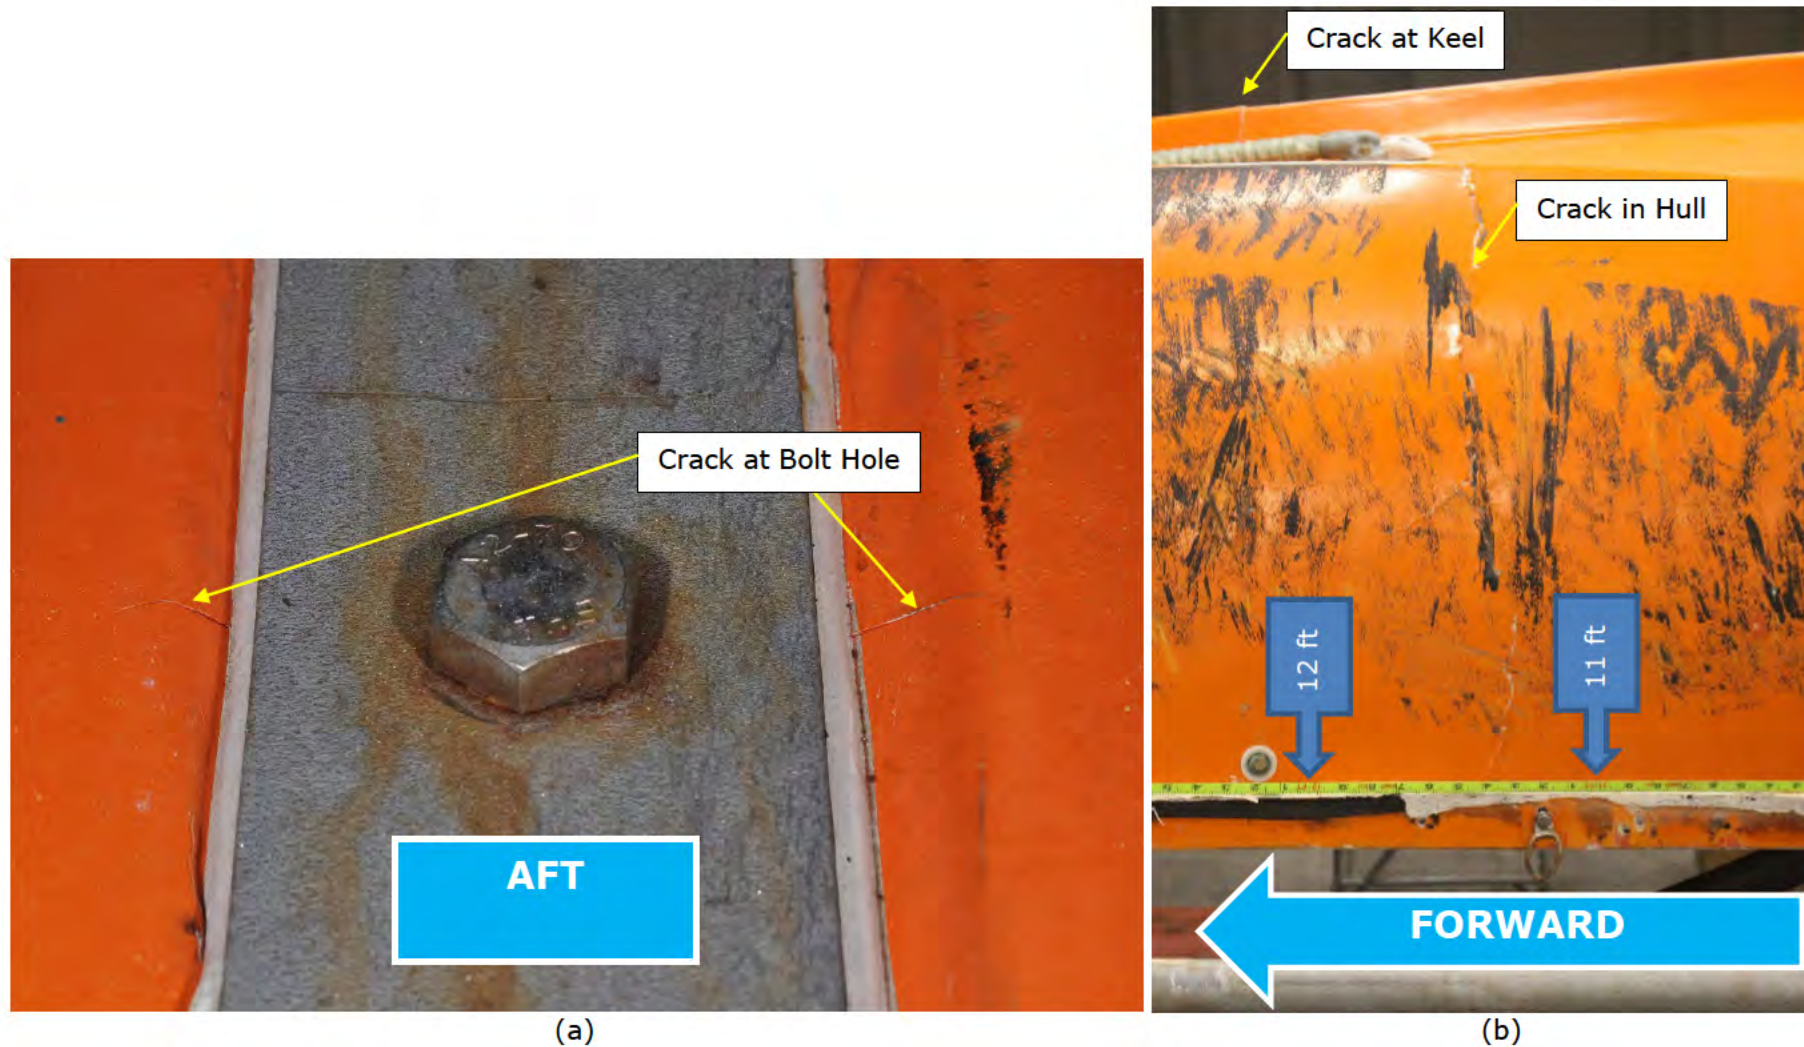
Figure 37. Photographs showing locations of cracks of interest at (a) the aft shoe plate and (b) 11.4 feet from reference location; locations shown in Figure 36. Tape measure is in feet.

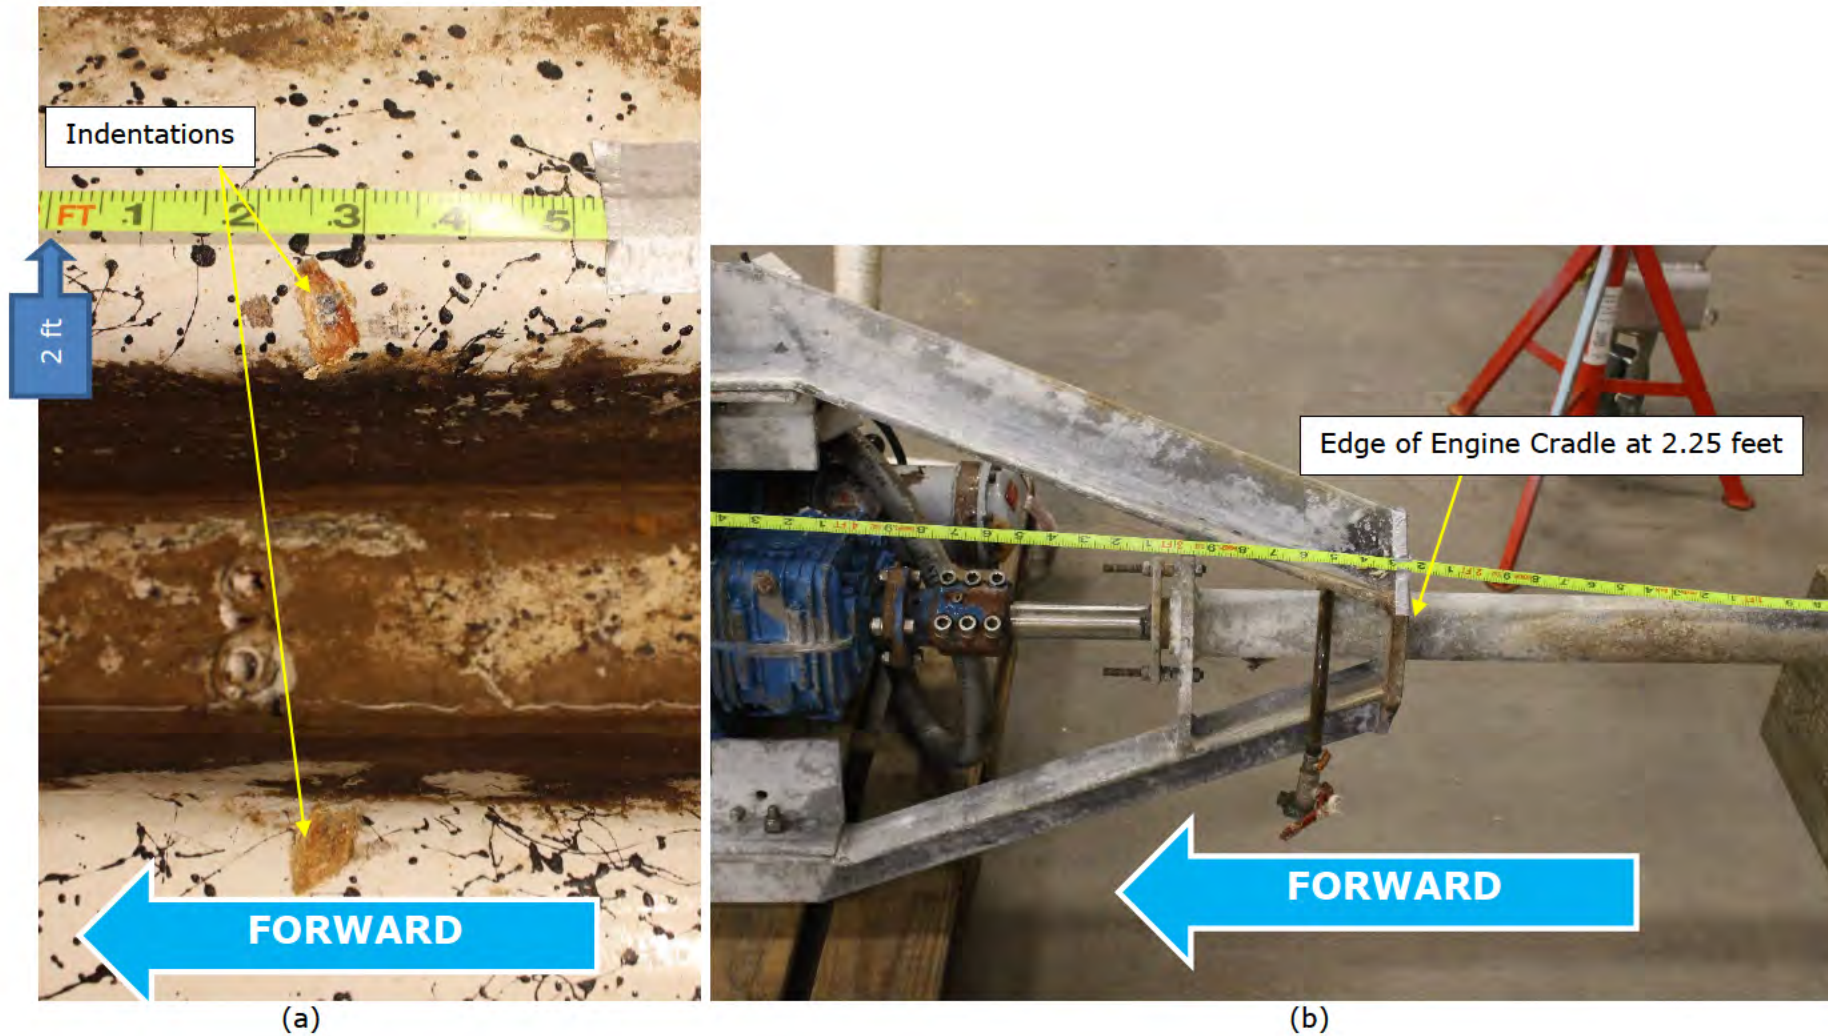
Figure 39. Photographs showing (a) indentations / contact damage at the hull interior 2.25 feet from the reference location and (b) the corresponding location on the engine and engine cradle. Tape measure is in feet.

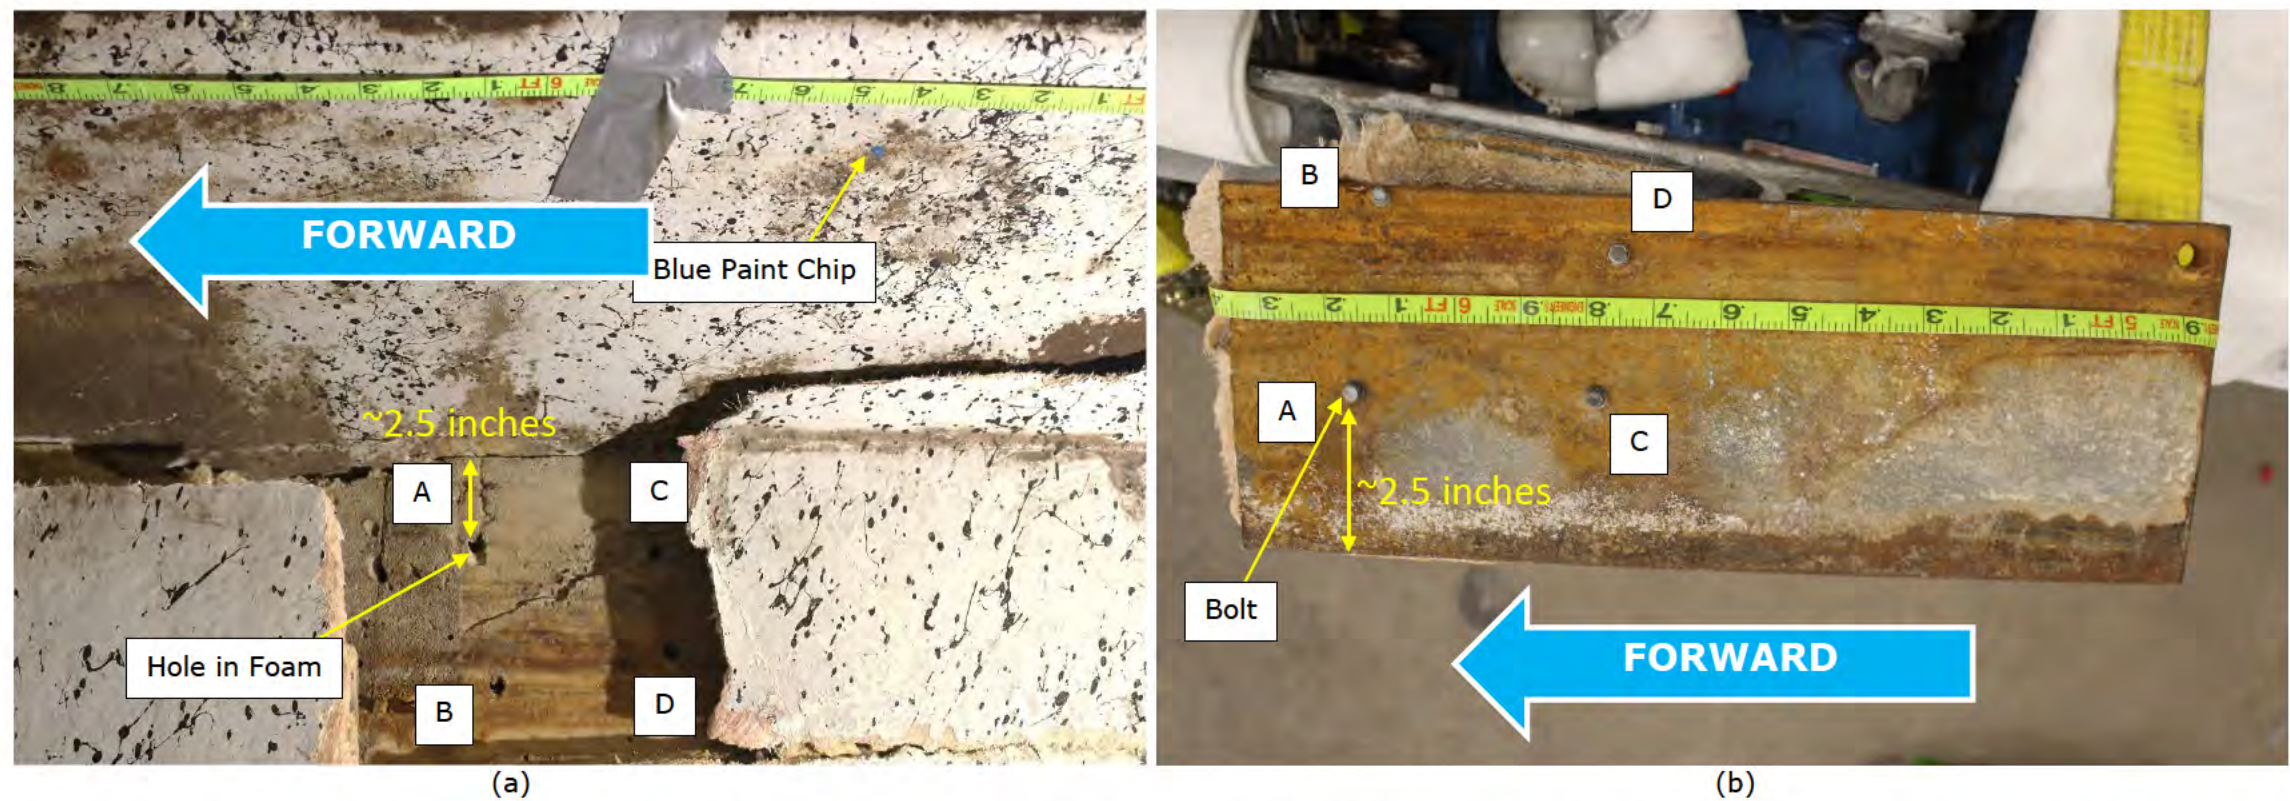
Figure 40. Photographs showing (a) a missing section of the hull interior 5.8 feet to 6.4 feet from the reference location and (b) the corresponding location on the engine and engine cradle. Tape measure is in feet.

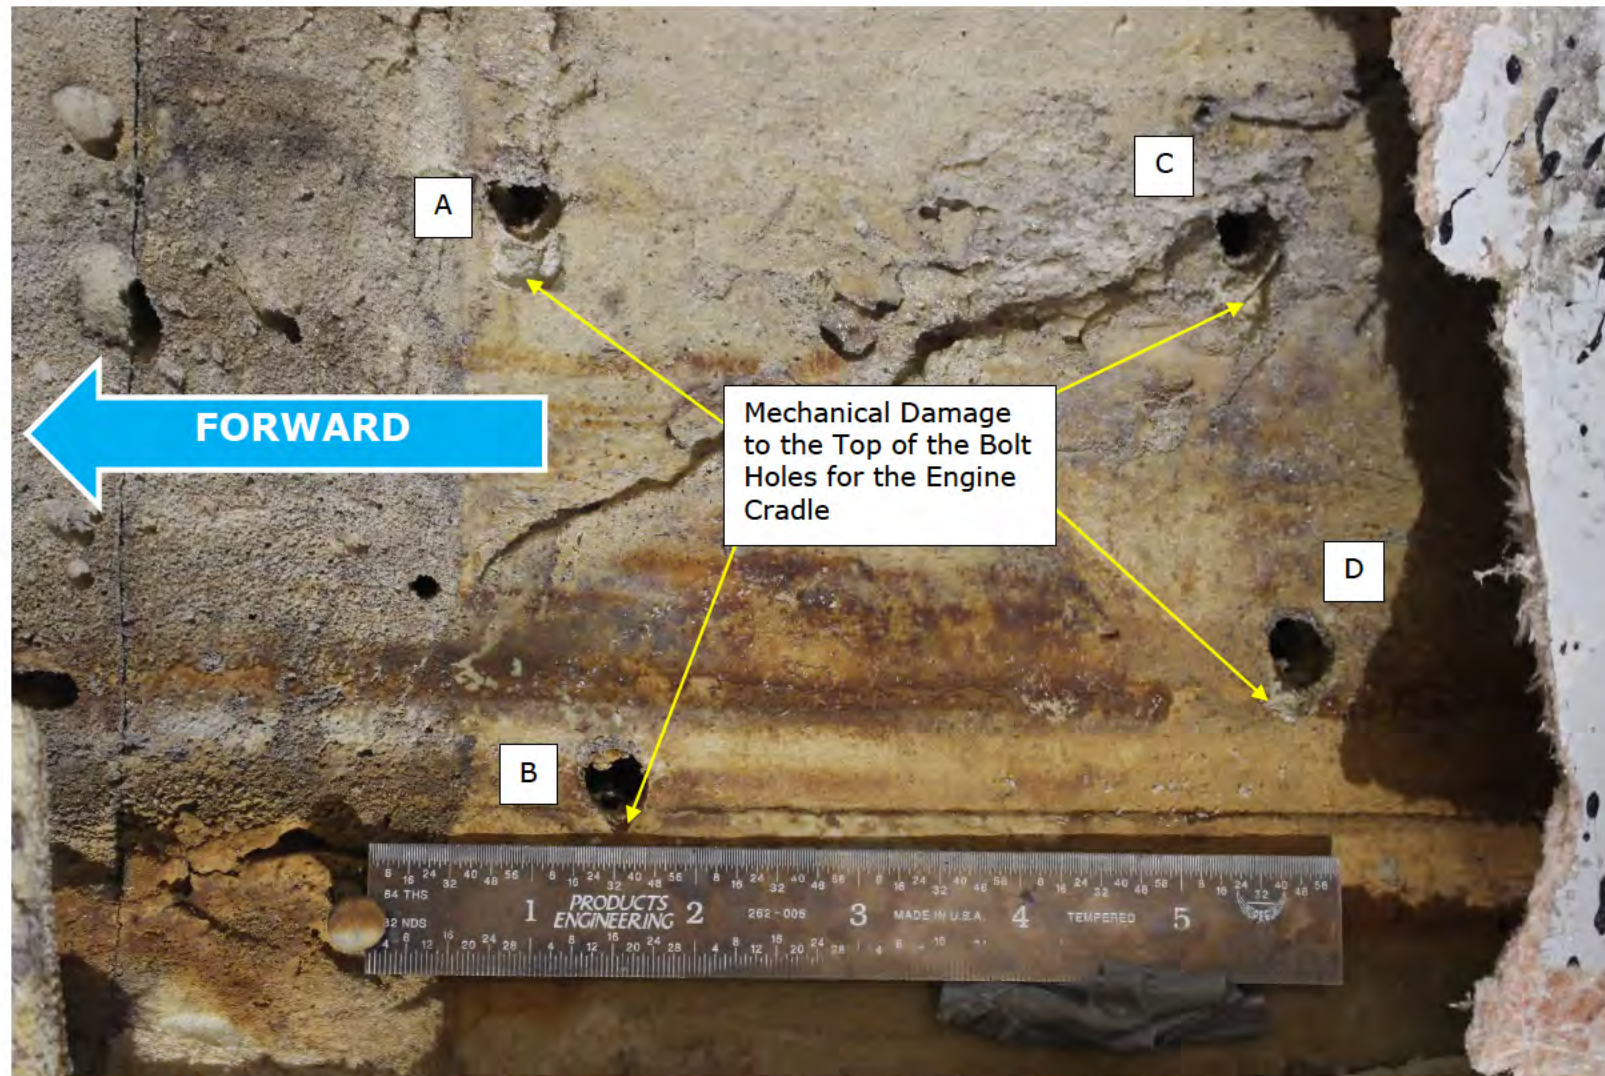
Figure 41. Photograph showing hole impressions left from the bolt studs used to attach support structure for the engine. Directionality of the damage can be seen adjacent to each hole. Ruler is in inches.

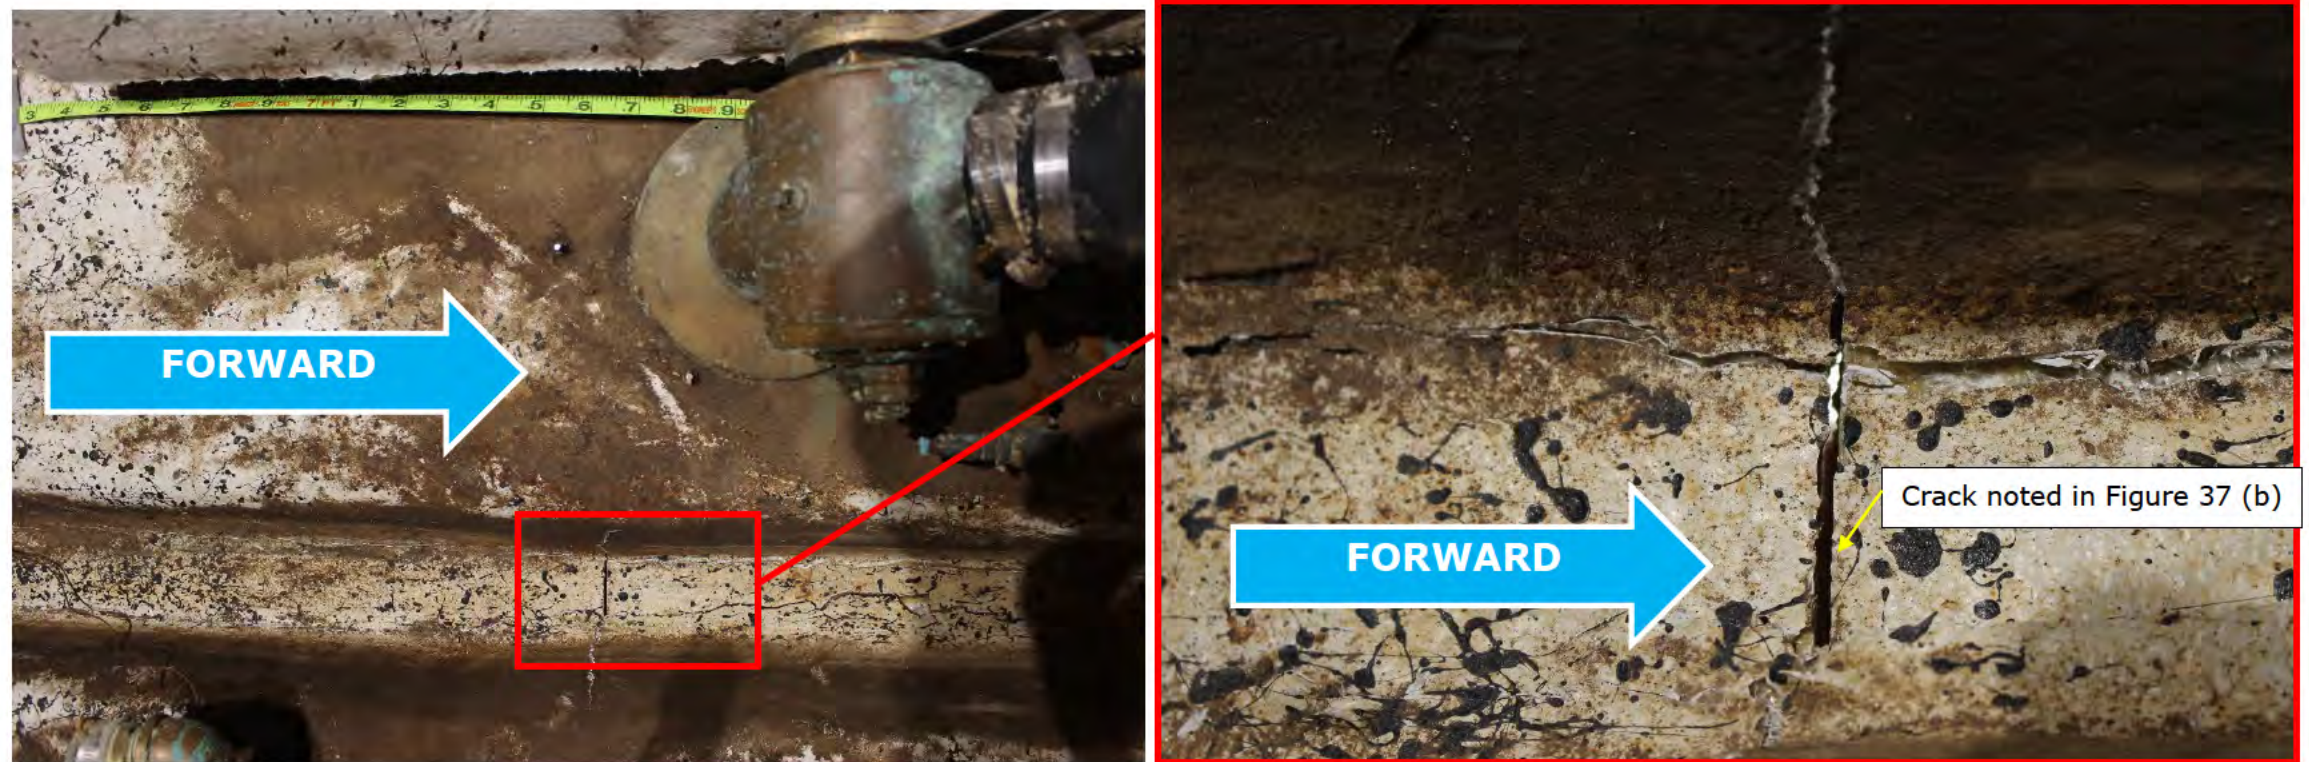
Figure 42. Photographs showing a transverse crack in the keel of the hull interior located 7.6 feet from the reference location. Tape measure is in feet.

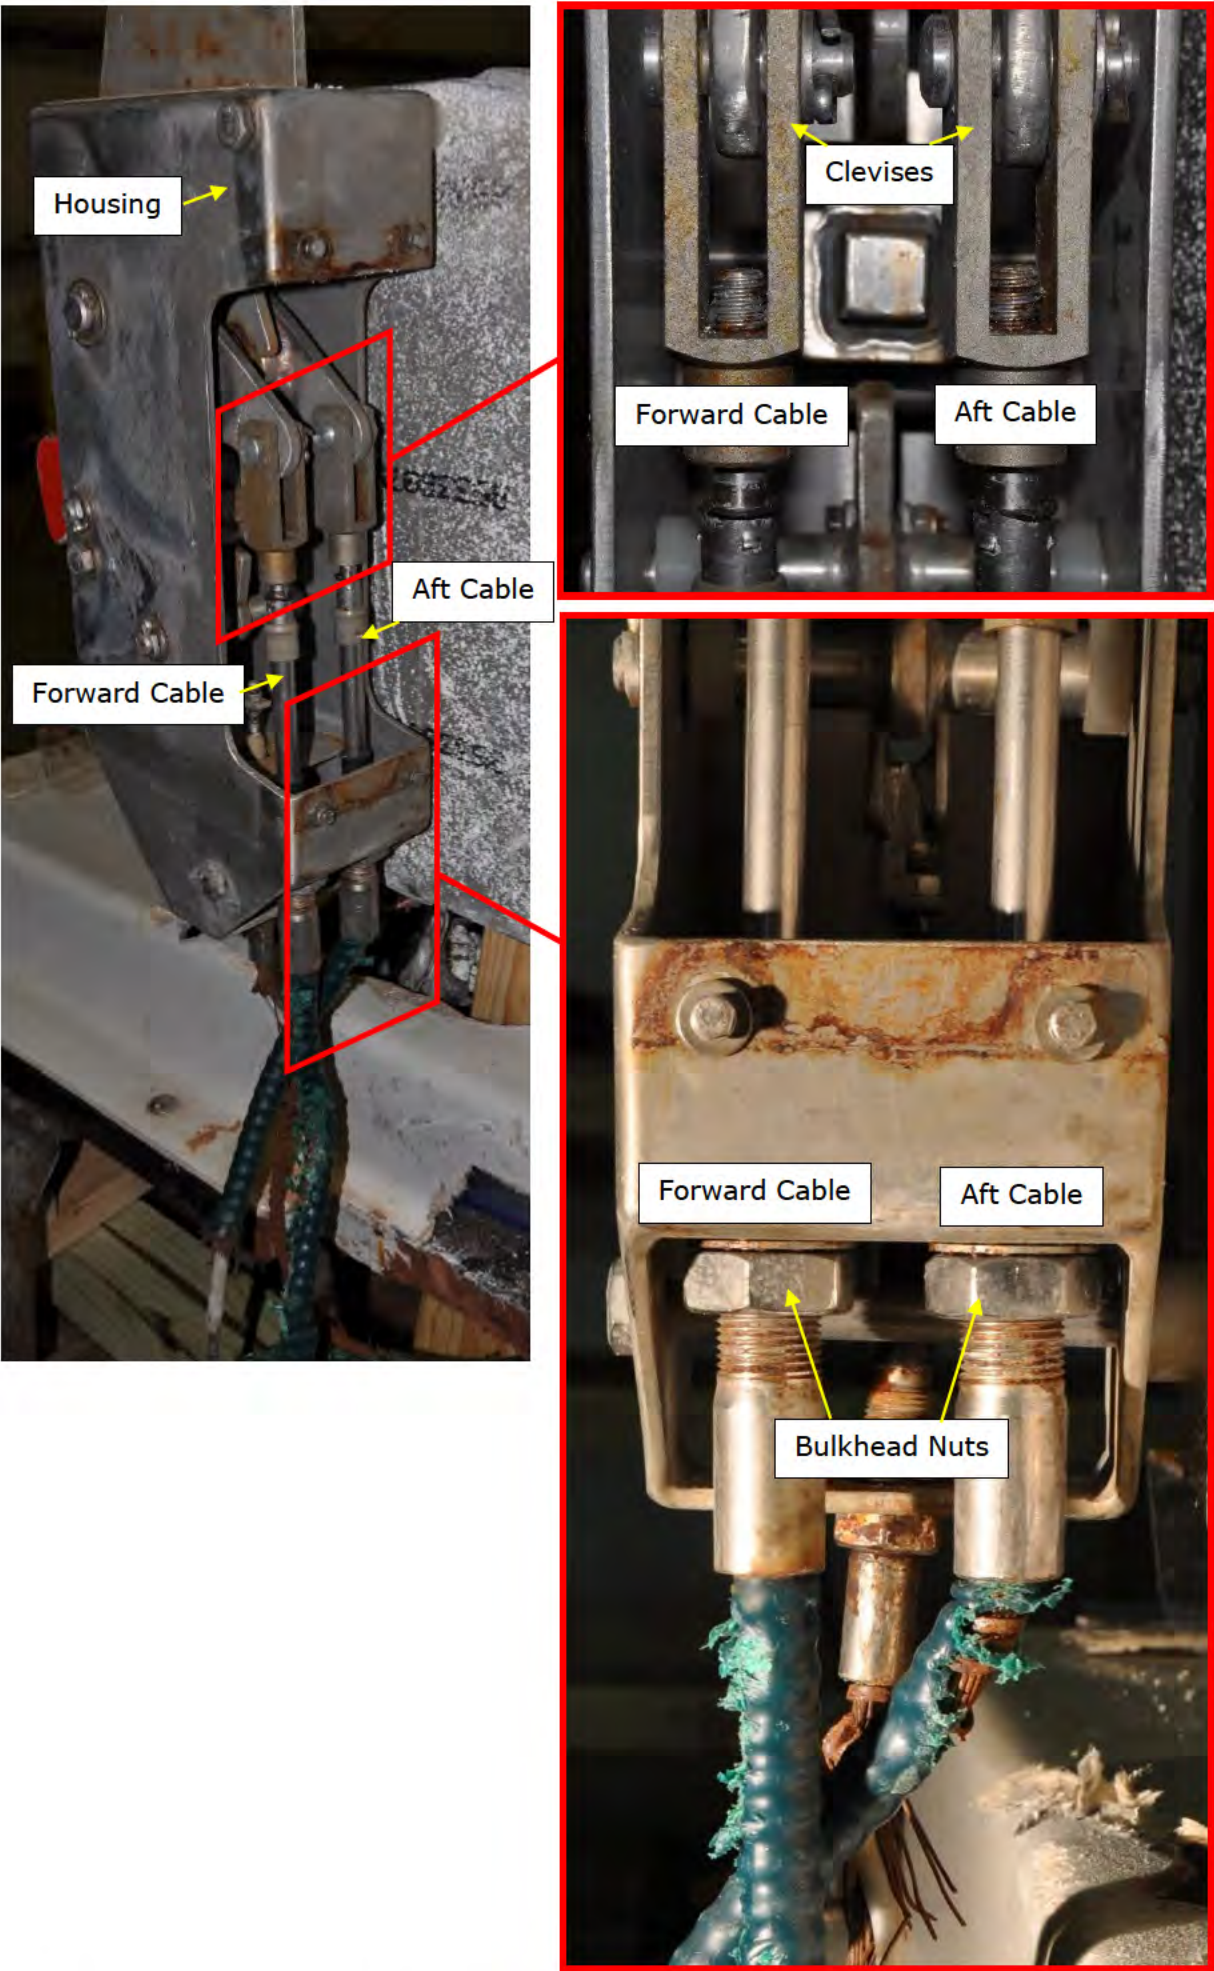
Figure 54. Photographs of the Subject Release Unit at DNV GL showing the as-found condition of the clevises and bulkhead nuts, after removing the protective coverings.

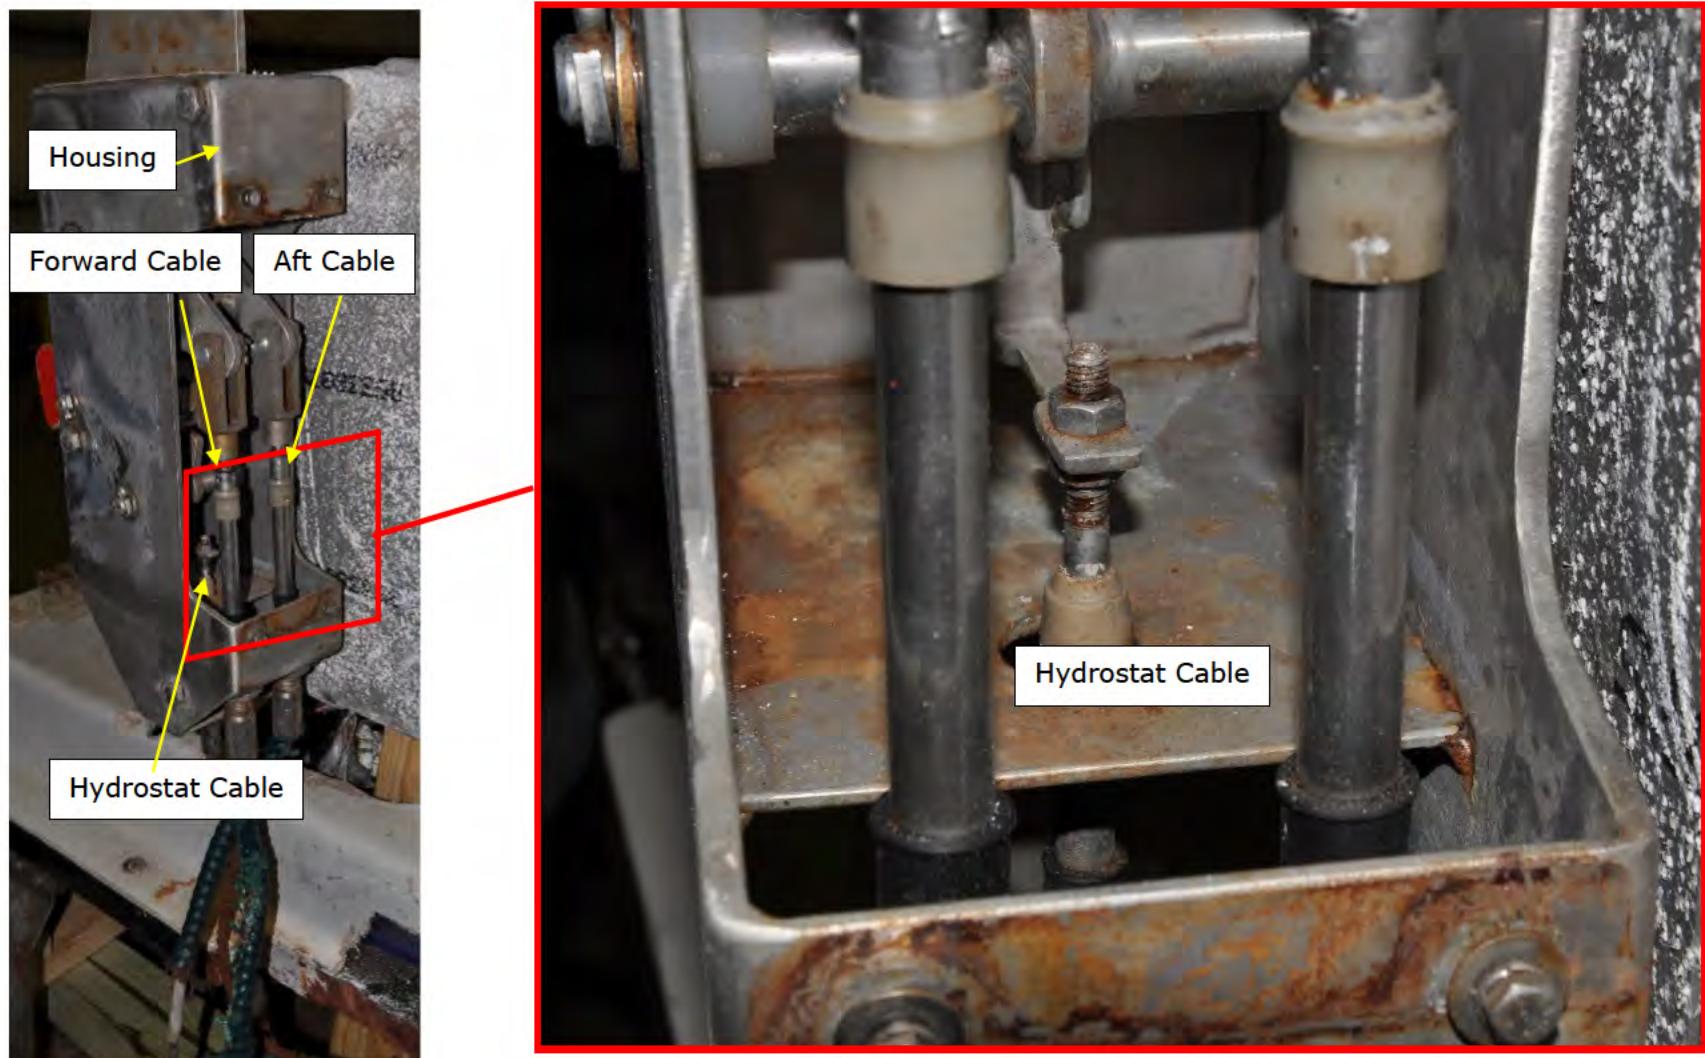
Figure 55. Photographs of the Subject Release Unit at DNV GL showing the as-found condition of the hydrostat cable and end rod jam nuts, after removing the protective coverings.

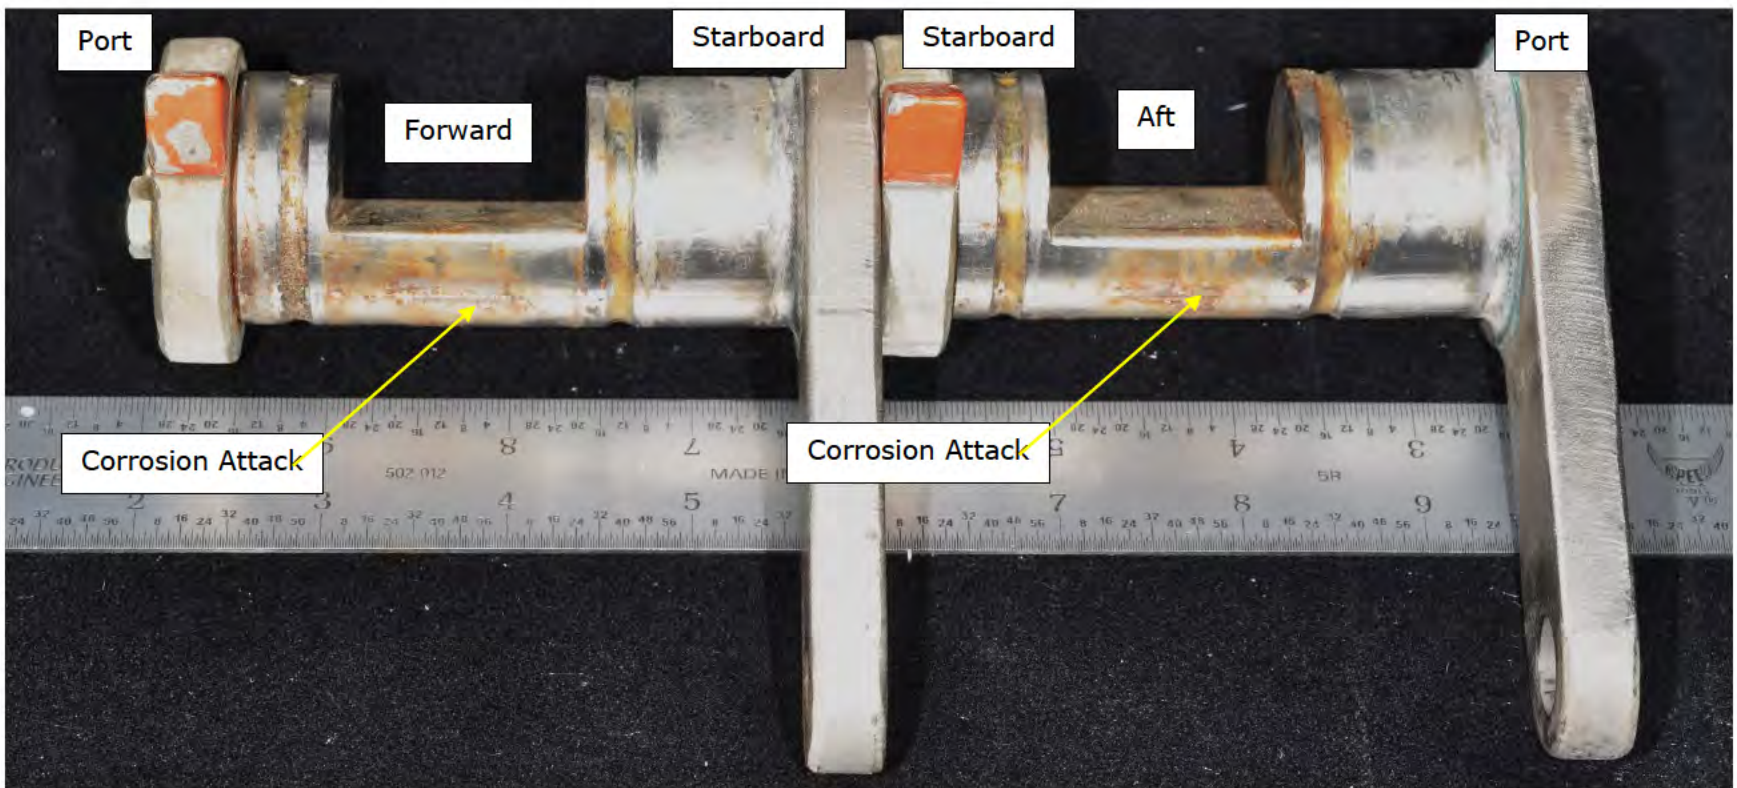
Figure 64. Photograph of the locking shaft from the Subject Forward and Aft Hooks comparing the areas of corrosion attack on the round of the locking shaft and comparing the overall geometry. Ruler is in inches.
