Final Report

Auger Lifeboat 6 Incident

Shell Oil Company
Houston, Texas, USA

Report No.: O-AP-FINV / BPADG (10165575)
July 9, 2020

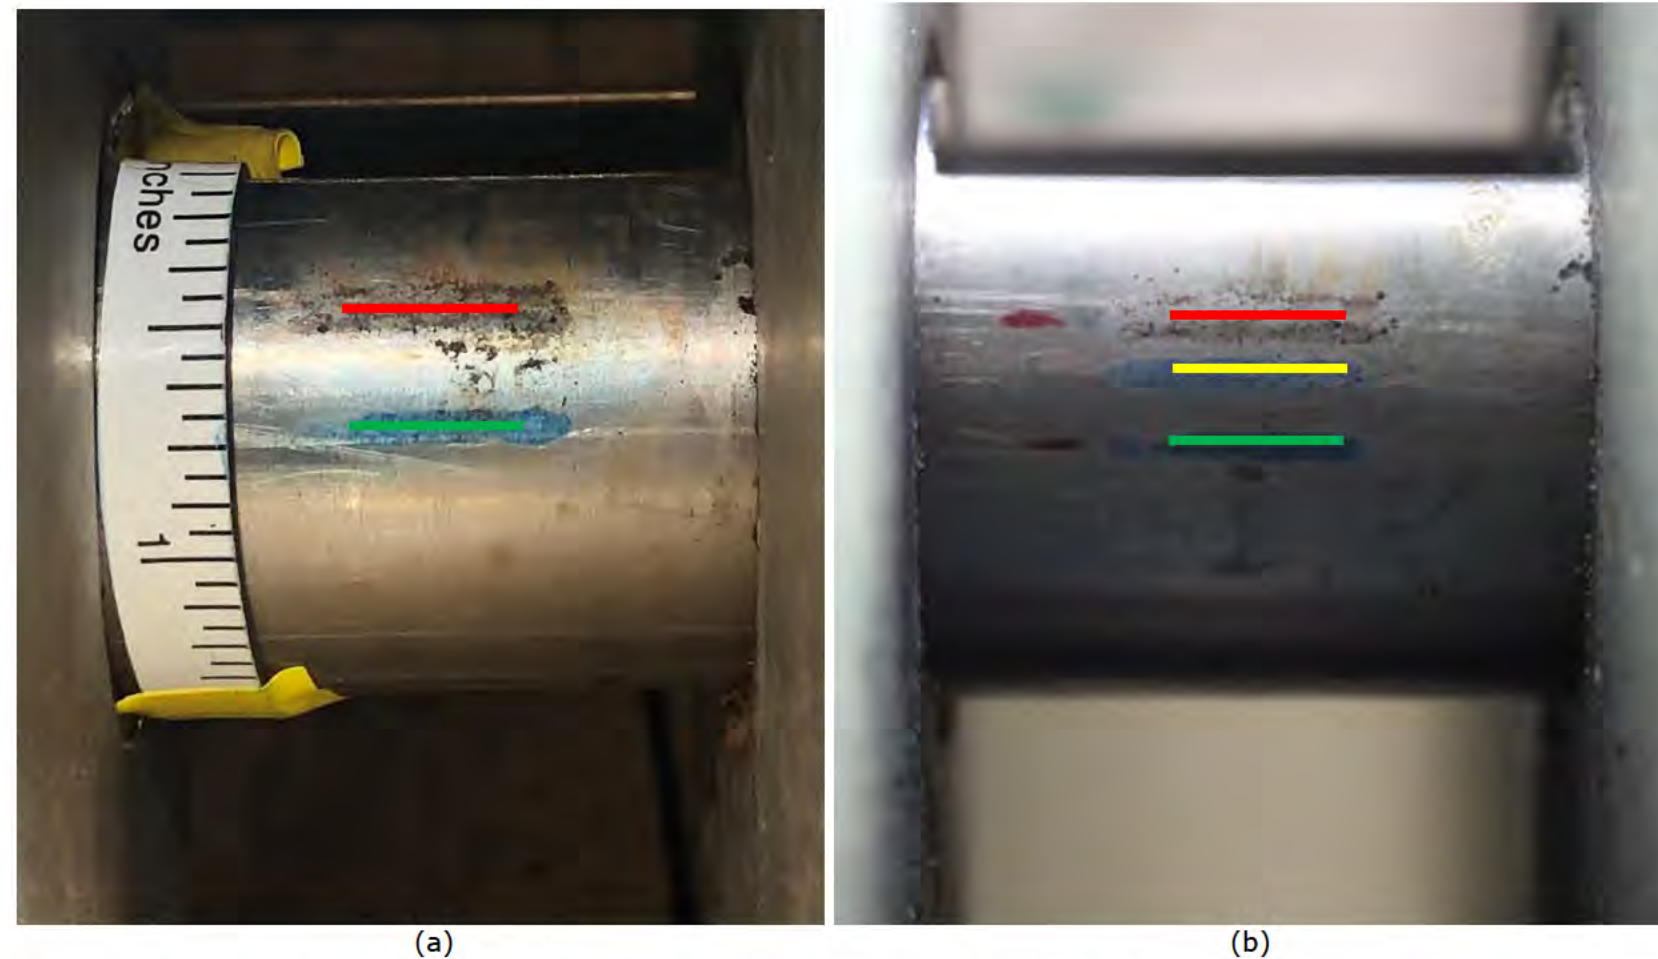
Figure 67. Photographs of the locking shaft from the Subject Aft Hook installed (a) in the Subject Aft Hook and (b) in the Exemplar Hook with the clevises and bulkhead nuts set to the as-found condition of the subject components. In both cases, the Subject Release Unit was in the closed position and the Exemplar Cable was used. The blue markings were produced by placing articulating paper between the hook roller and locking shaft contact location. The green line indicates the contact location between the hook roller and locking shaft when the locking shaft arm is fully closed. The red line is consistent with an area of corrosion and wear. The yellow line indicates the contact location between the hook roller and locking shaft when the release unit is closed, but the locking shaft arm is rotated as far as possible towards the open orientation. The red line is consistent with an area of corrosion and wear.

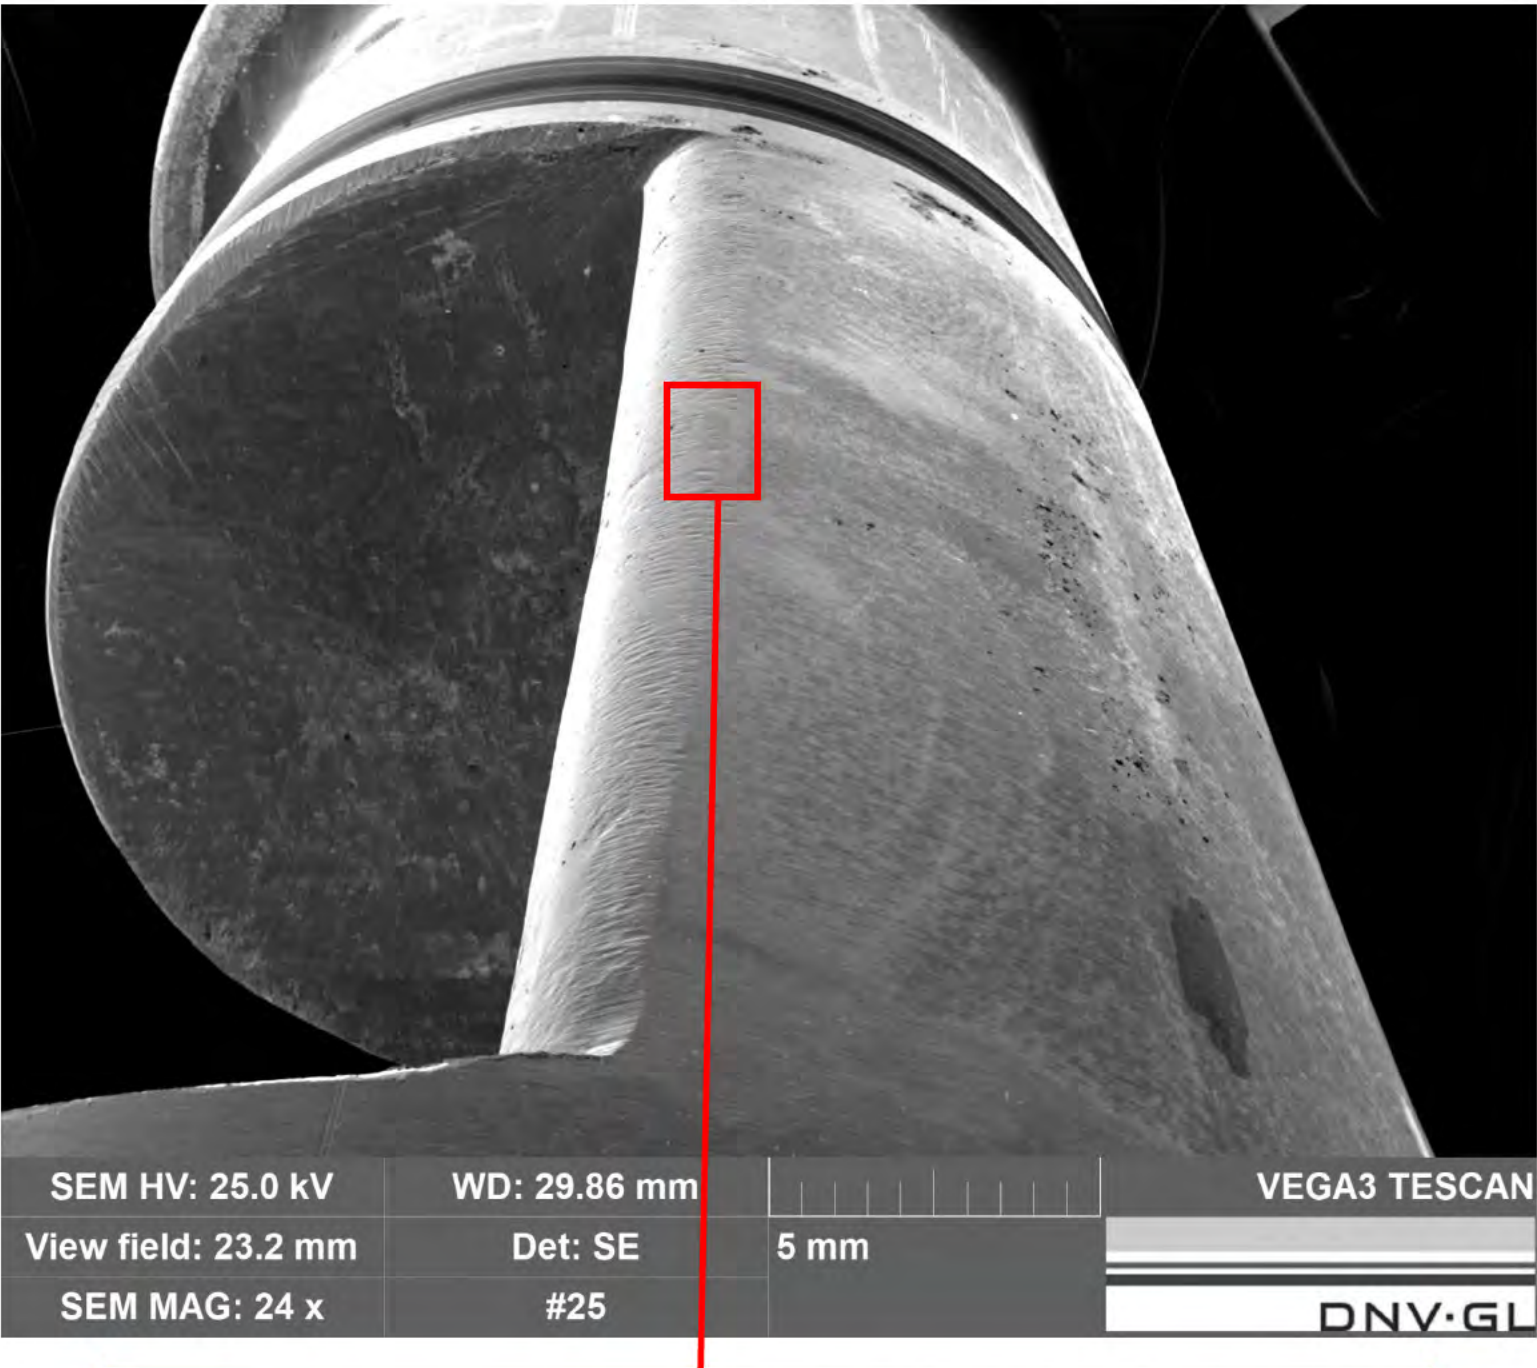
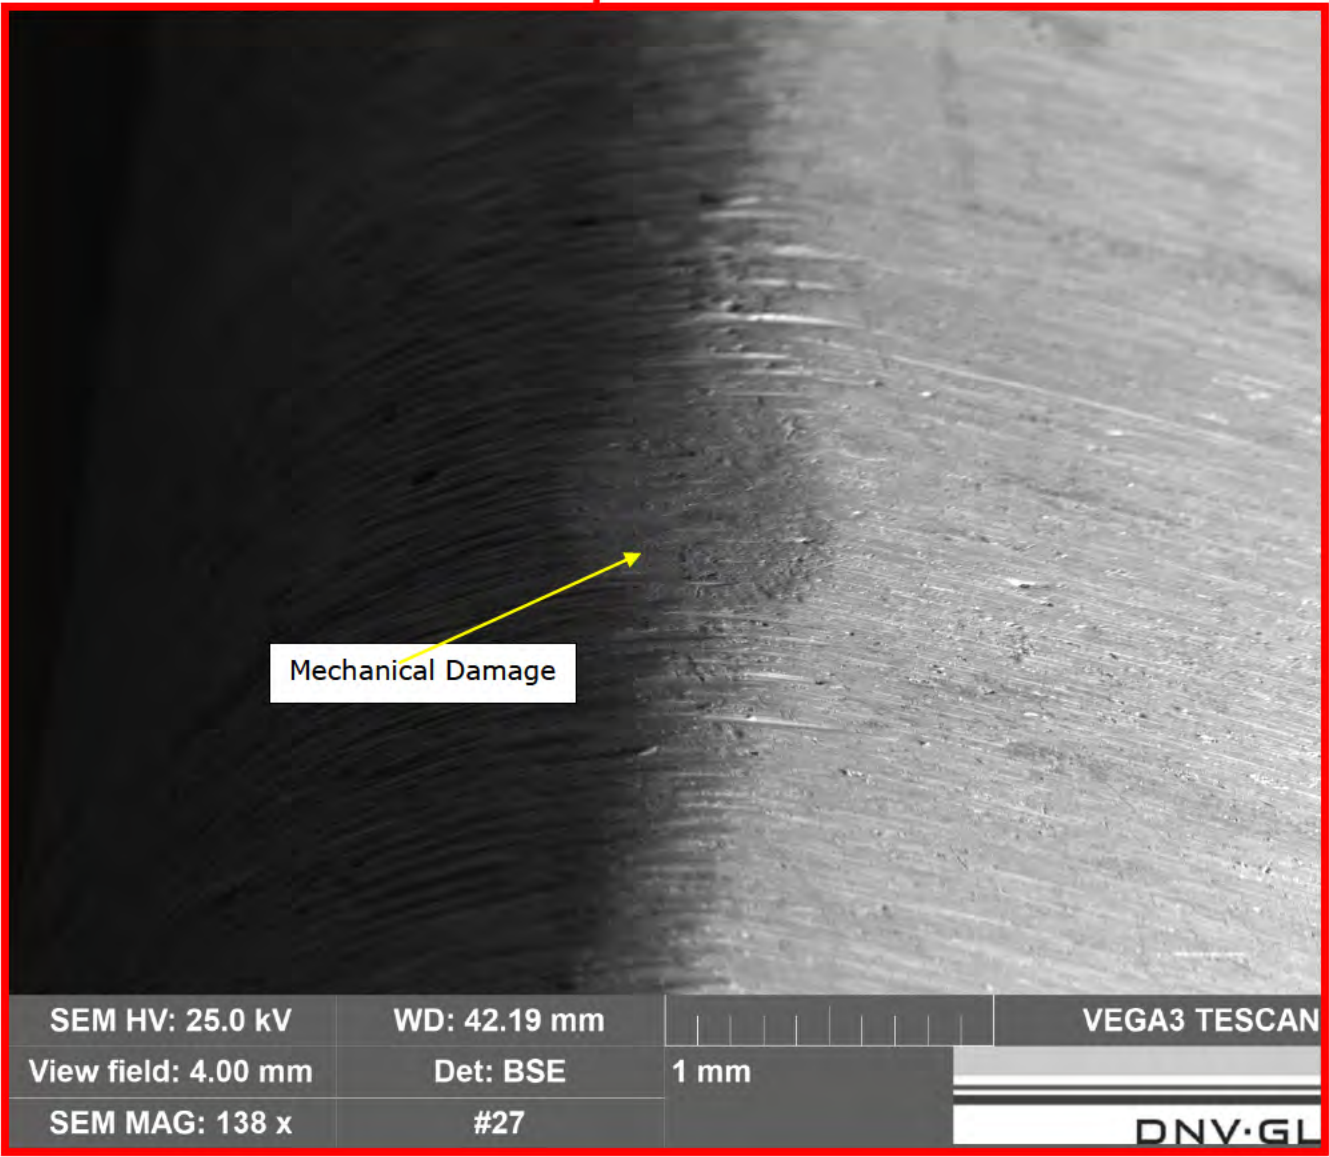
Figure 69. SEM images showing mechanical damage near the transition to the flat of the locking shaft from the Subject Aft Hook.

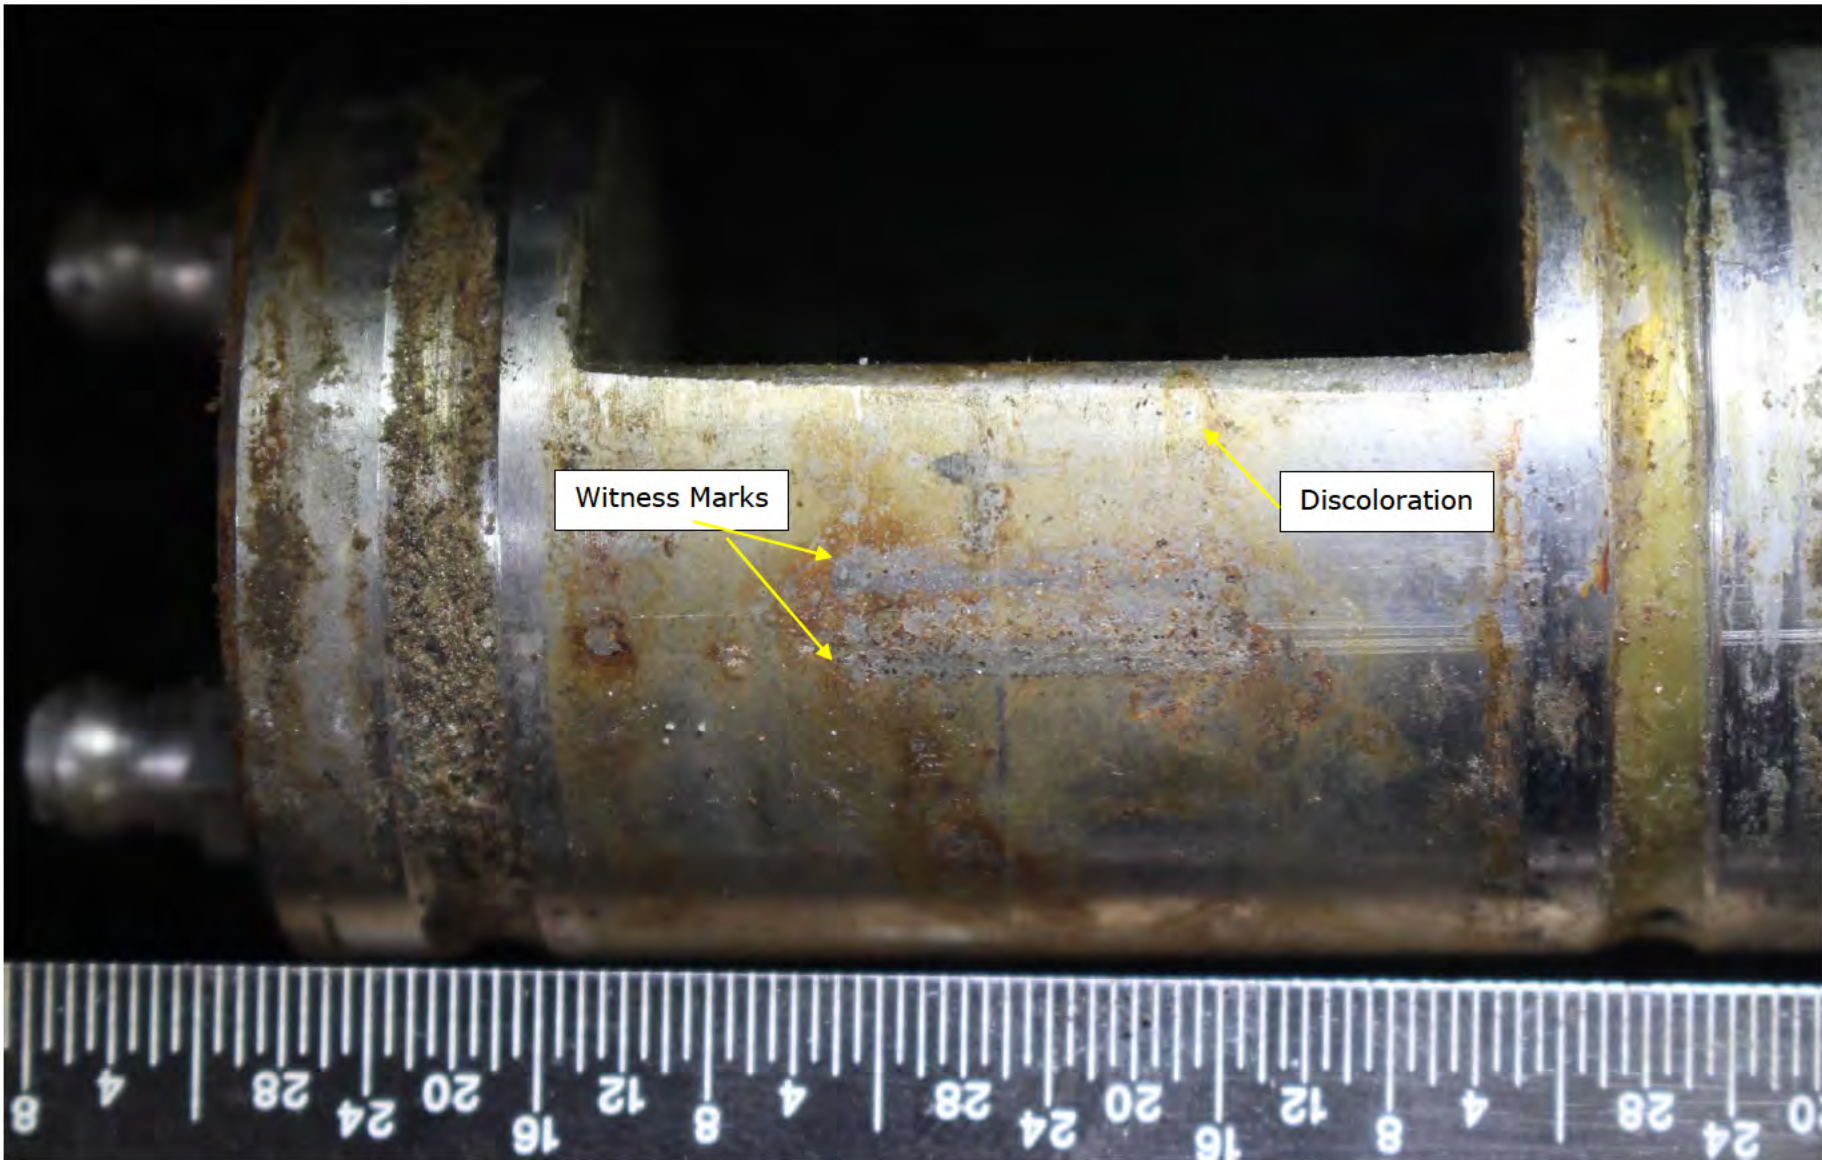
Figure 75. Photograph of the locking shaft from the Subject Forward Hook showing an area with corrosion attack on the round of the locking shaft; area shown in Figure 73. Ruler is in inches.

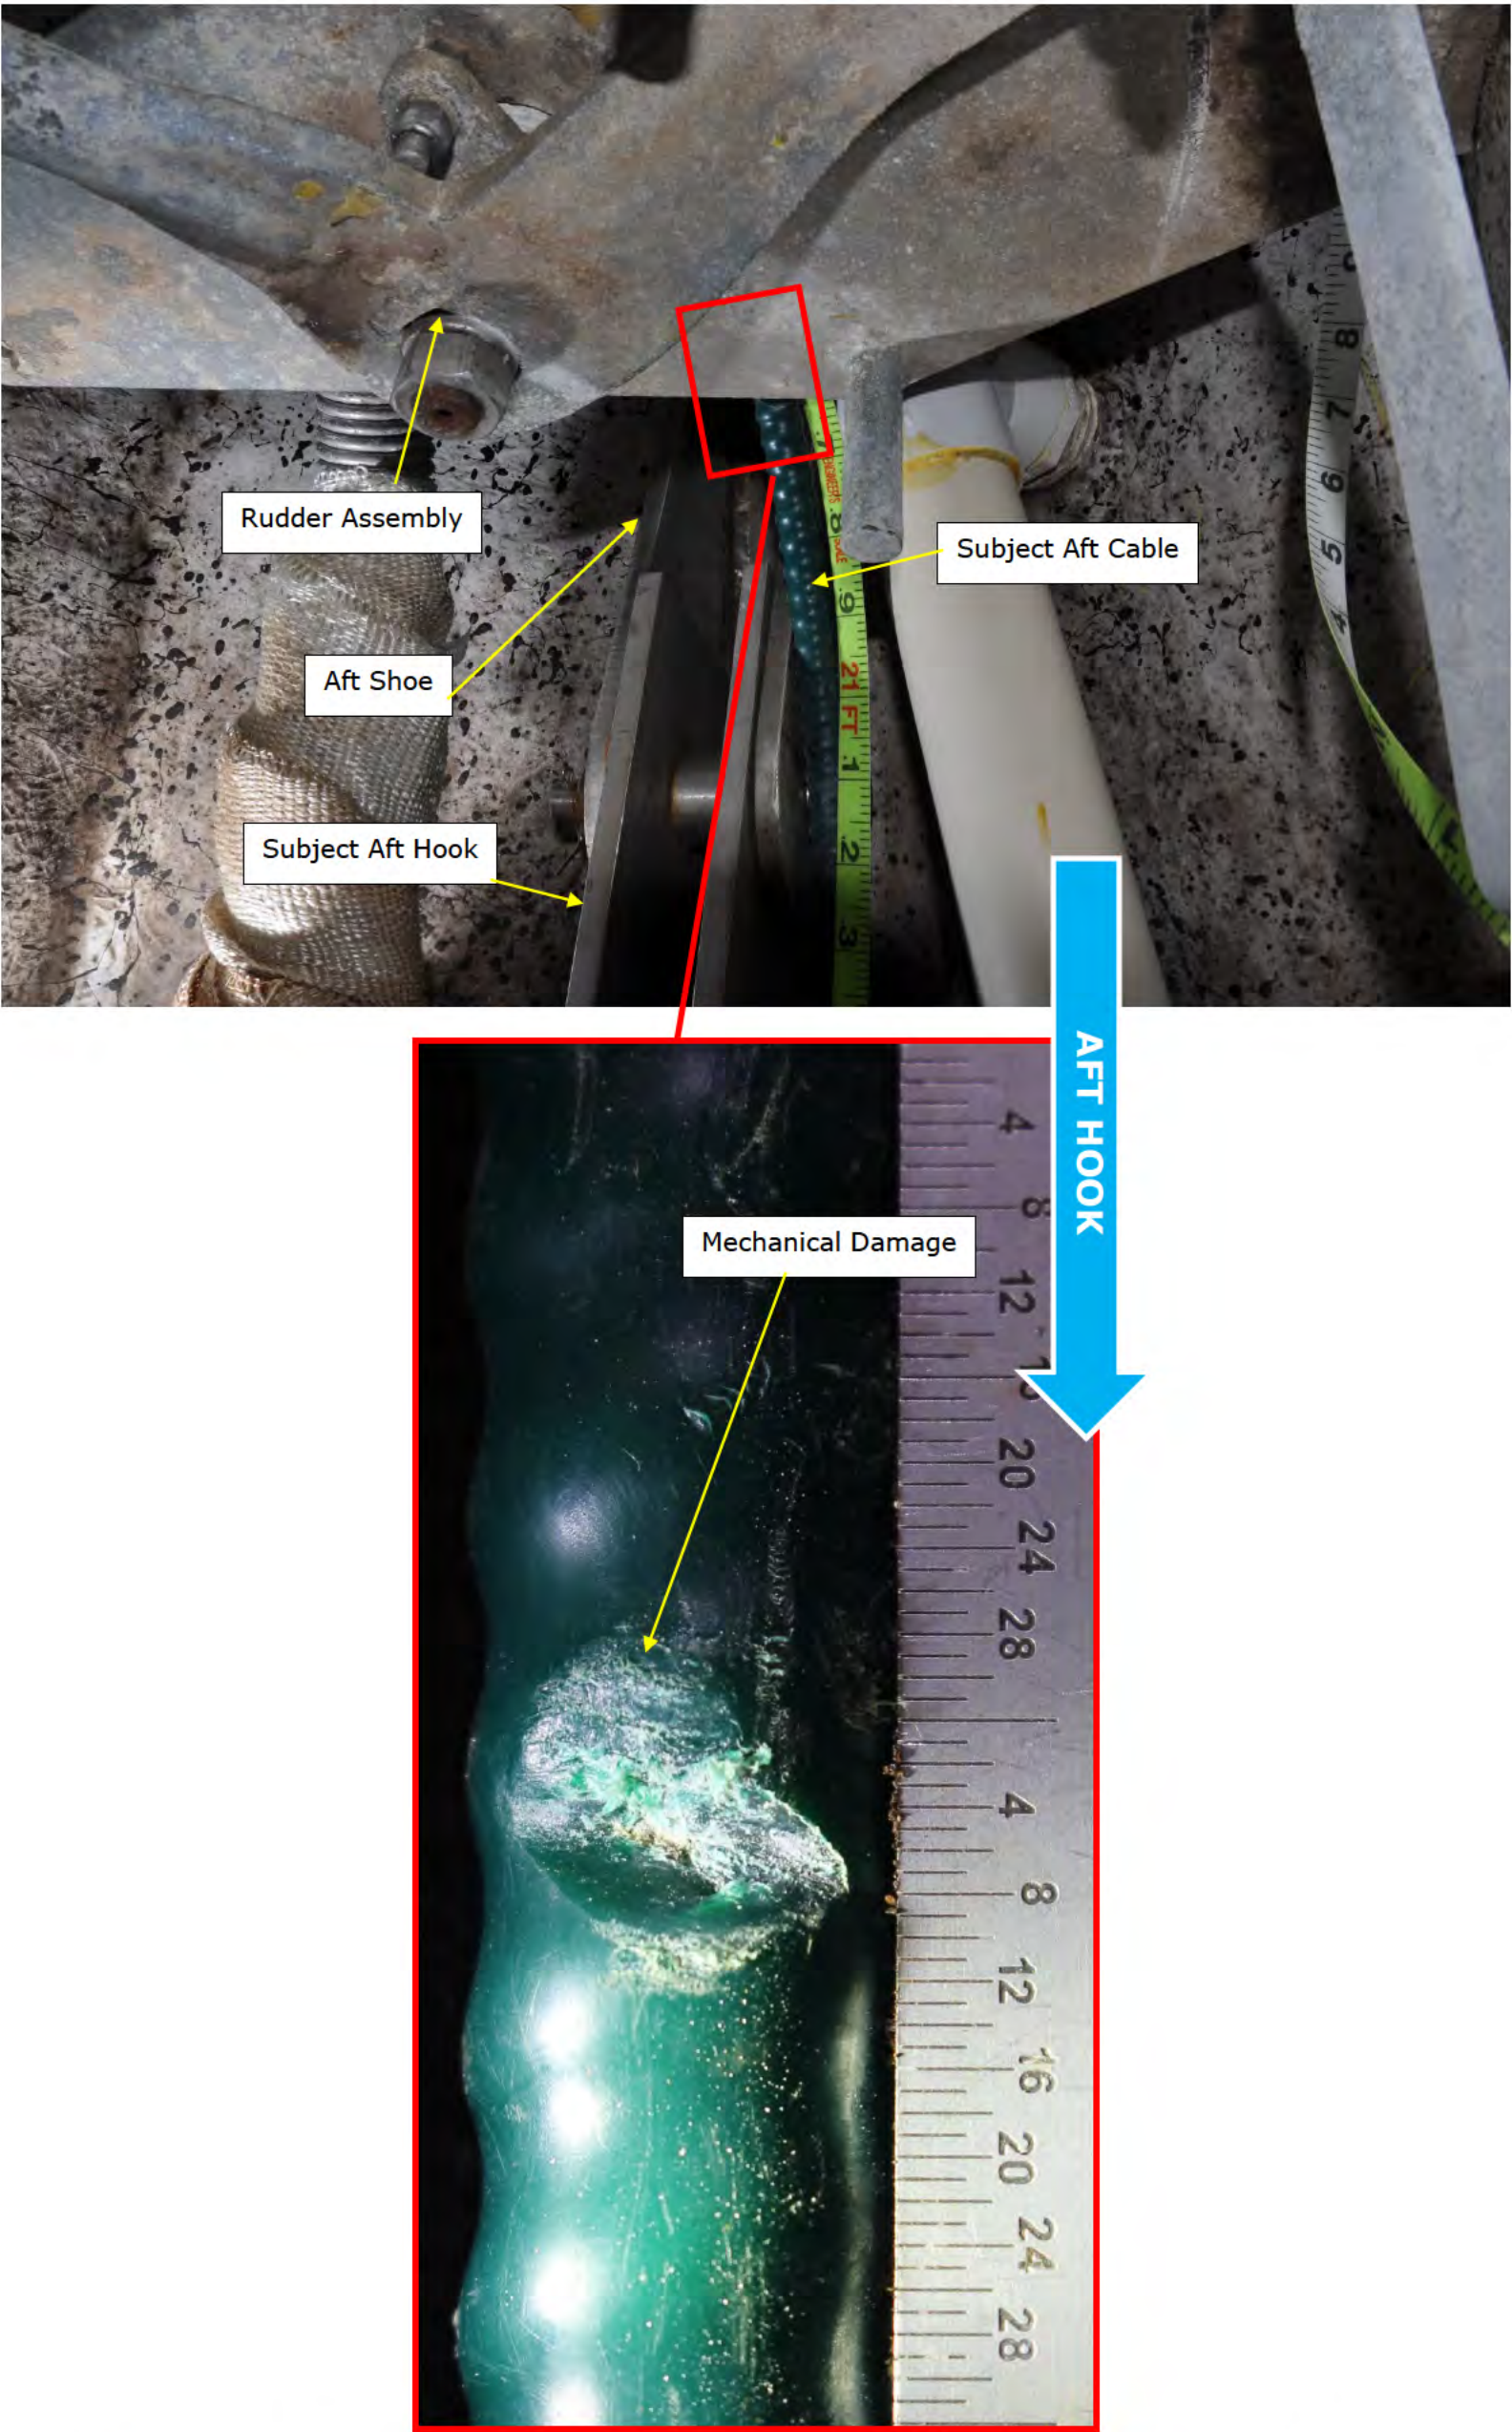
Figure 104. Photographs showing mechanical damage to the cover layer of the Subject Aft Cable 20.63 feet from the conduit cap at the Subject Release Unit. The top photograph was taken by DNV GL during a site visit to Harvey Terminal on July 31, 2019 and the lower photograph was taken at DNV GL's laboratory in Dublin, Ohio. The direction of the Subject Aft Hook is noted with the blue arrow. Tape measure is in feet and ruler is in inches.

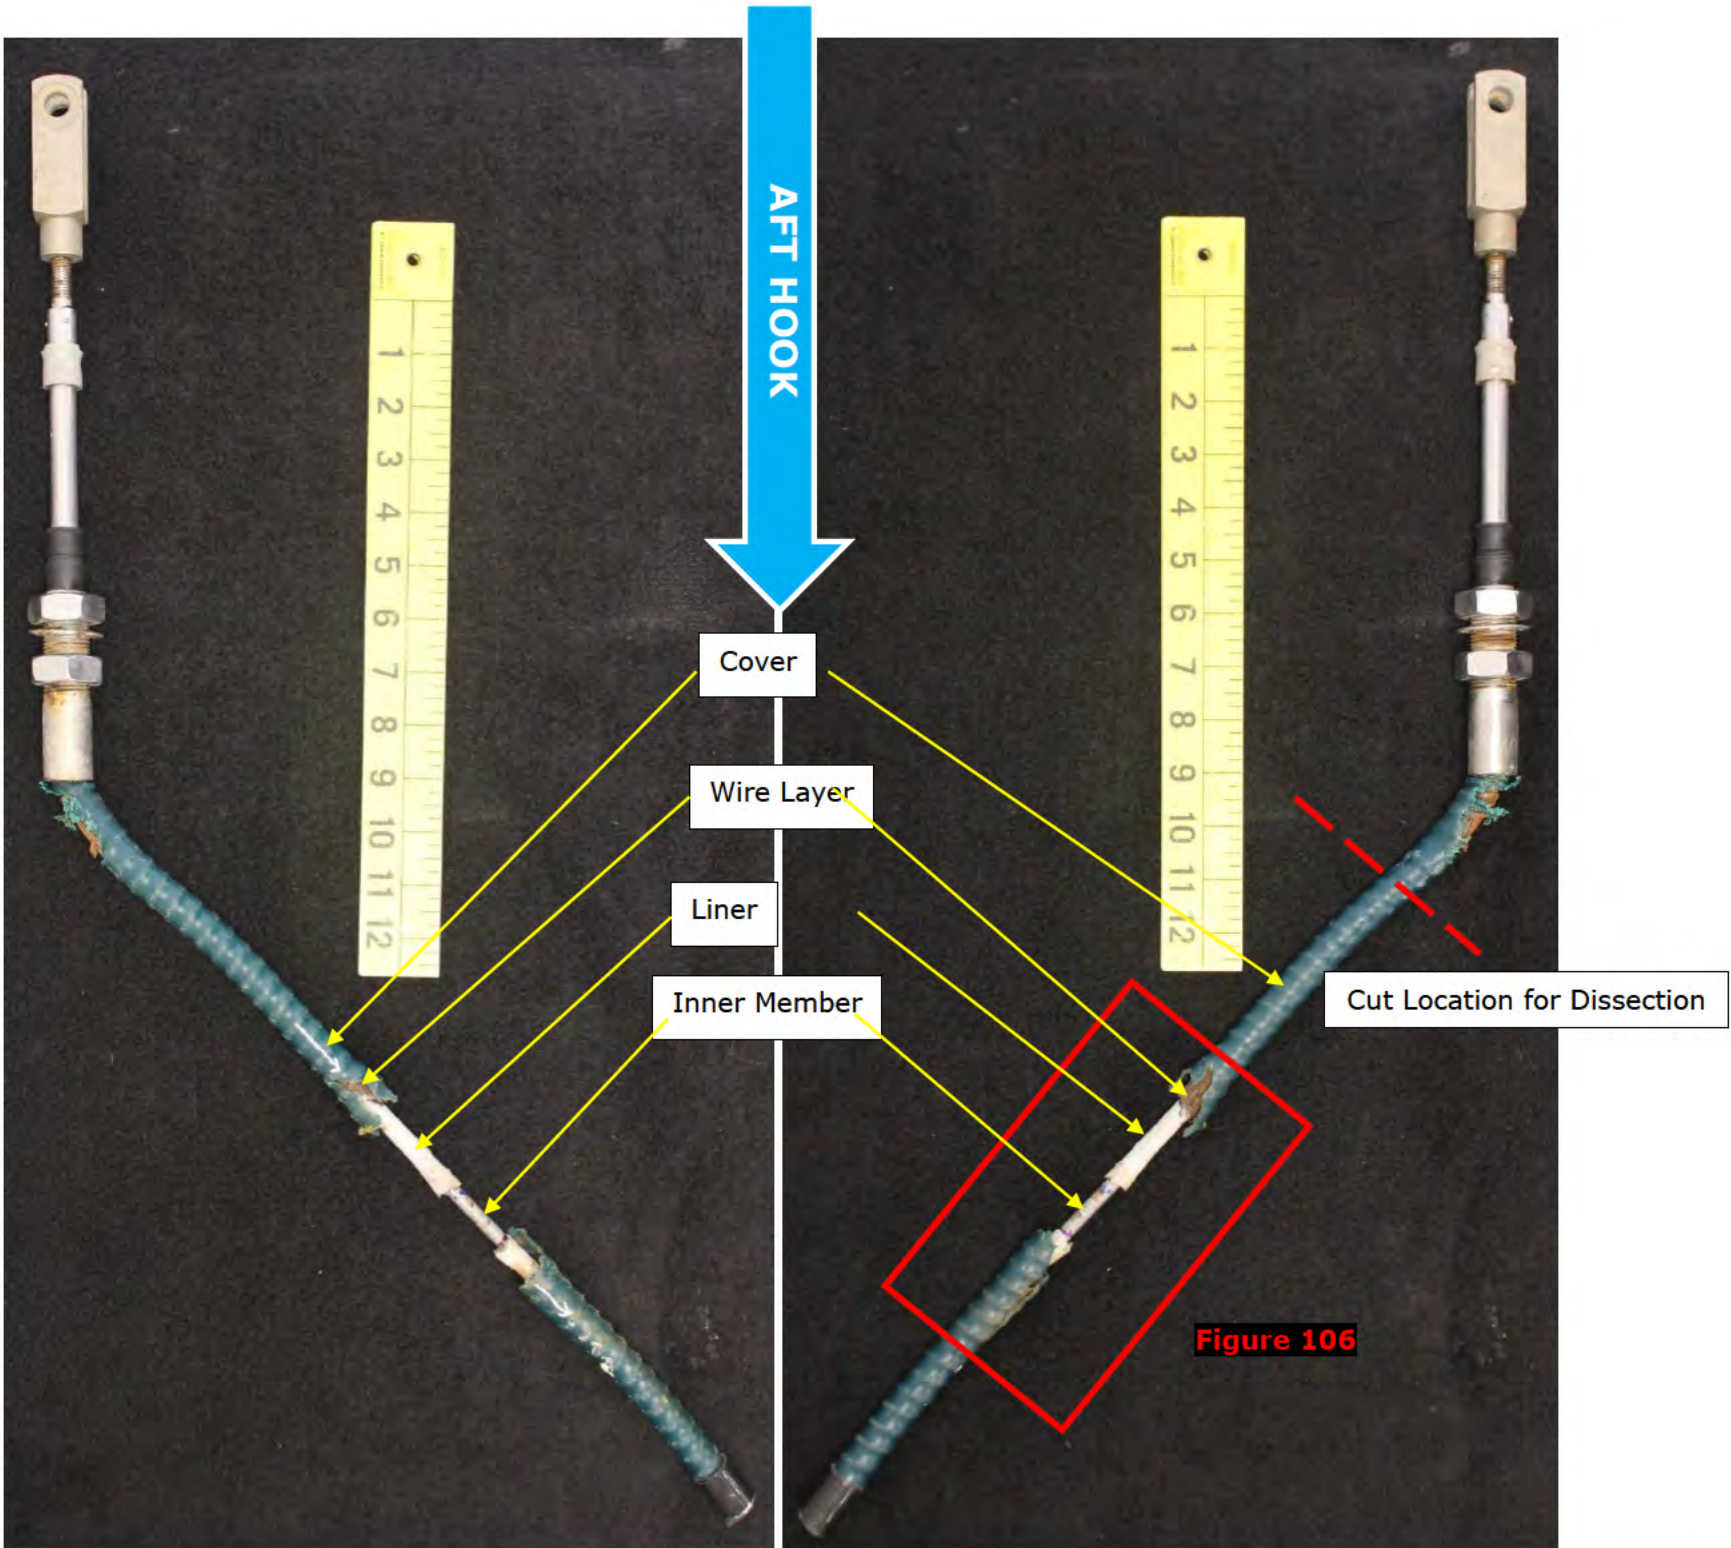
Figure 105. Photographs of the Subject Aft Cable after removing a section with the failure in the outer layers. The direction of the Subject Aft Hook is noted with the blue arrow. Rulers are in inches.

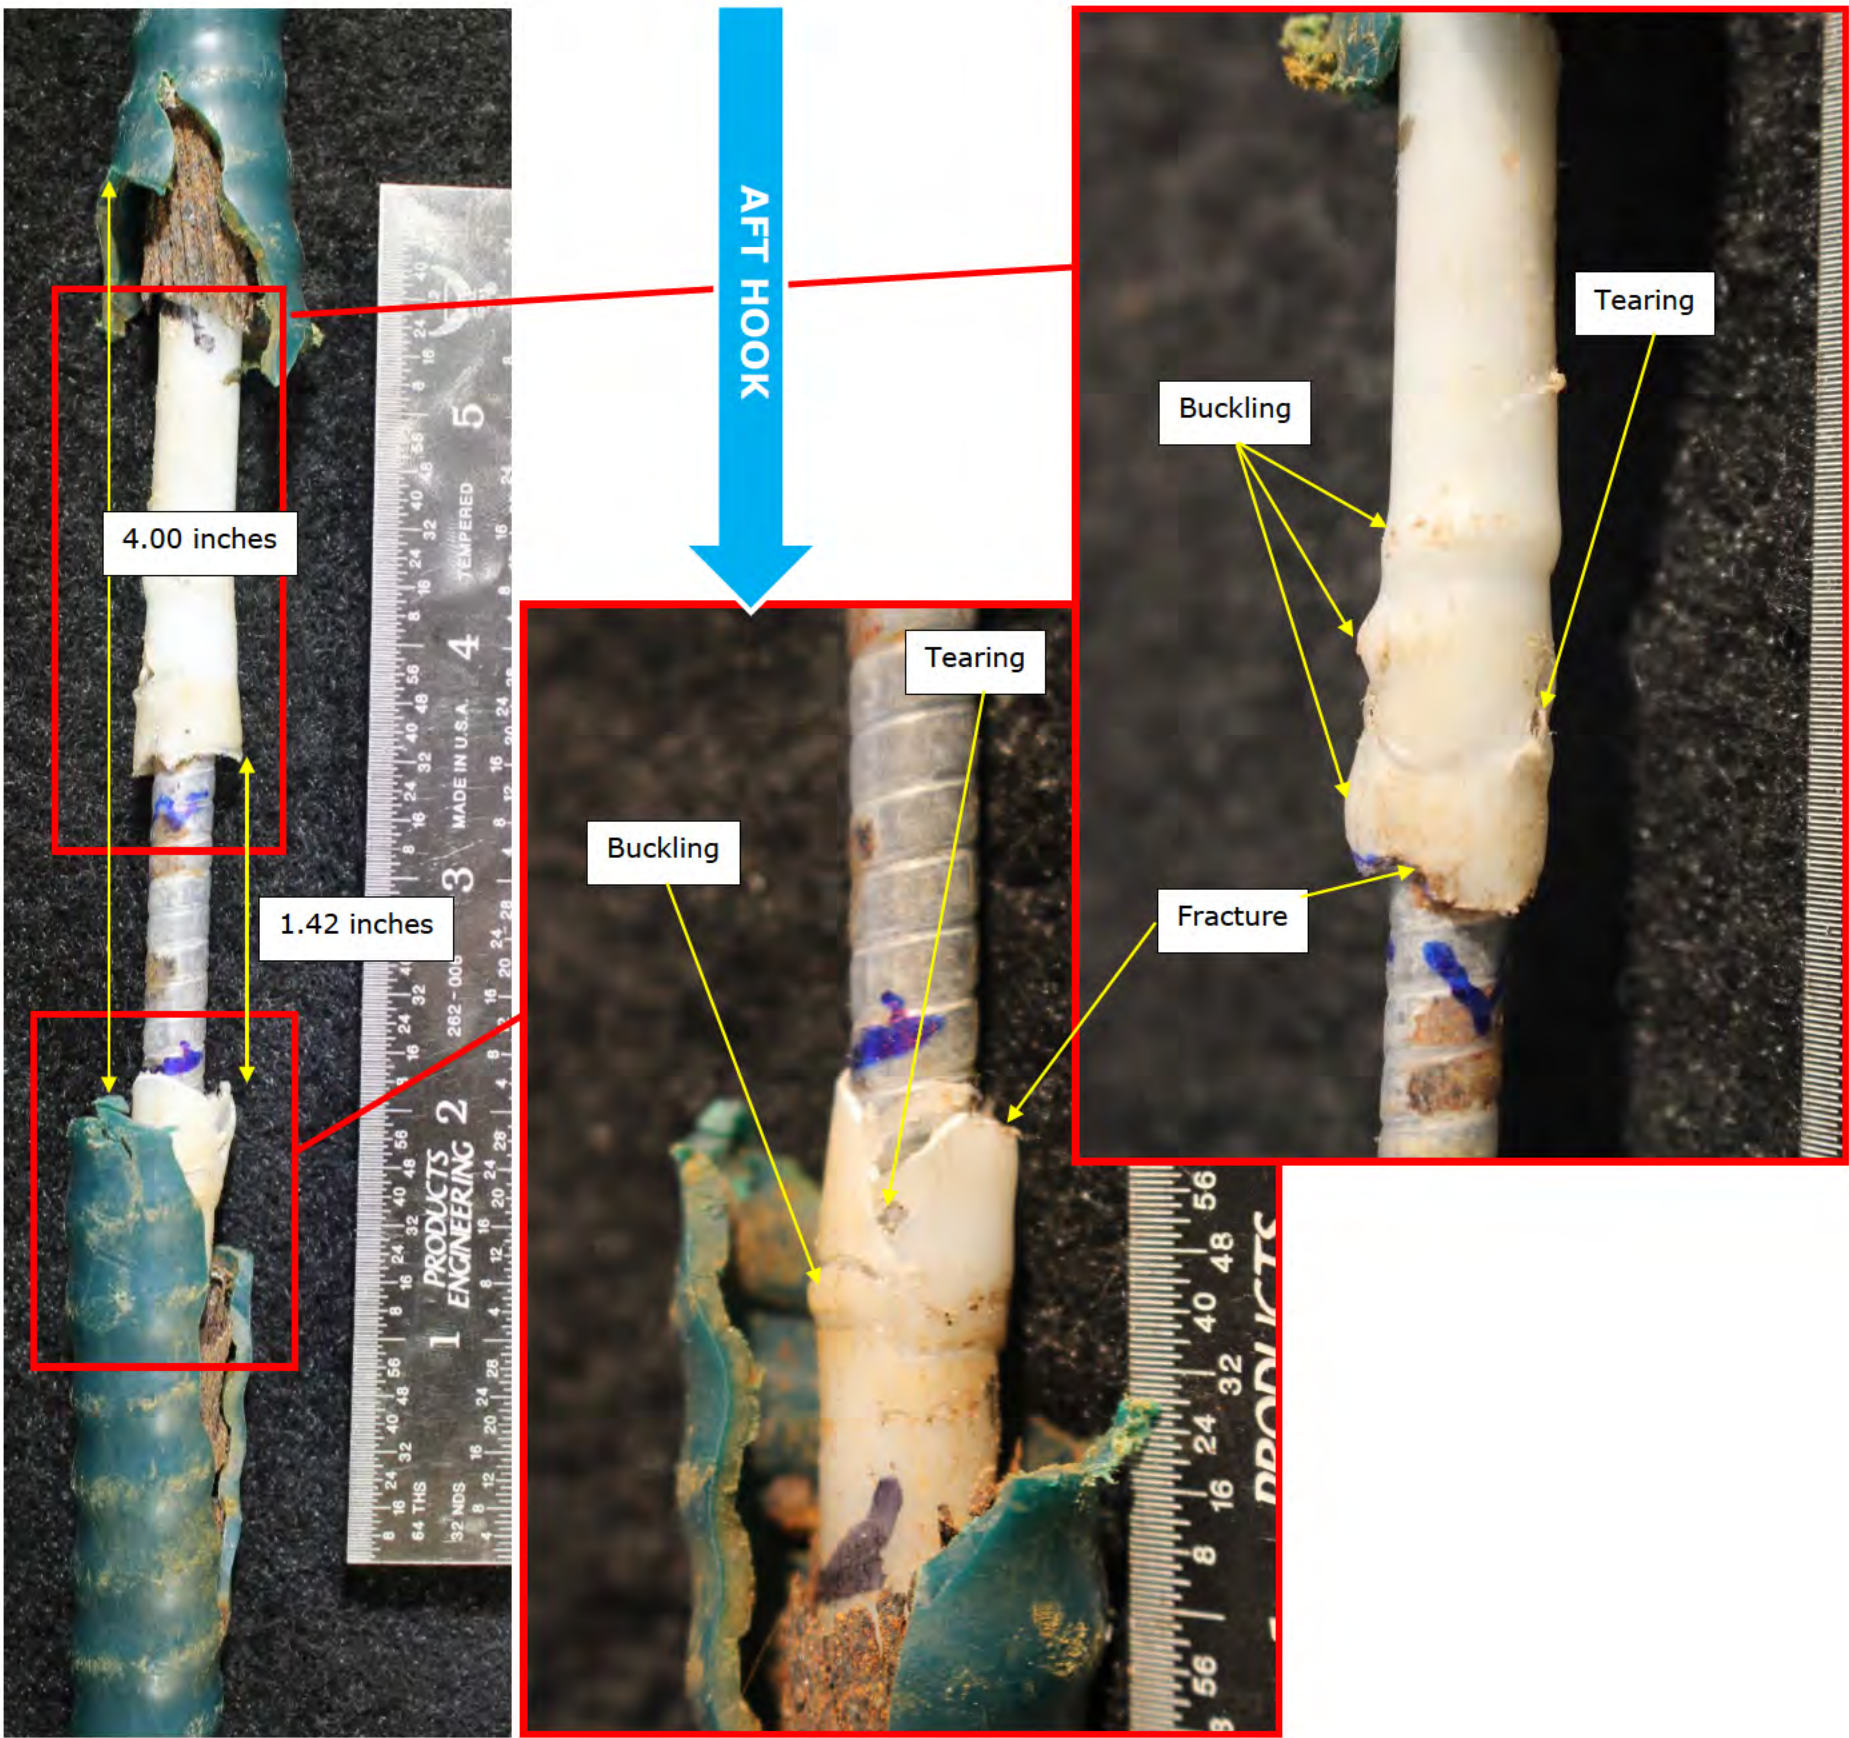
Figure 106. Photographs of the Subject Aft Cable showing the detail of the failure. The direction of the Subject Aft Hook is noted with the blue arrow. Rulers are in inches.

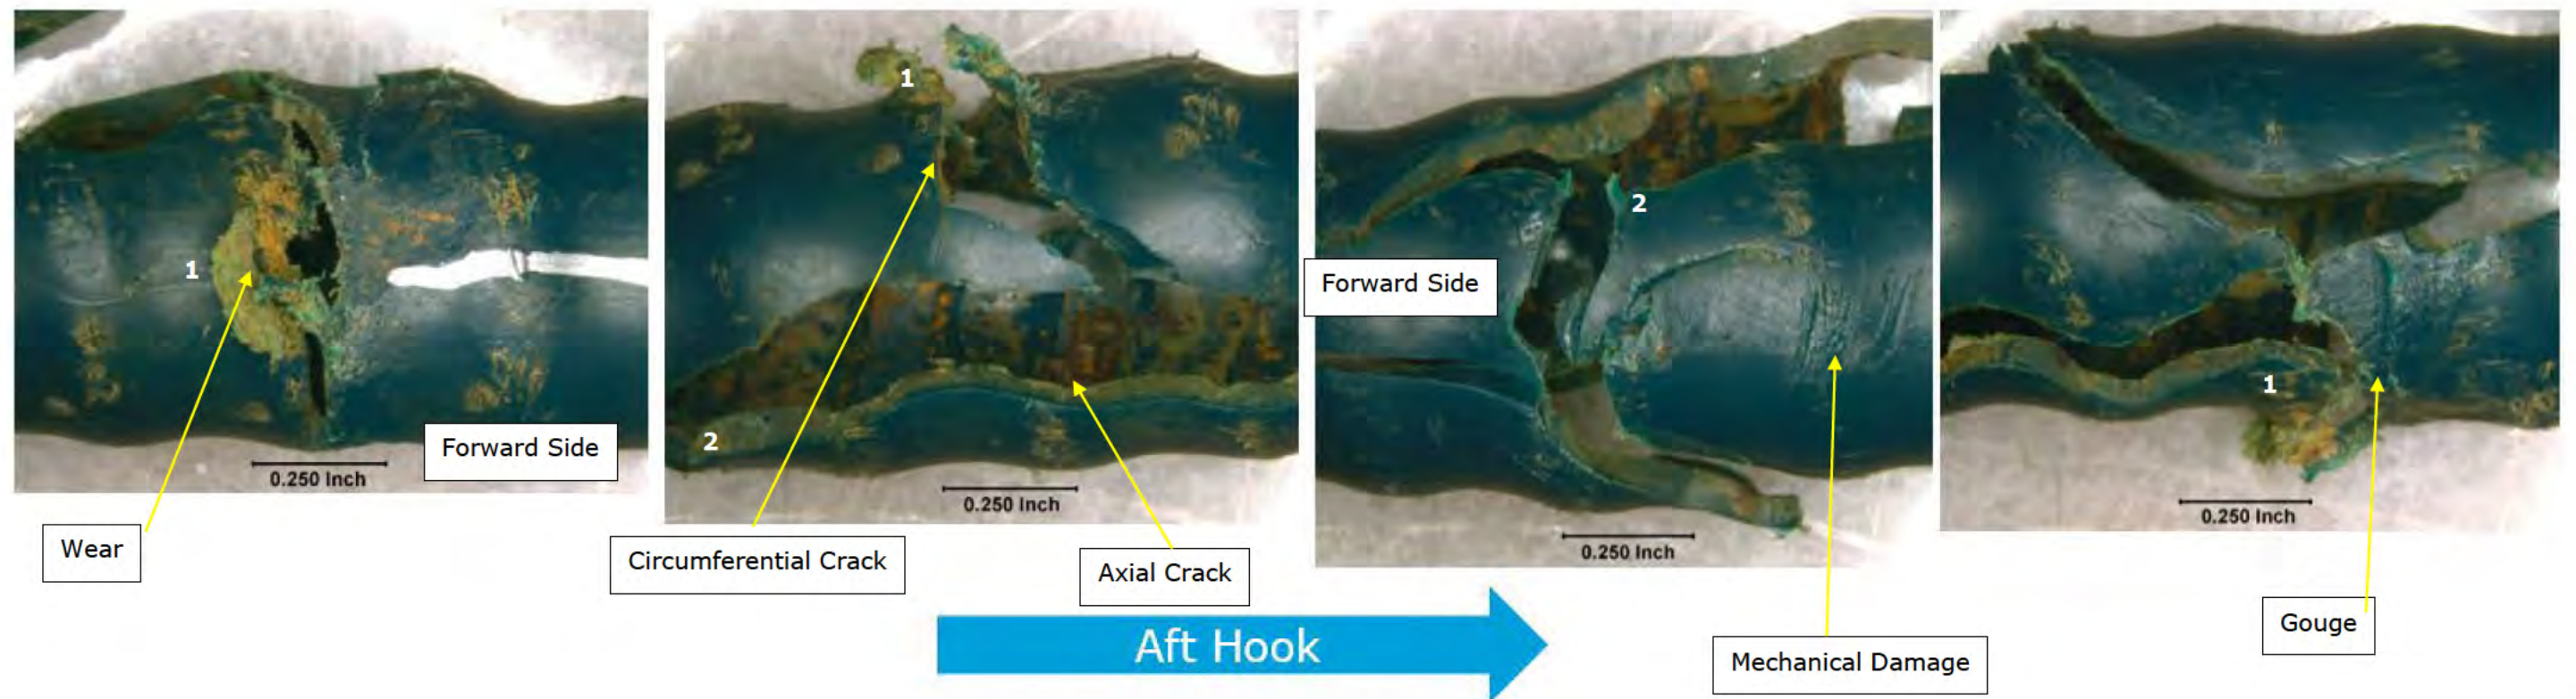
Figure 111. Light photomicrographs of the cover from the Subject Aft Cable after matching the fractures surfaces at the failure. The numbers "1" and "2" are reference locations. Forward and aft refer to the orientation of the cover relative to the lifeboat. The direction of the Subject Aft Hook is noted with the blue arrow.

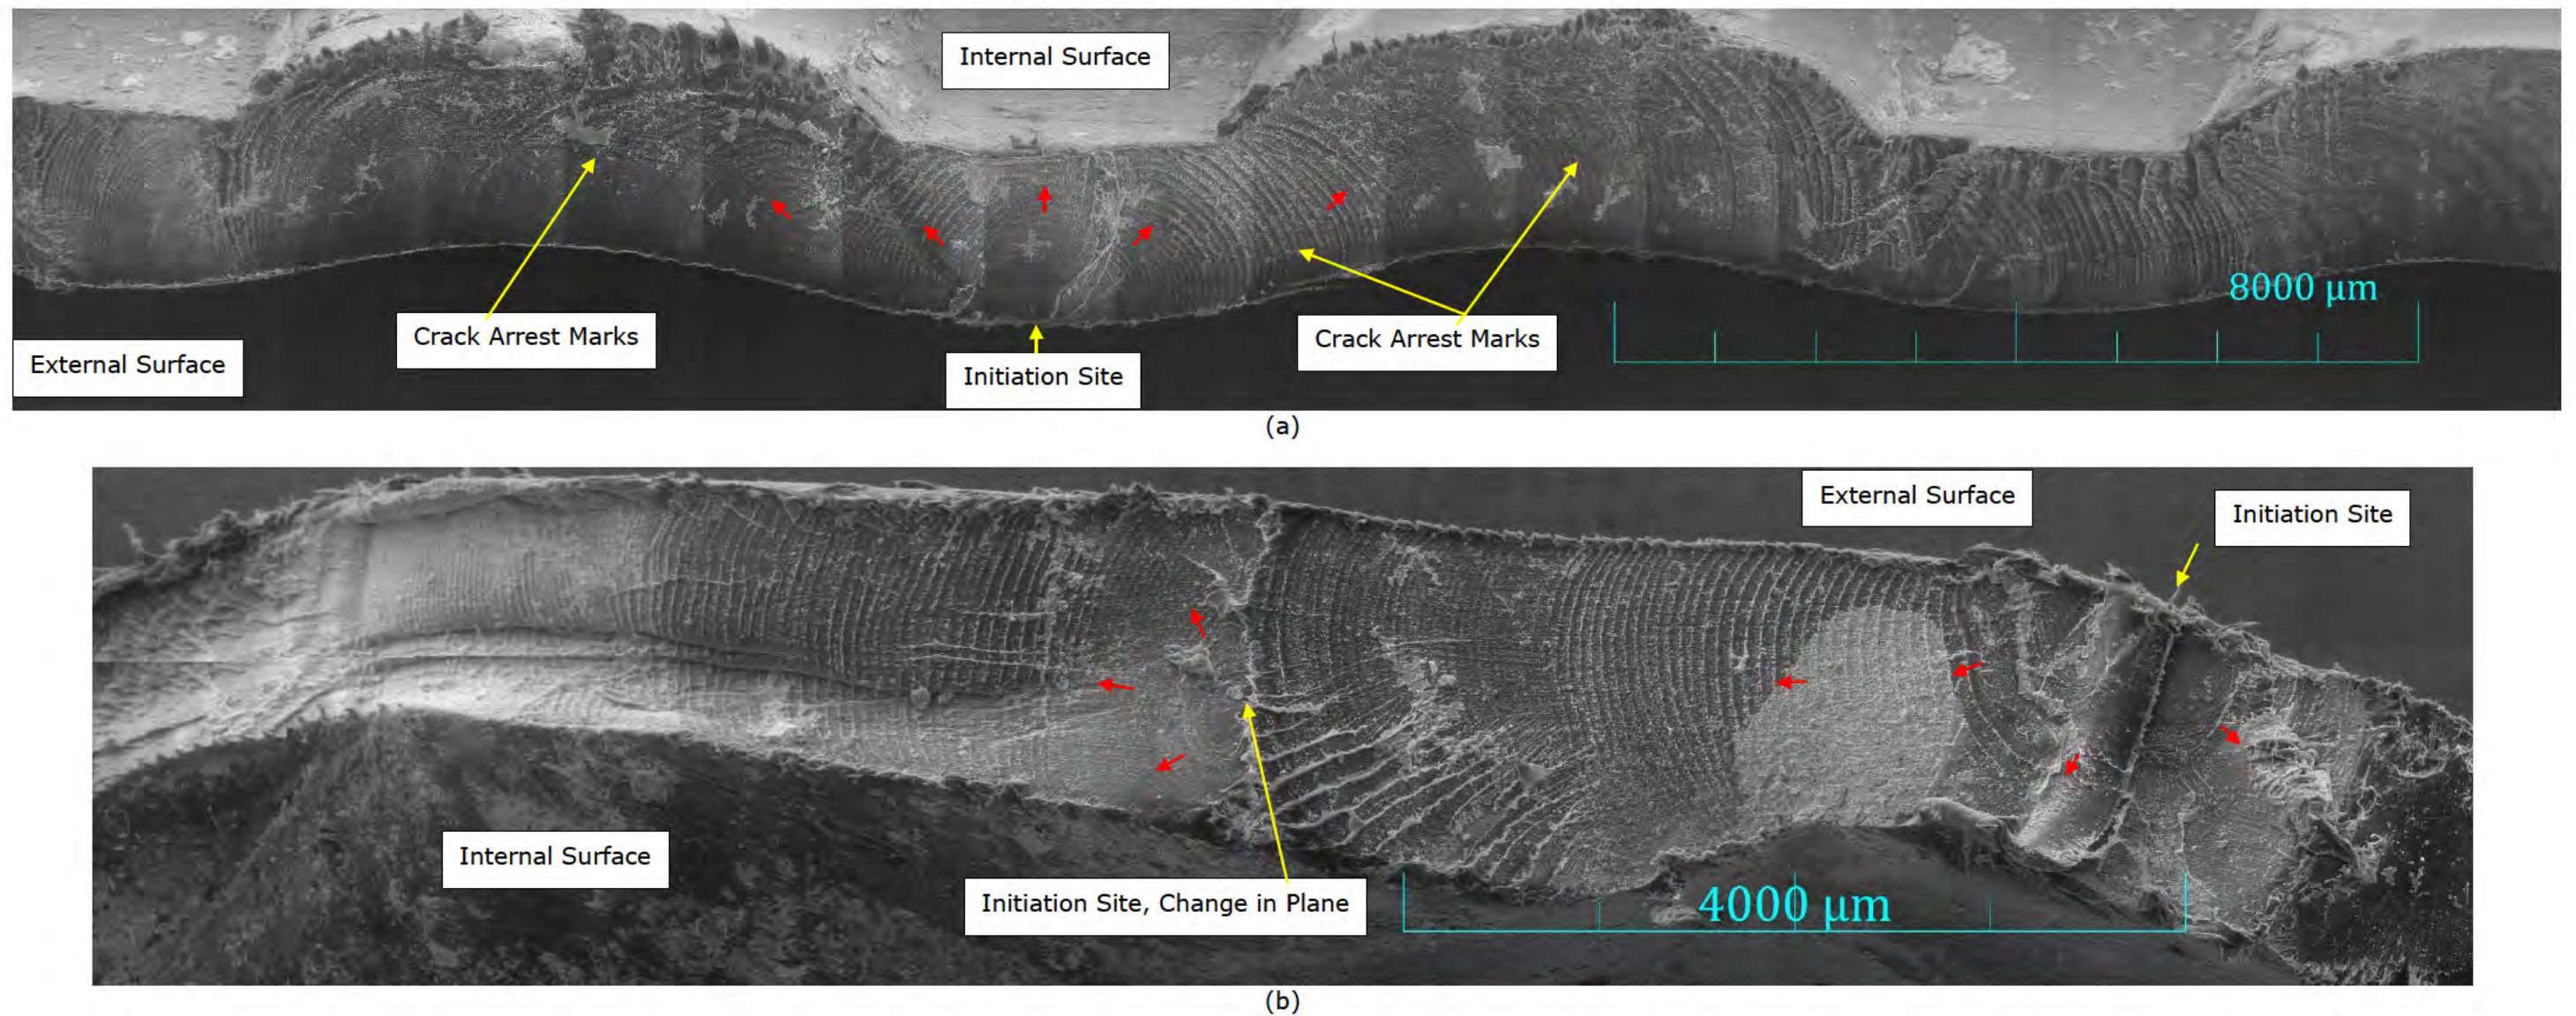
Figure 112. Montages of SEM images taken of the fracture surfaces from the cover of the Subject Aft Cable showing crack arrest marks and initiation sites; locations for (a) and (b) are shown in Figure 110. The red arrow indicated the direction of fatigue propagation.
