Final Report

Auger Lifeboat 6 Incident

Shell Oil Company
Houston, Texas, USA

Report No.: O-AP-FINV / BPADG (10165575)
July 9, 2020

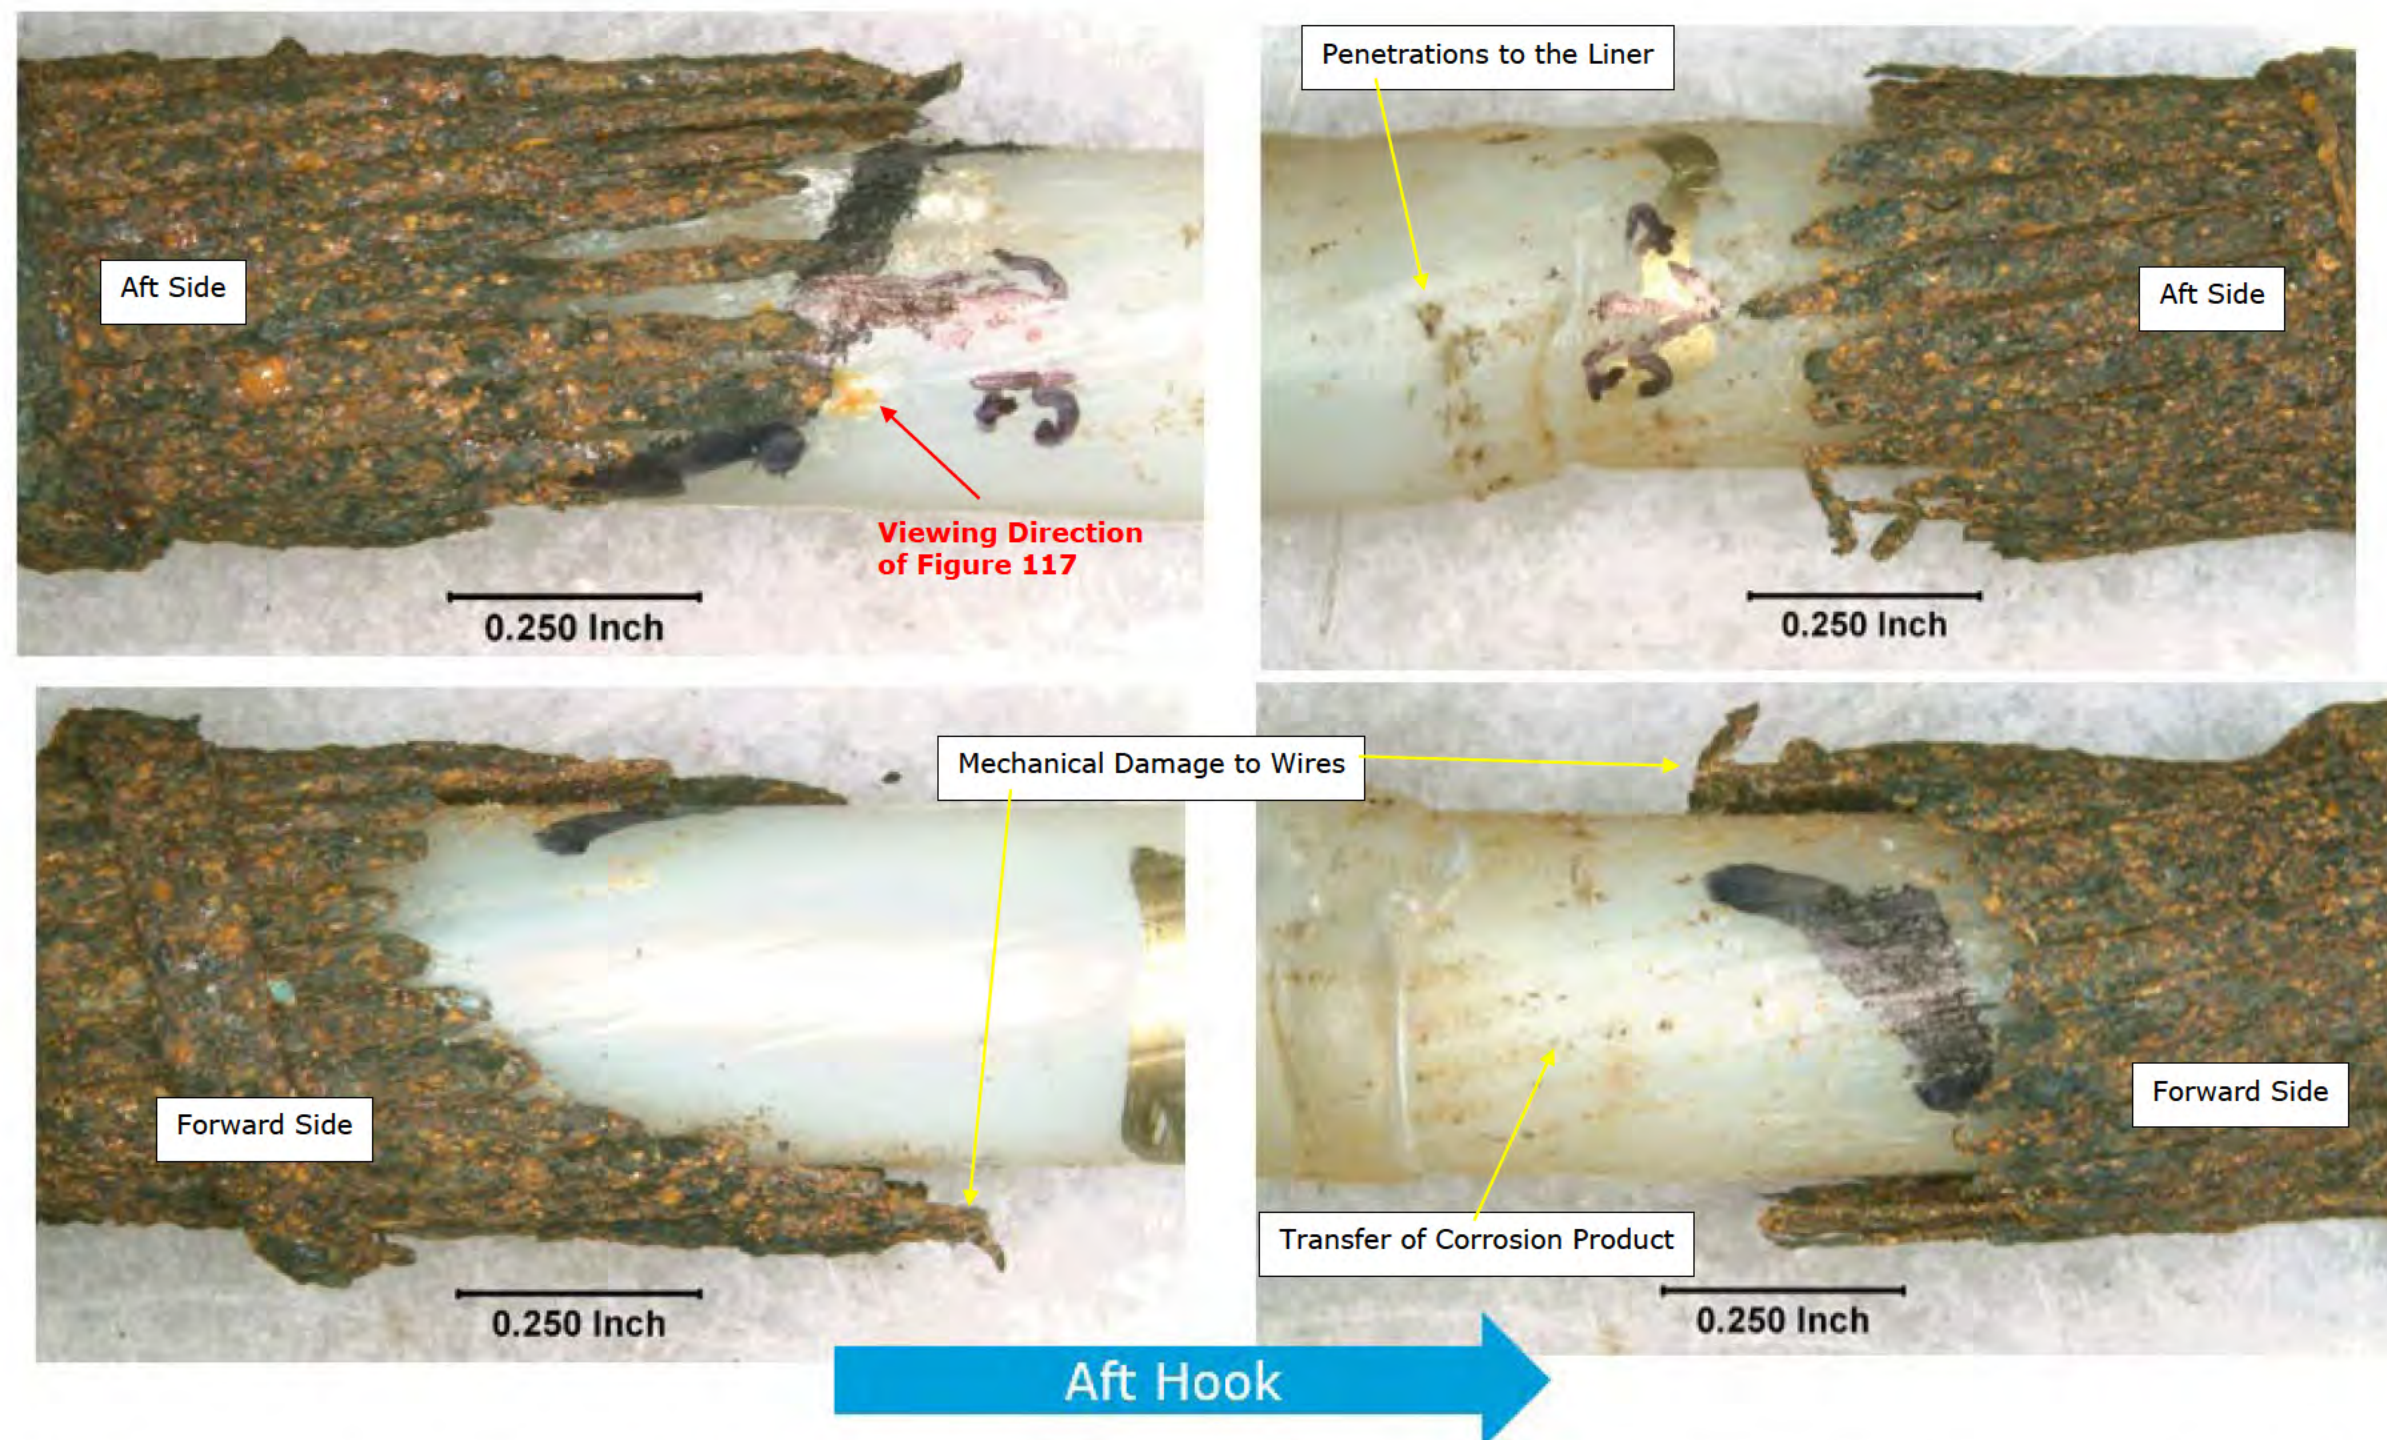
Figure 116. Light photomicrographs of the wire layer from the Subject Aft Cable showing the corrosion damage at the failure. The direction of the Subject Aft Hook is noted with the blue arrow.

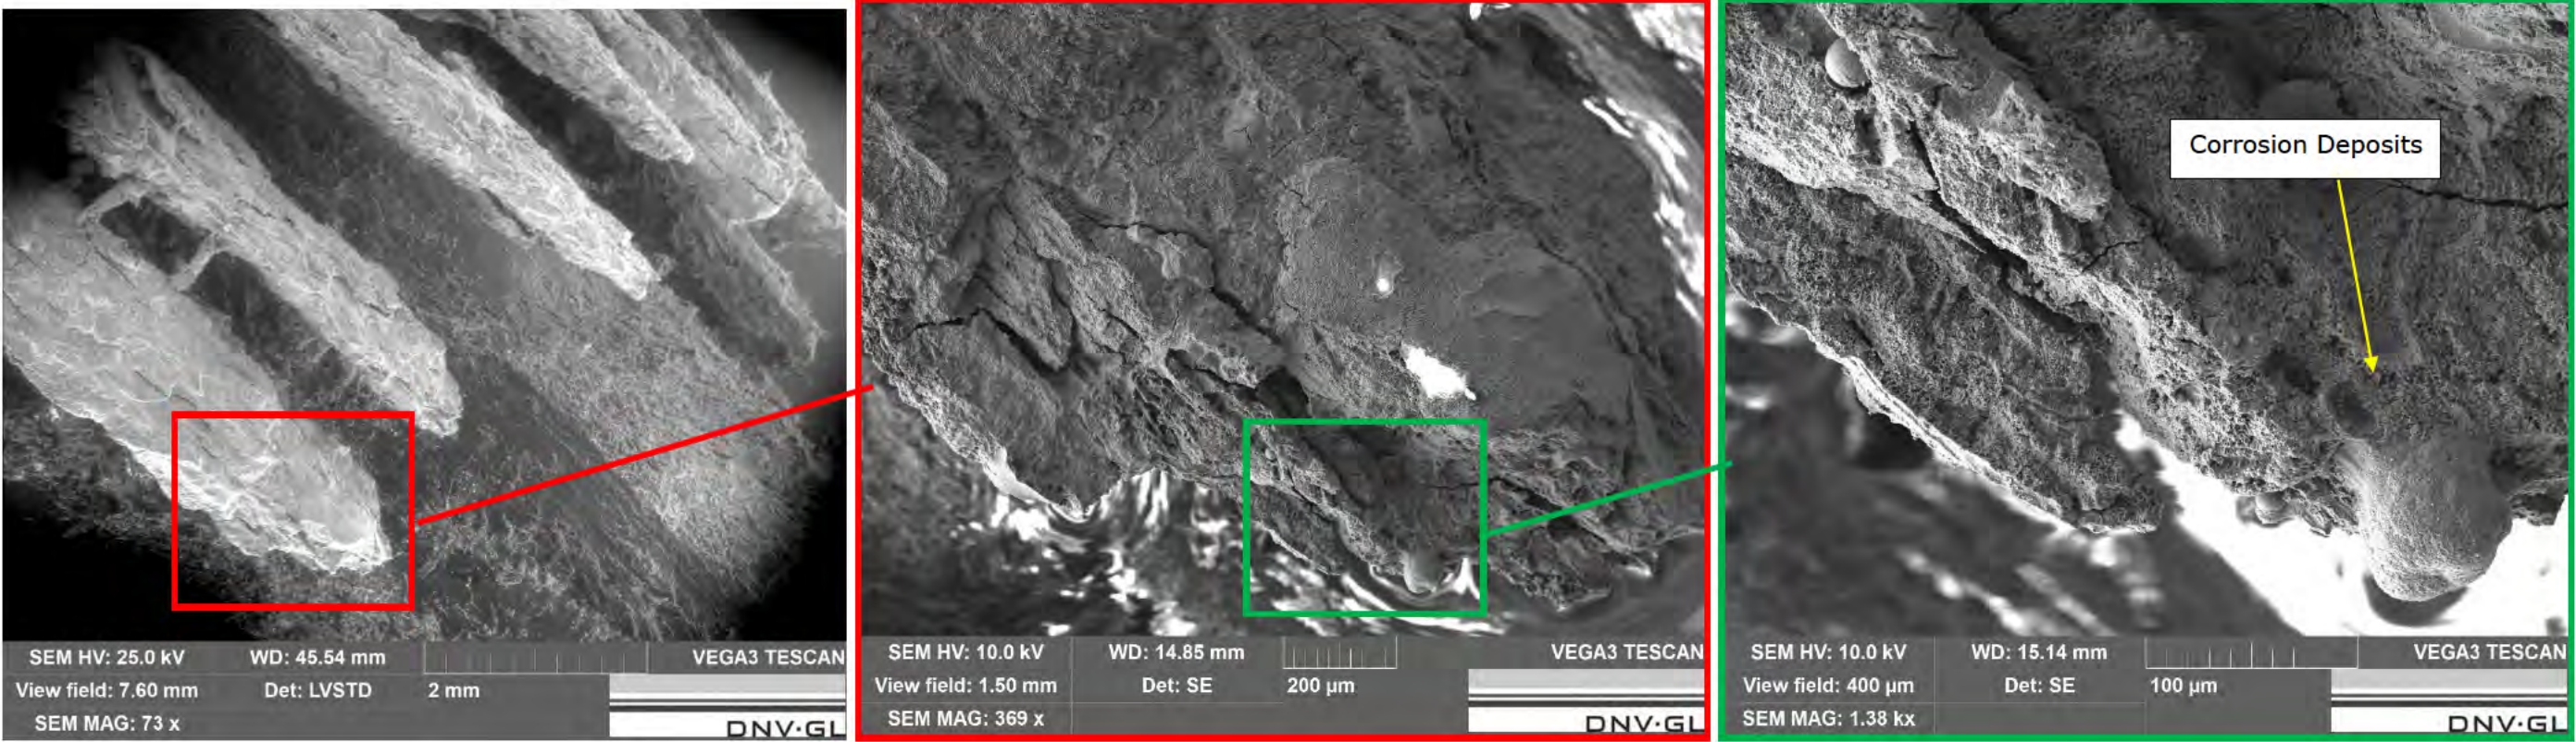
Figure 117. SEM images taken of the strand wires from the wire layer of the Subject Aft Cable showing corrosion damage; viewing direction is shown in Figure 116.

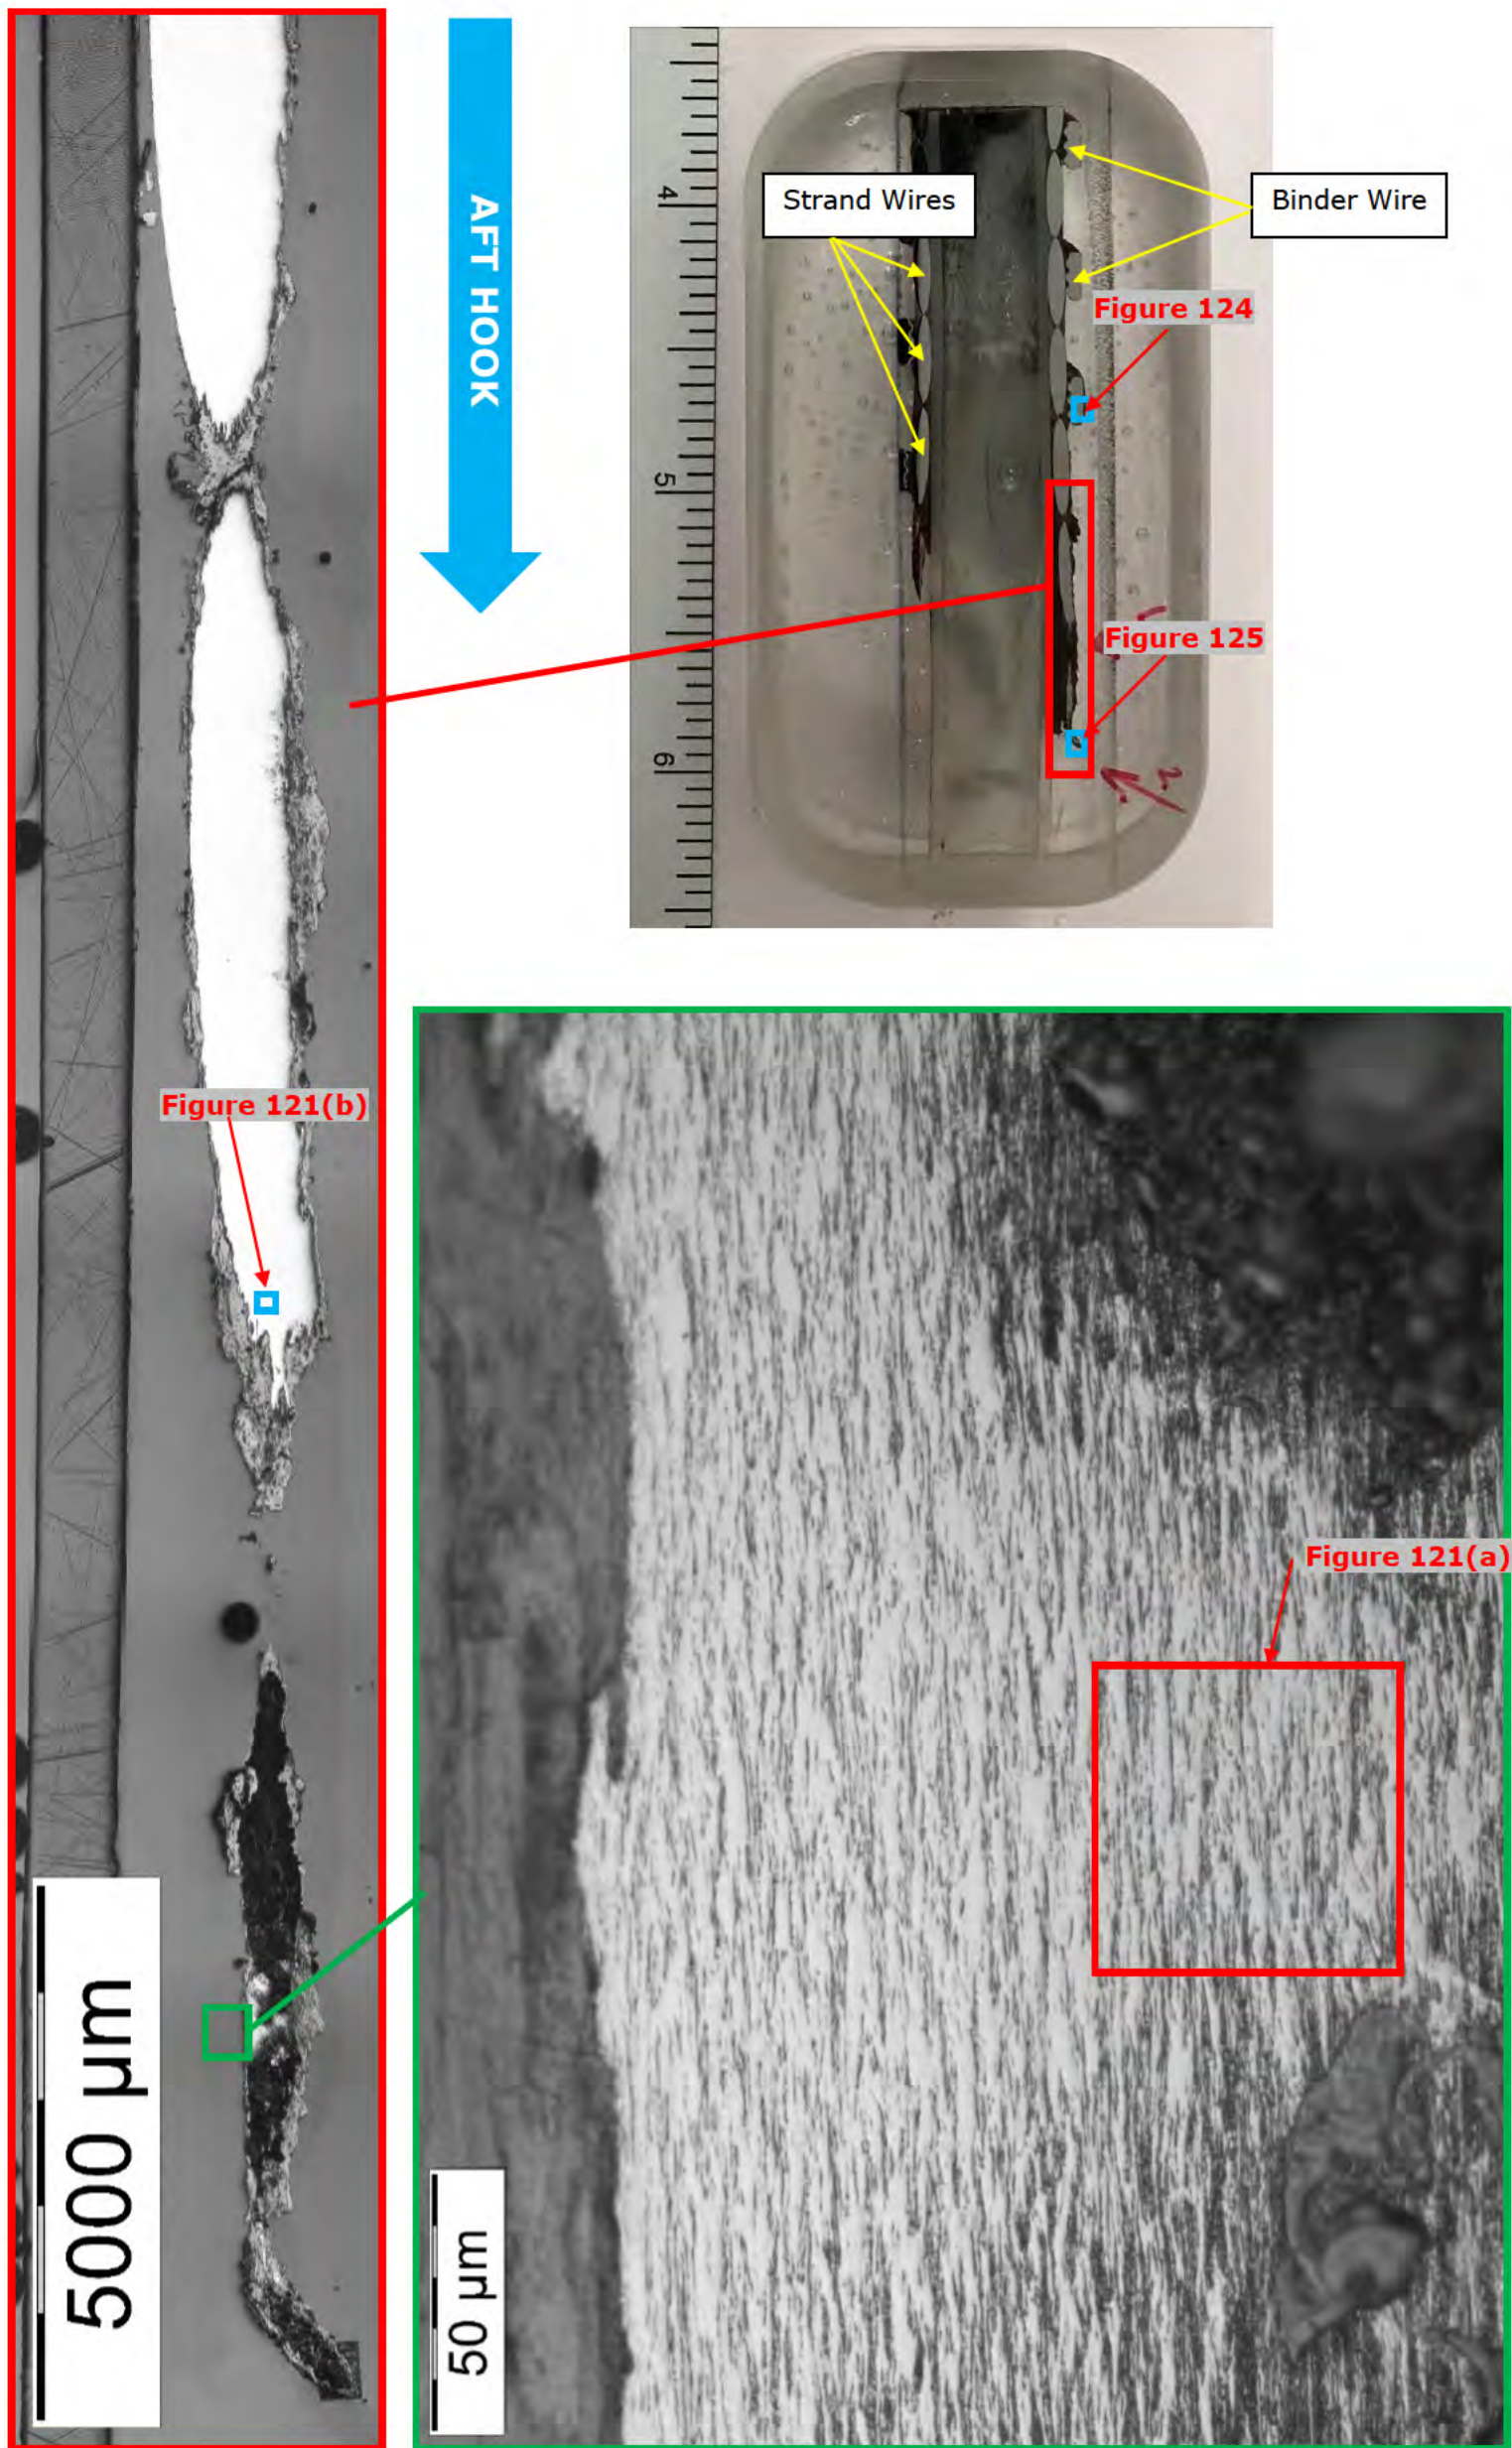
Figure 120. Photograph and photomicrographs of a longitudinal metallographic mount, Mount M1, showing the corrosion attack of the strand wires from the wire layer of the Subject Aft Cable; mount removed from location shown in Figure 114. The direction of the Subject Aft Hook is noted with the blue arrow. The ruler in the upper right photograph is in inches.

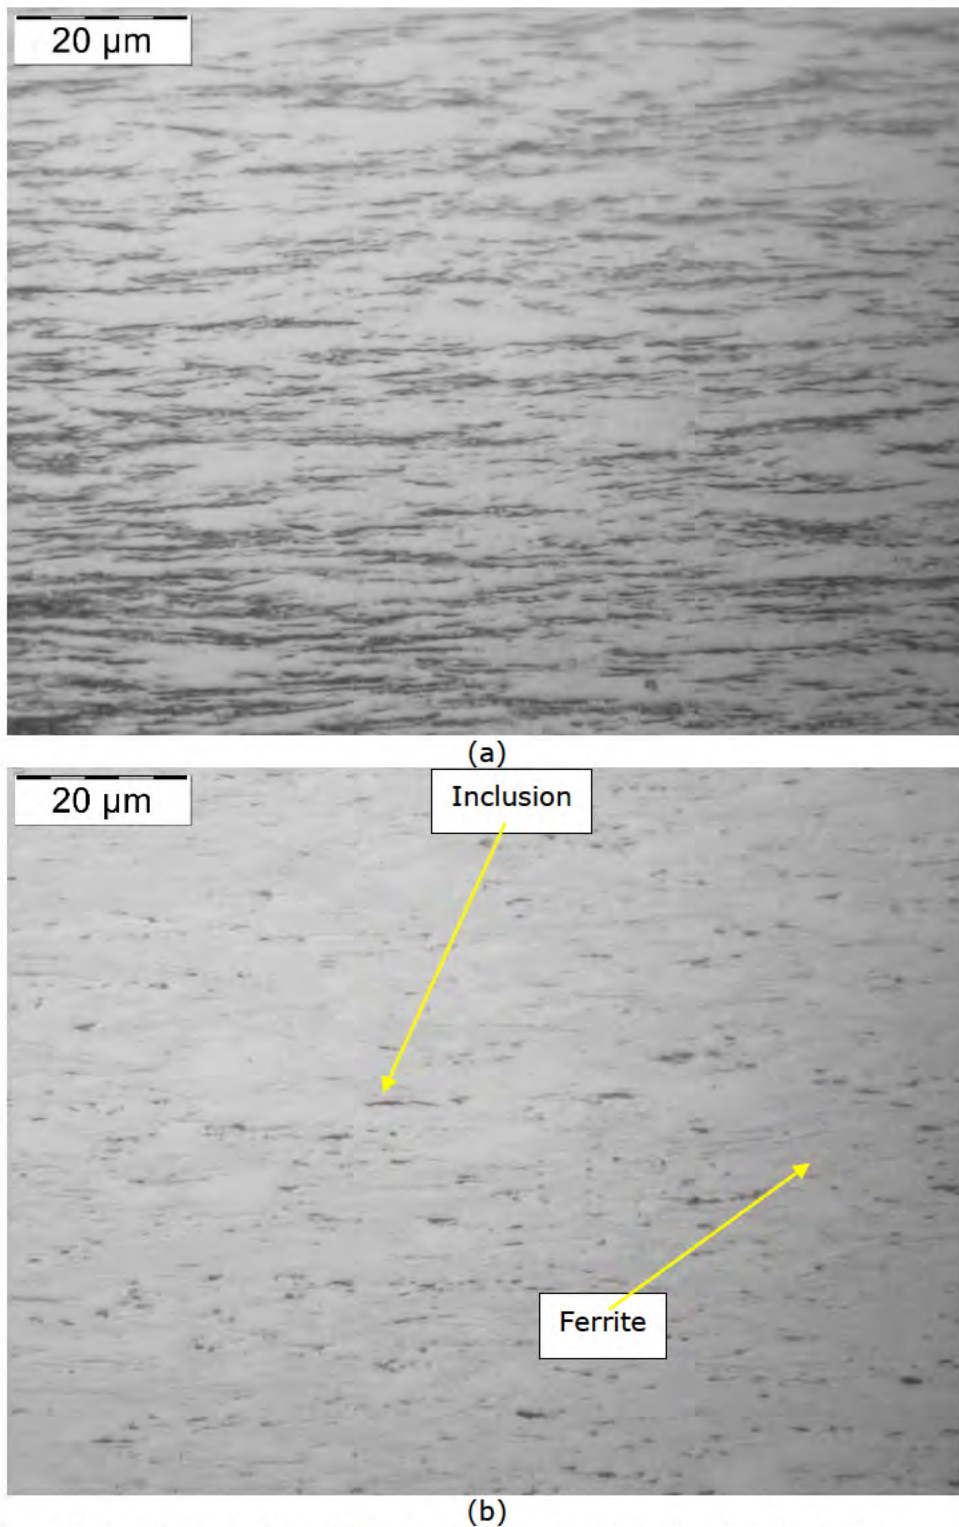
Figure 121. Photomicrographs of Mount M1 showing (a) the detail of the corrosion attack and (b) the microstructure of the strand wires from the wire layer of the Subject Aft Cable; locations shown in Figure 120.

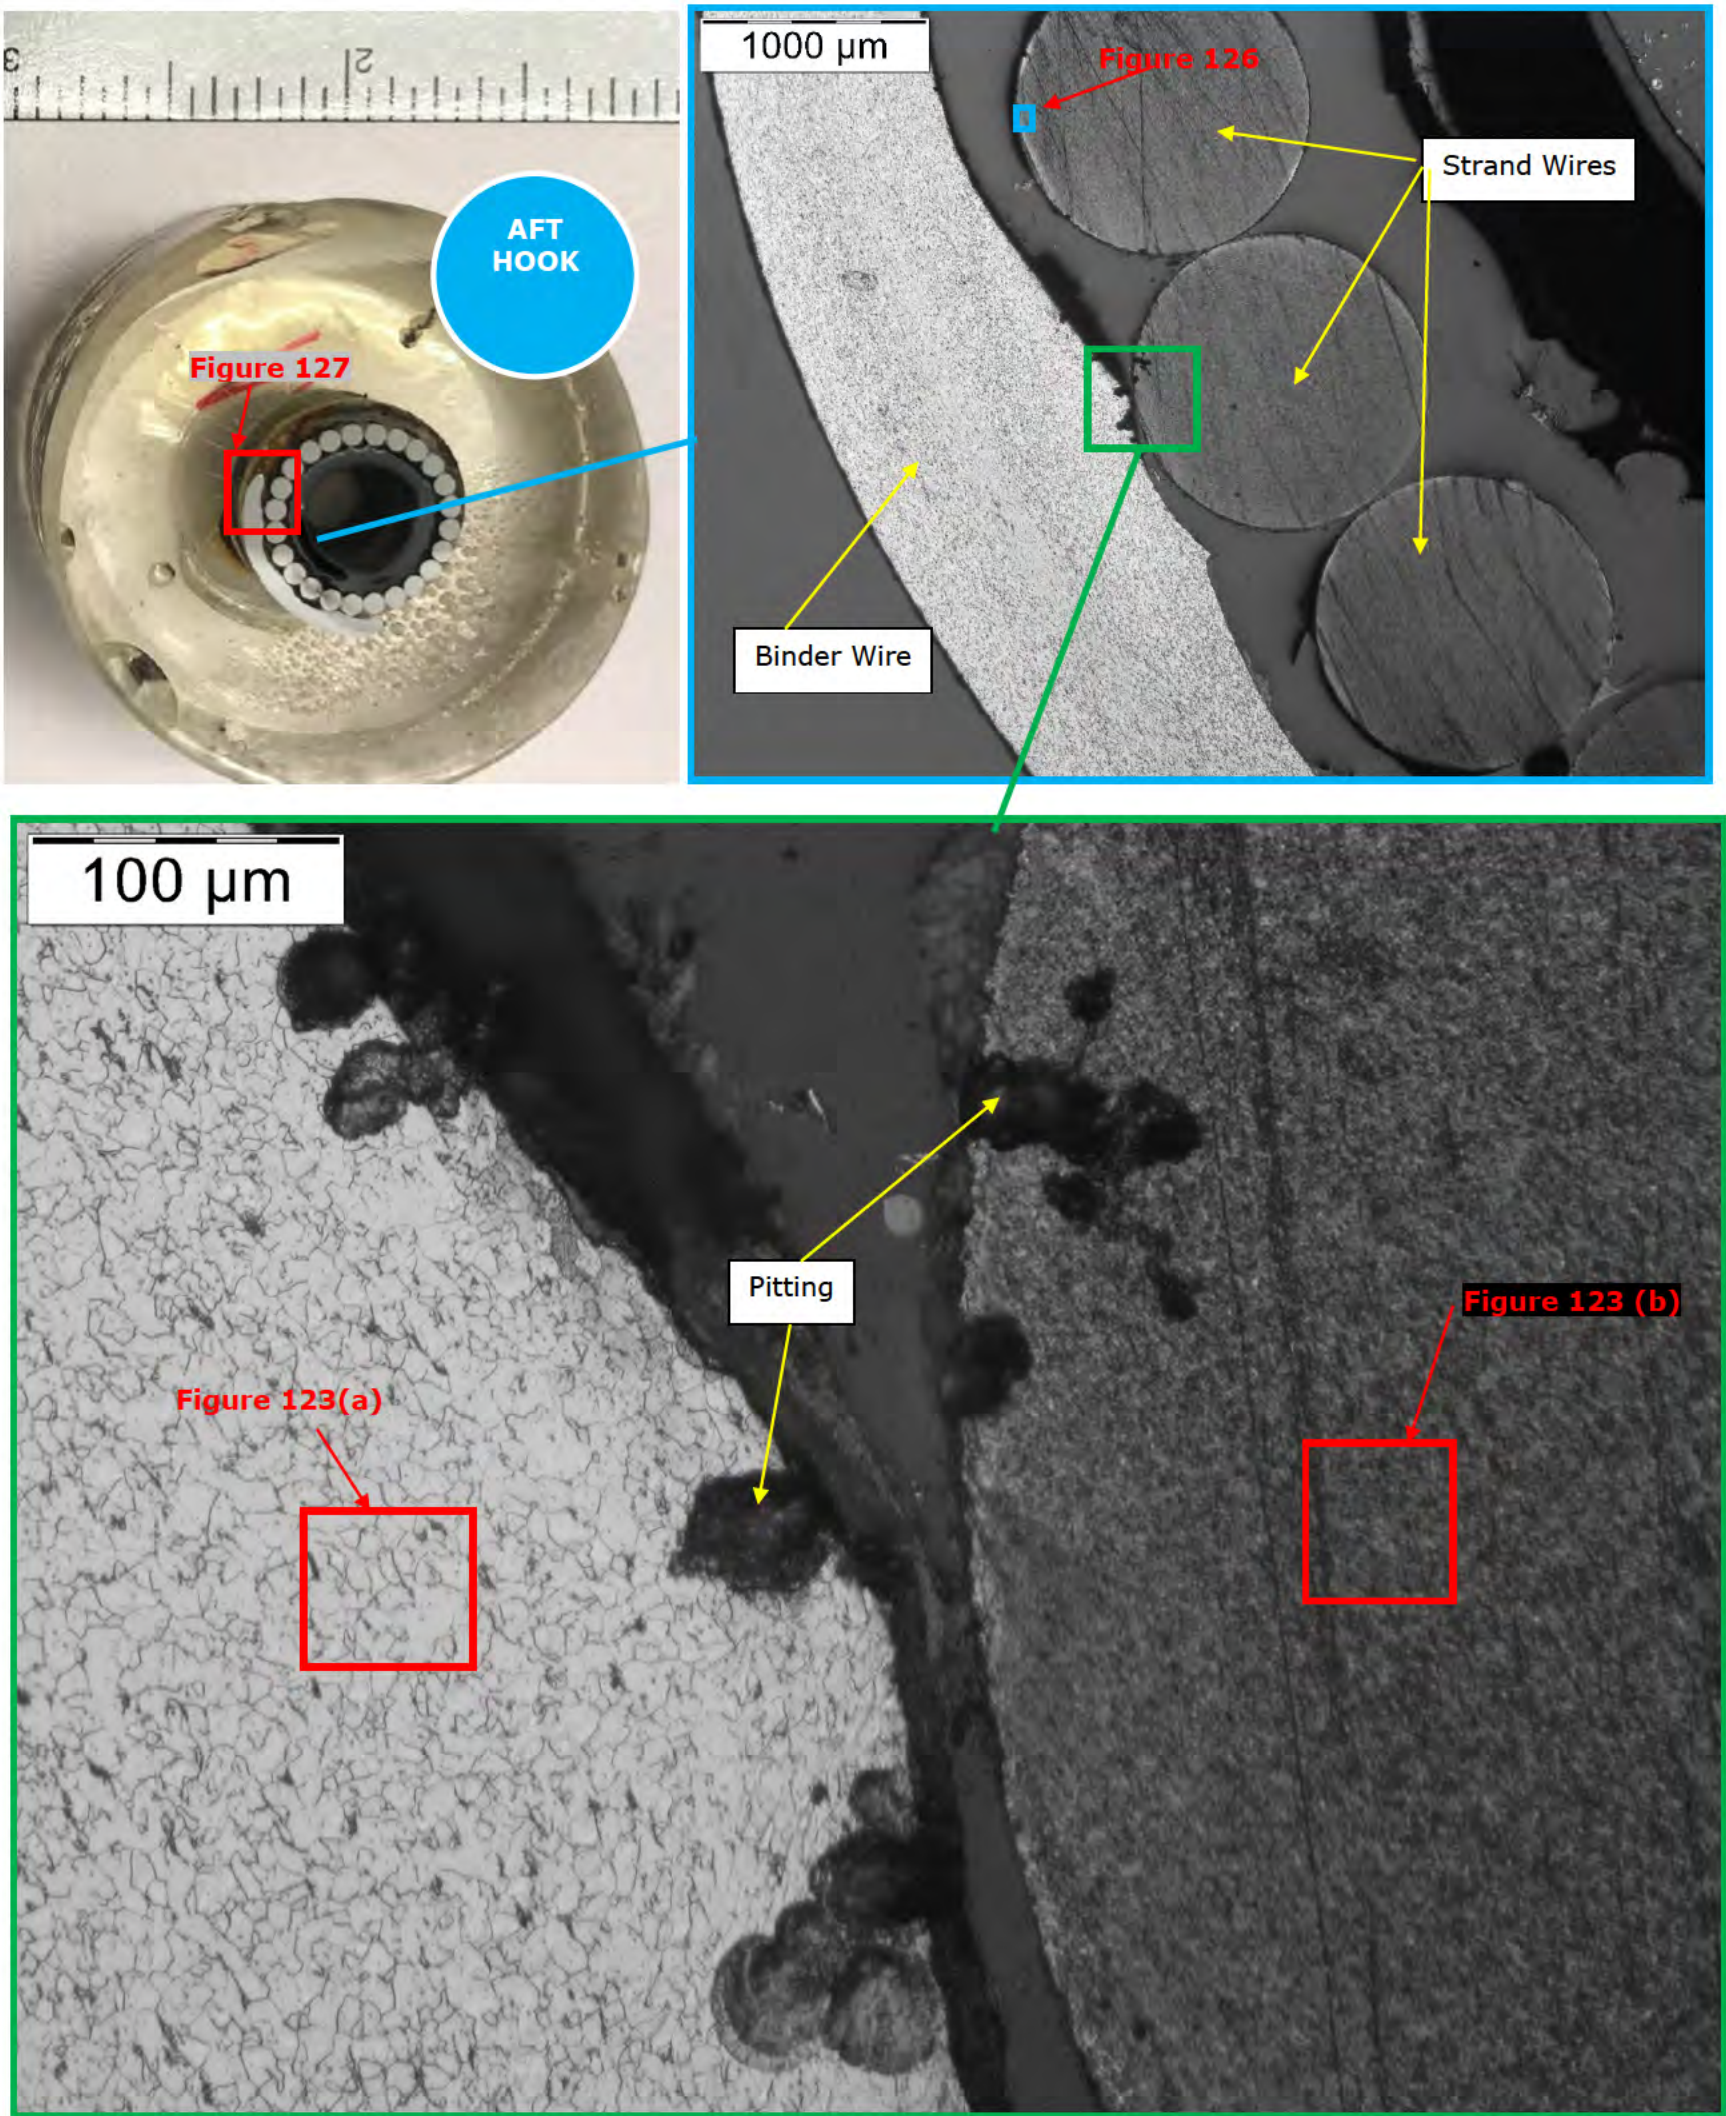
Figure 122. Photograph and photomicrographs of a transverse metallographic mount, Mount M2, showing the corrosion attack of the binder and strand wires from the wire layer of the Subject Aft Cable; mount removed from location shown in Figure 114. The blue circle indicates that the direction toward the Subject Aft Hook is out of the paper. The ruler in the upper left photograph is in inches.

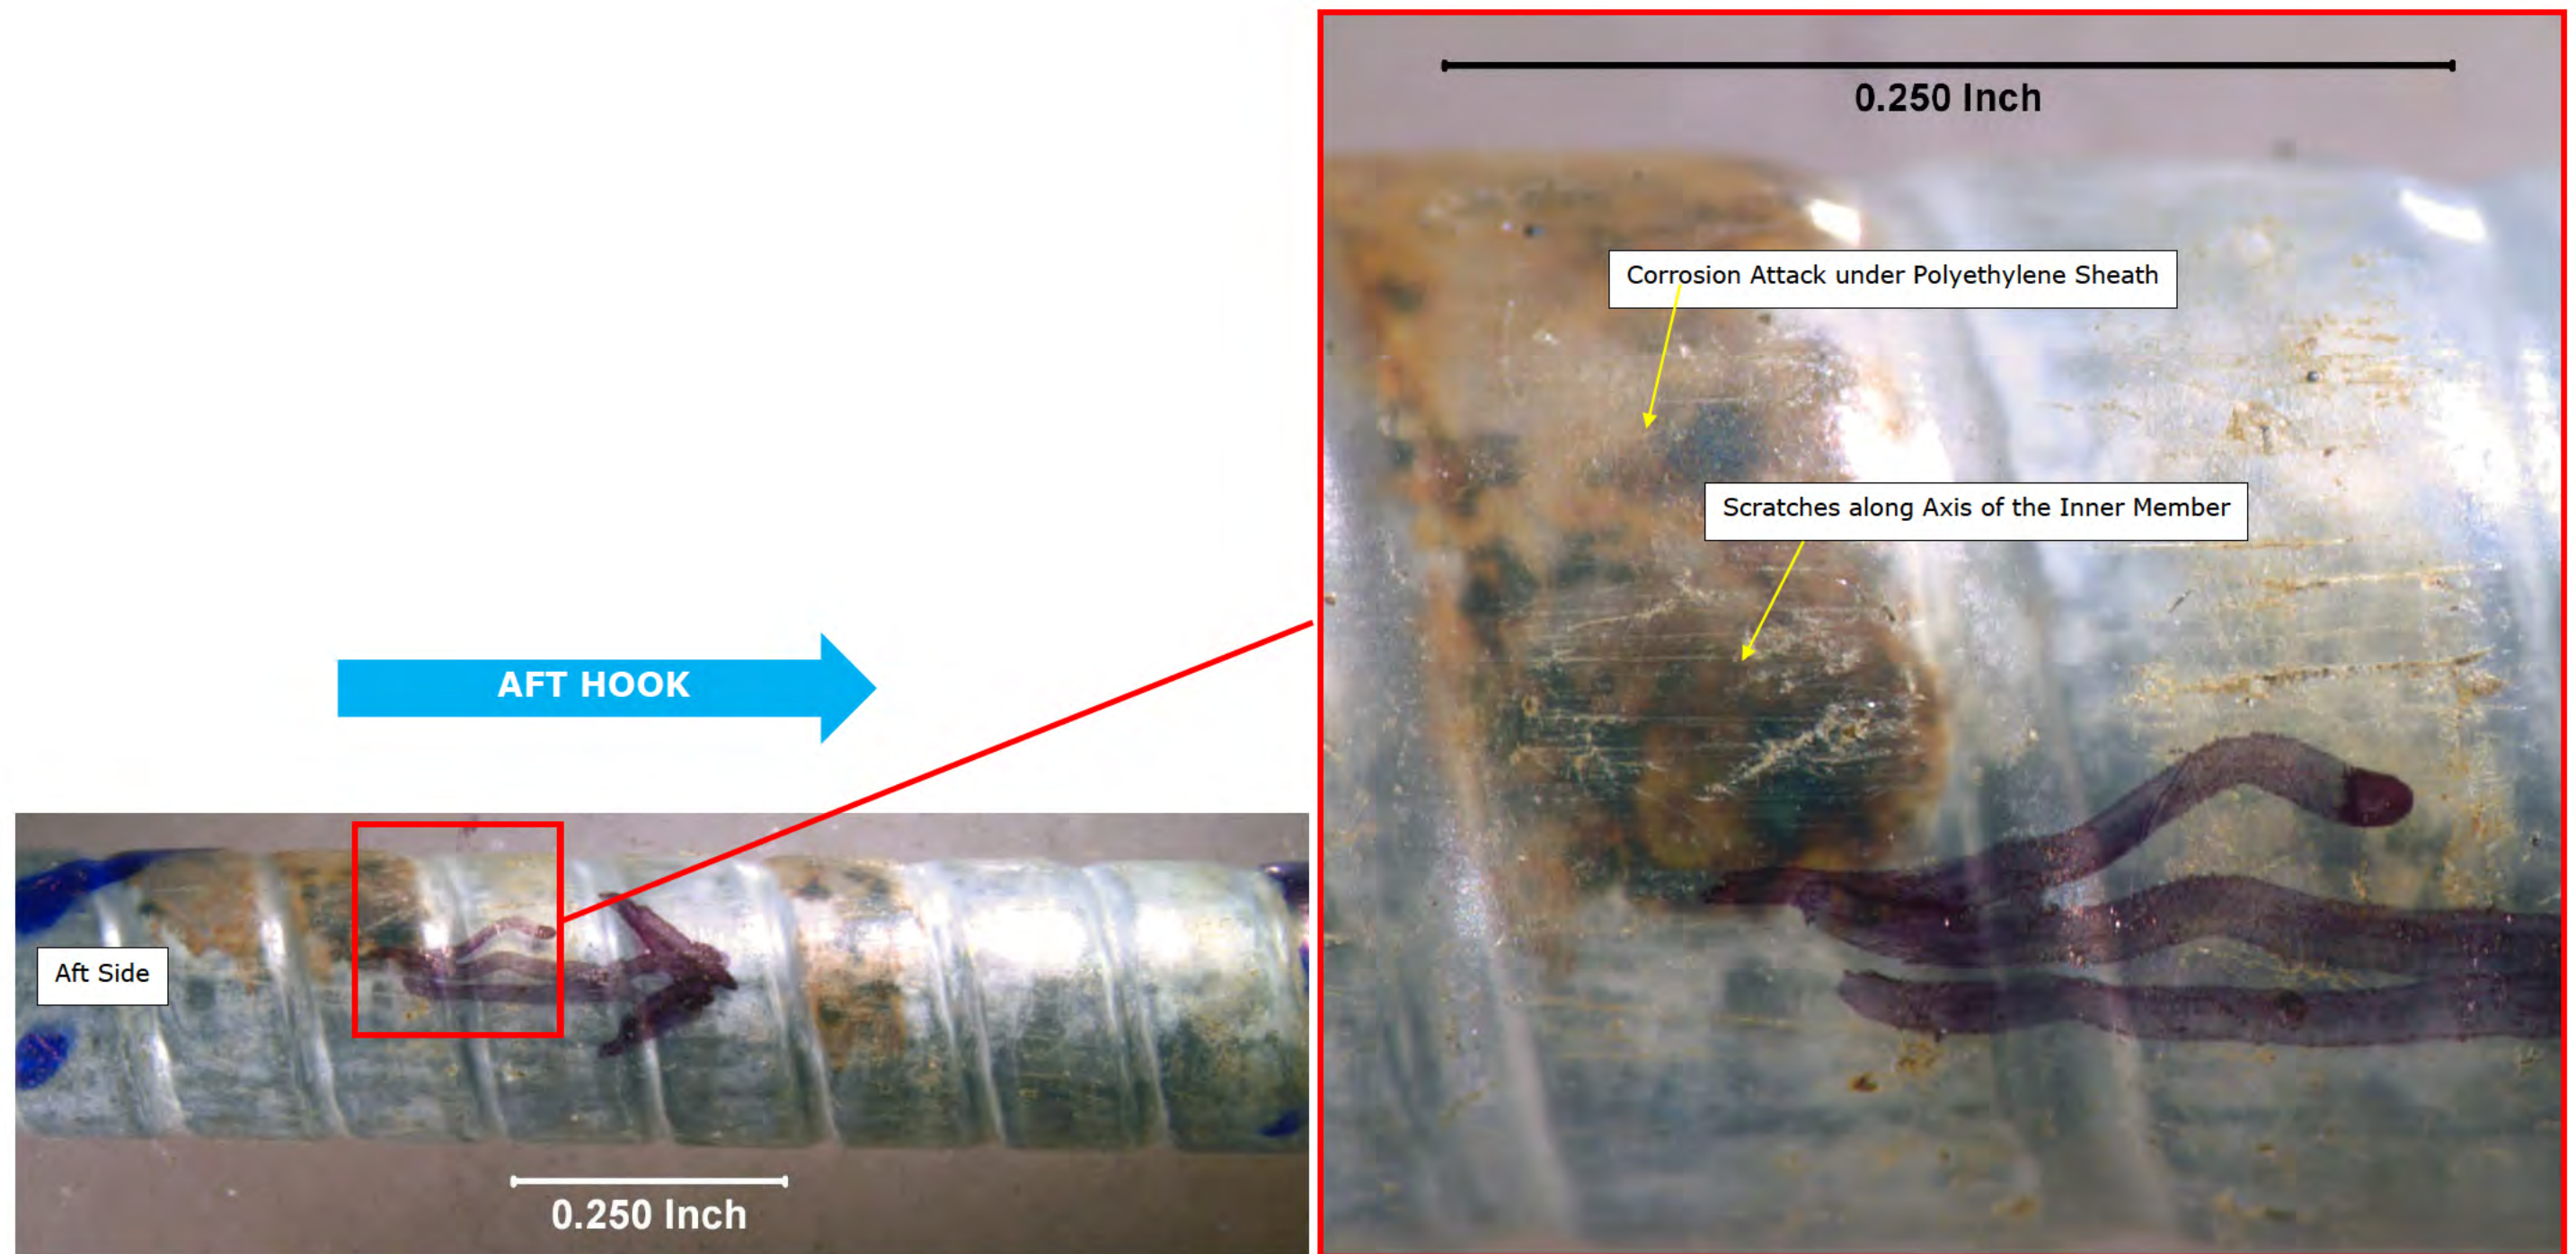
Figure 141. Light micrographs of the inner member of the Subject Aft Cable showing the detail of the minor corrosion attack to the binder wire and damage to the sheath layer of the inner member. The direction of the Subject Aft Hook is noted with the blue arrow.

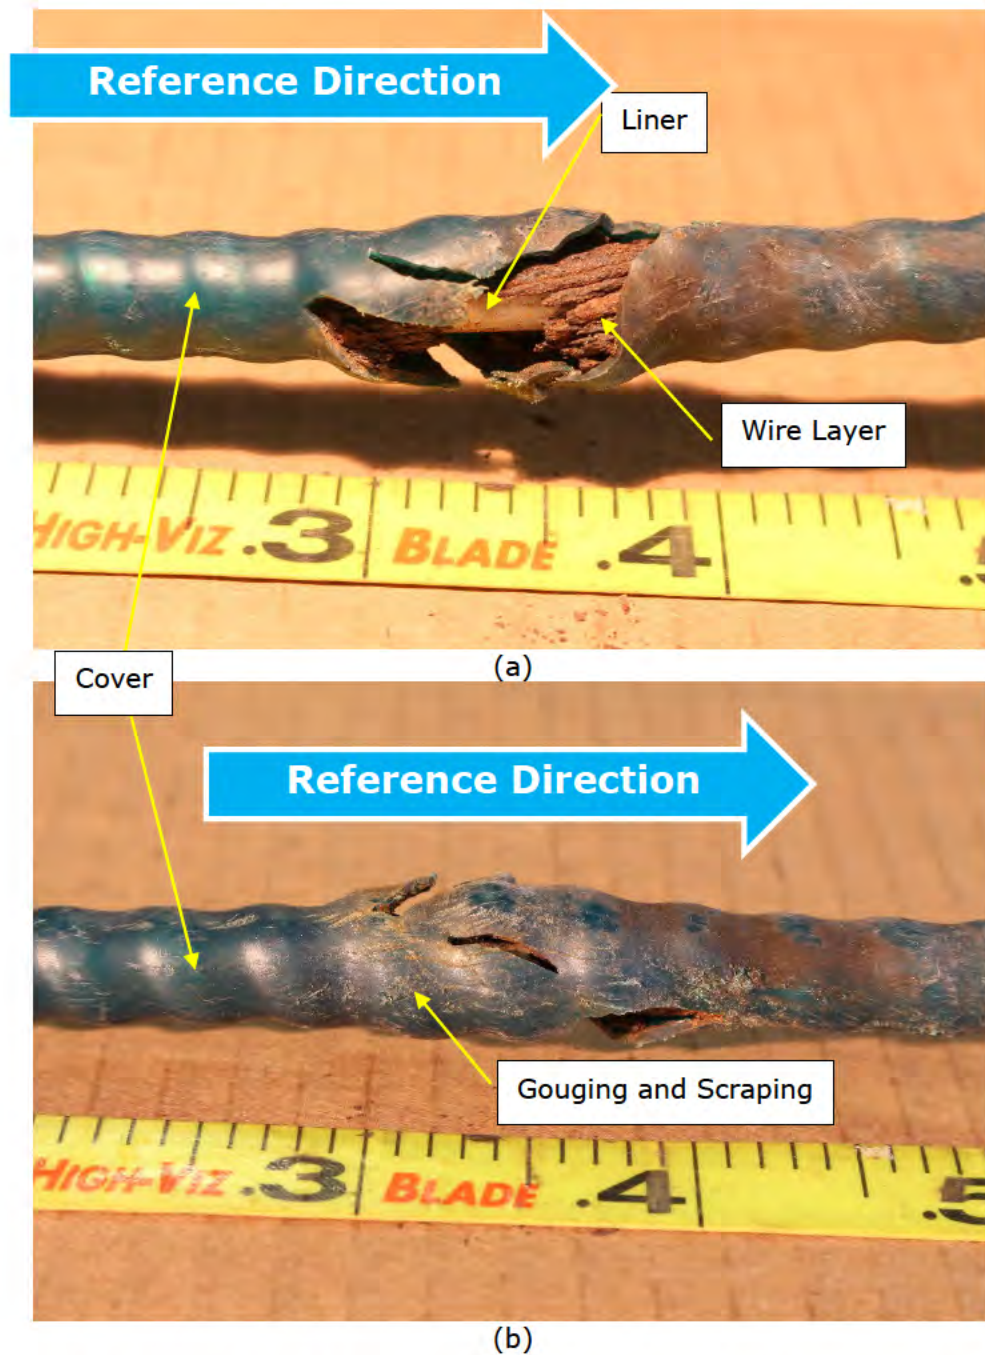
Figure 145. Photographs of the hydrostat cable from Lifeboat 7 showing damage at (a) the assumed top orientation and (b) the assumed bottom orientation. Measuring tape is in feet.

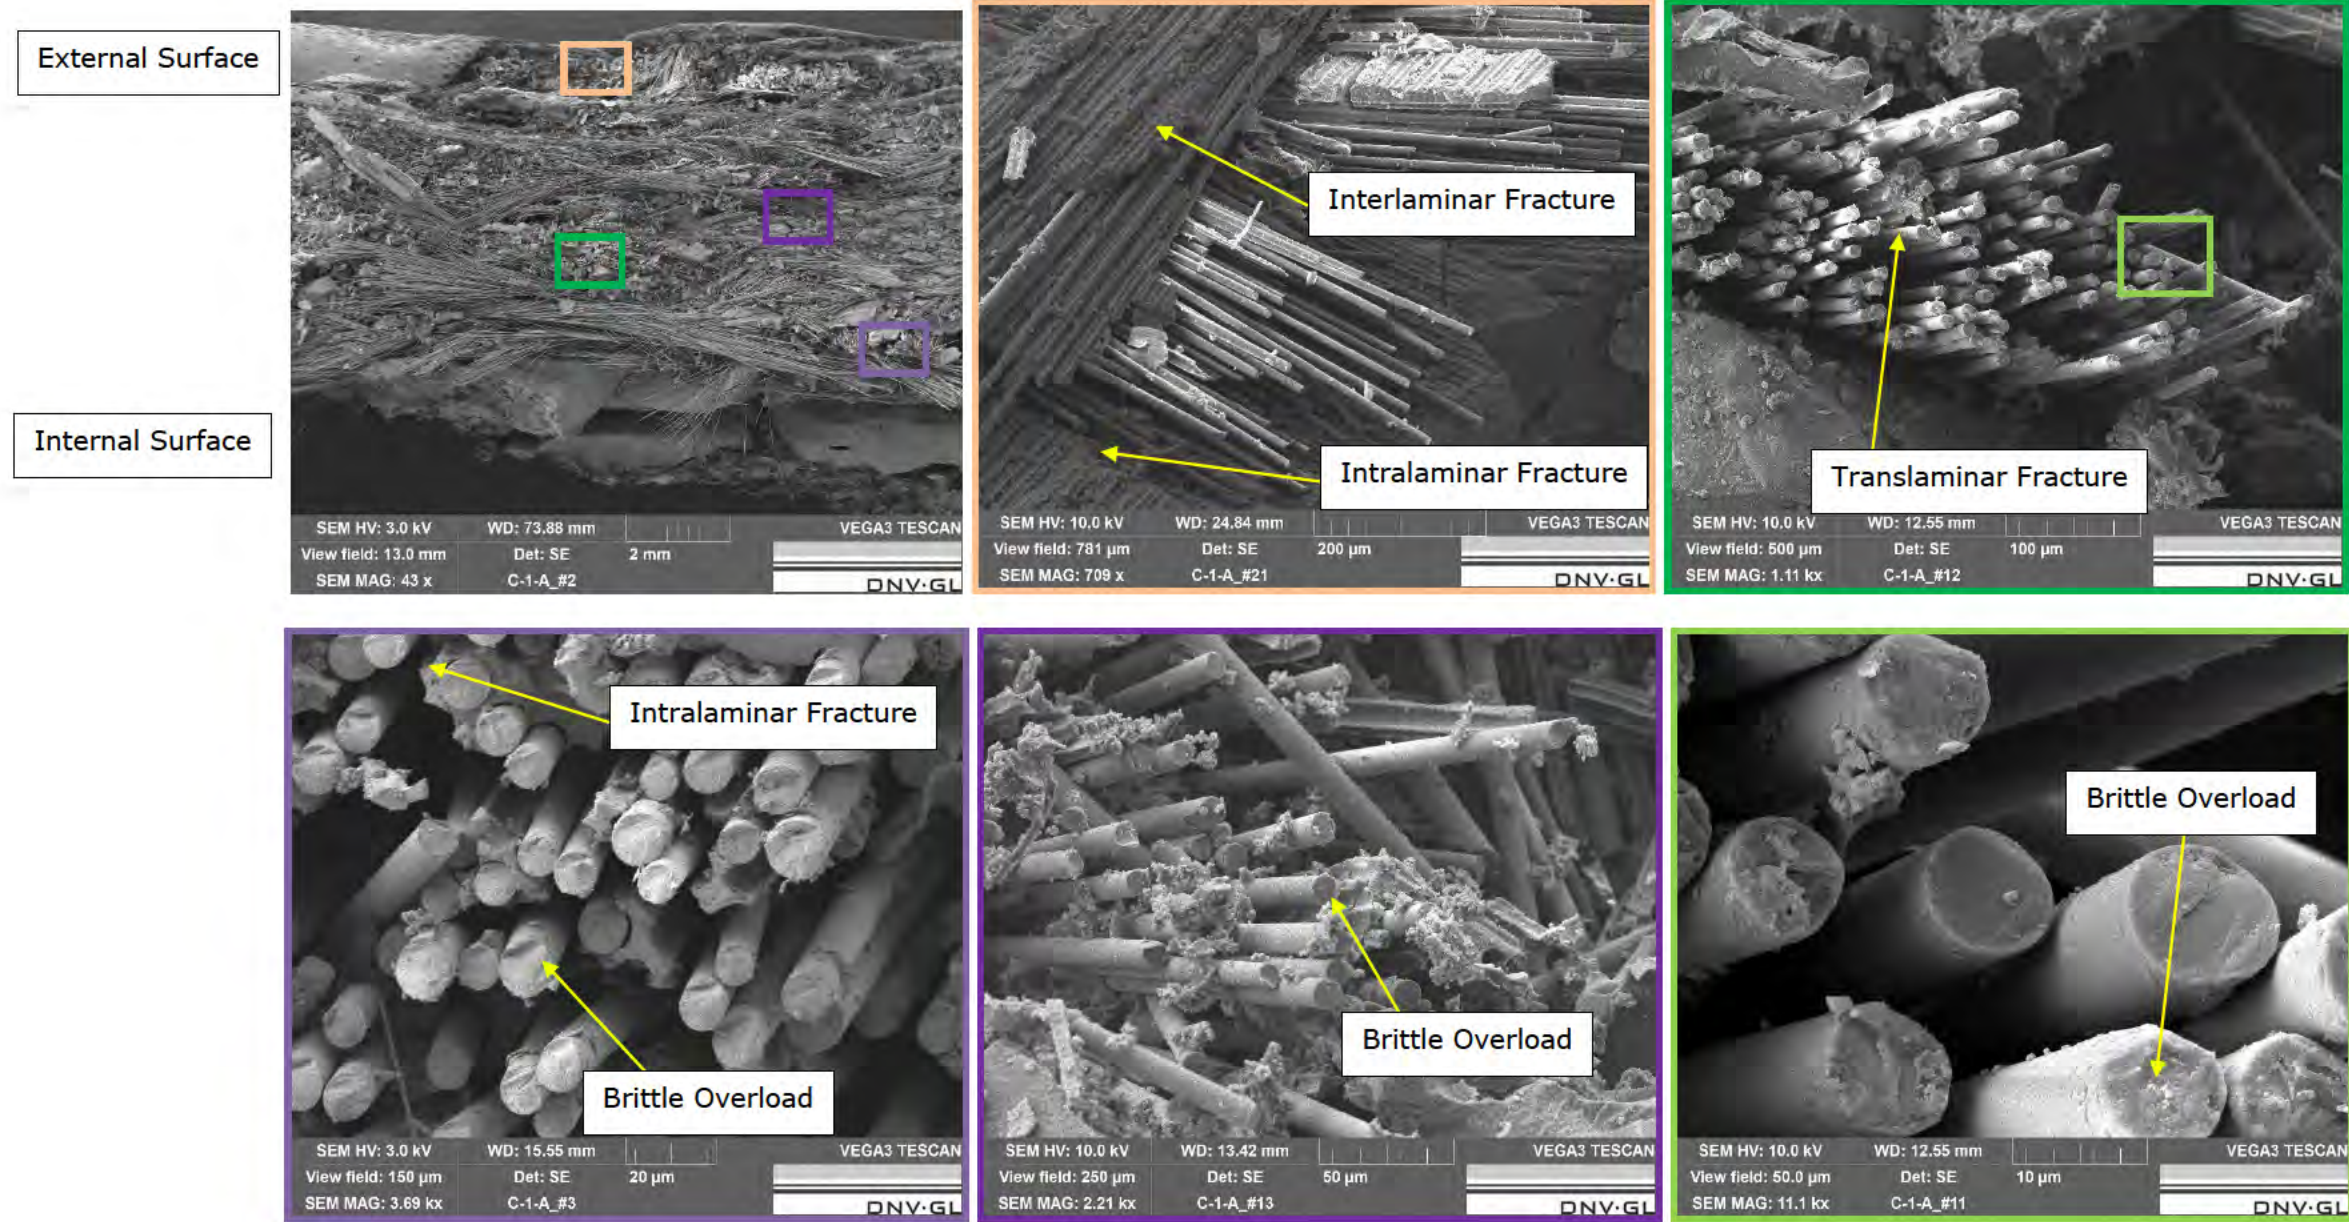
Figure 170. SEM images of Sample C-1-A showing notable fractures of glass fibers. Location of upper left image shown in Figure 169 (right).
