# UNITED STATES COAST GUARD

### FLOATING OCS FACILITY - TENSION LEG PLATFORM

### LIFEBOAT FALL WITH LOSS OF LIFE ON JUNE 30, 2019

**SHELL AUGER FLOATING OCS FACILITY LIFEBOAT NO. 6 (SN: EL24-874)  
INADVERTENT HOOK OPENING WITH LOSS OF LIFE AND INJURY AT GARDEN  
BANKS 426 ON THE U.S. OUTER CONTINENTAL SHELF  
ON JUNE 30, 2019**

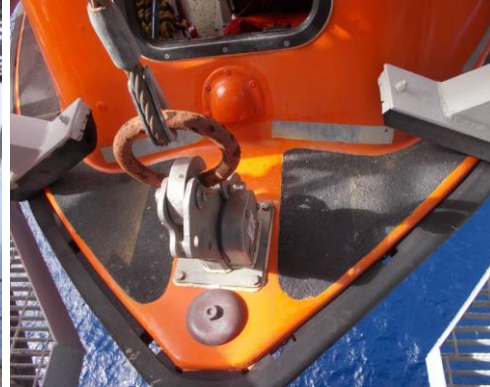
*Image 1 (left): Lifeboat No. 6.  
Image 2 (above): Photo Lifeboat No. 6 aft hook  
from 2014. Credits: Palfinger Marine.*

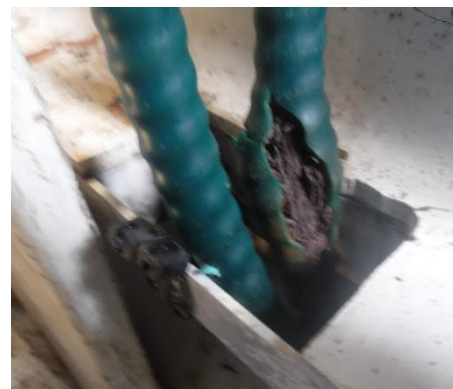
On the day of the casualty, the crew cycled the hooks (open to closed position) two times while in the water. If a cable conduit is already damaged, the act of cycling exposes the conduit layers to additional stresses, including compression and tension (stretching). It is probable<sup>4</sup> that during the second cycling event, the

Image 6: Photograph of damage to Lifeboat No. 6 aft control cable dated June 6, 2019. Credit: Palfinger.

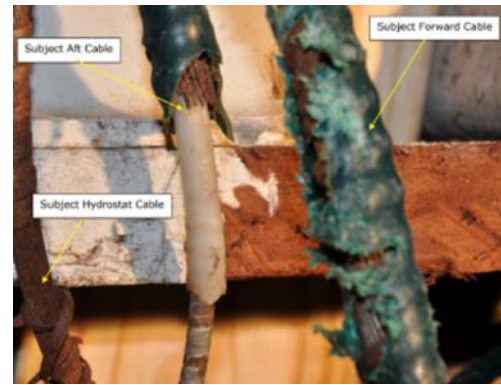
conduit, already weakened and damaged, separated during the closing action (see Image 7). As a result, when the system was reset, the locking shaft on the aft hook did not return to the fully closed position, but rather, came to rest at an “almost open” position. In this position, the hook could support the weight of the lifeboat and its occupants as the lifeboat was hoisted from the water to the davit. However, at the davit, additional forces applied to the hook and the lifeboat, as a result of the winch pulling the boat against the bumpers, caused the locking shaft to rotate from the “almost open” to the open position. Under load, the aft hook was free to open and release from the lift ring (a ring attached to the end of the fall cable (wire rope); often called the “D” ring). The forward hook, not designed to bear the entire load of the lifeboat or operate outside of specified angles, was unable to sustain the weight of the lifeboat, separated from the hull and eventually opened.

*Image 7: Photograph of aft control cable after casualty. Photograph documents separation of three layers of the conduit: the green plastic cover; a steel wire; and a white polyethylene liner. Credit: DNV-GL.*

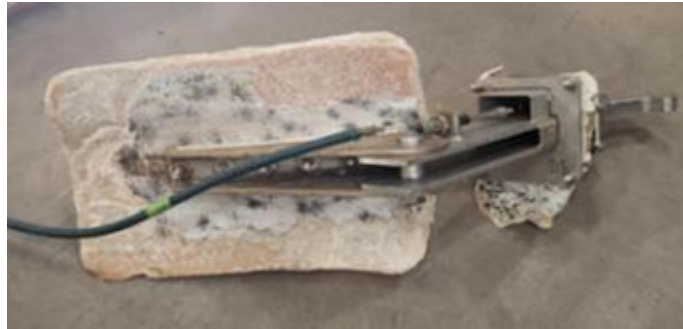
4.2.4.2.1. The bow end of the hull split, and the bow hook was torn free of the hull (see Figures 21). The bow split arrested approximately halfway along the length of the boat.<sup>15</sup> The patch that pulled out is consistent in shape with a previous repair made to the FRP around the bow hook (see Figure 21).

Figure 21: Bow hook and surrounding FRP post-casualty. Credit: CG.

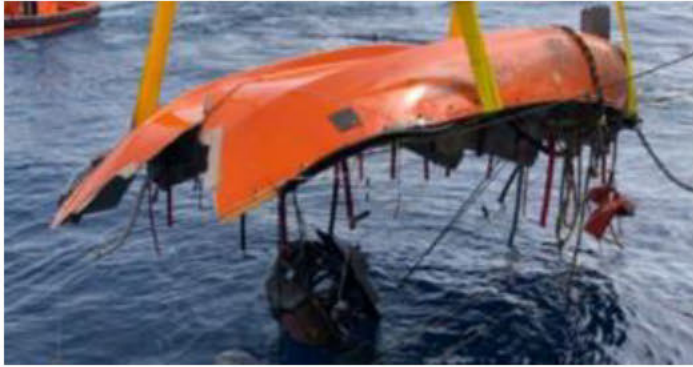
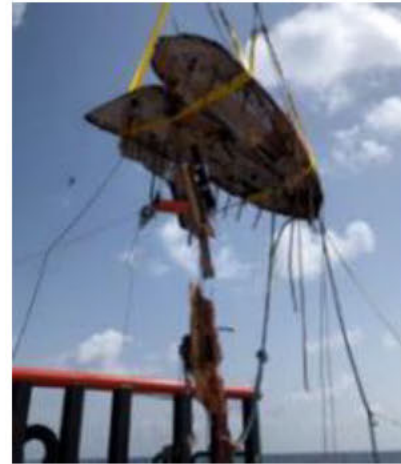
Figures 23 (above) and 24 (right): Photographs of Lifeboat No. 6 taken on July 5, 2019 during salvage operations. Credit: Shell.

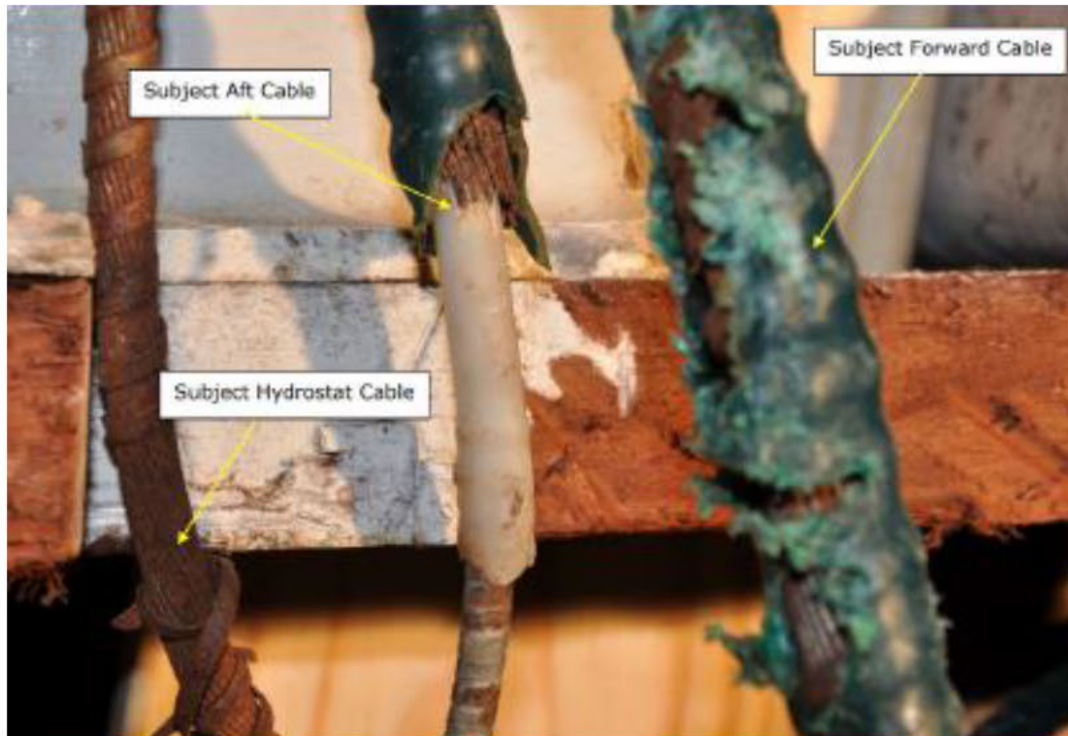
4.2.4.4.2. Significant damage to the aft control cable was found approximately .72 to 1.34 feet from the hook release station conduit cap. The outer green conduit cover, steel strands and polyethylene liner were totally separated. Only the inner member remained intact (see Figure 27).

Figure 27: As-found condition of Lifeboat No. 6 control cables after reassembly at DNV-GL facility. Credit: DNV-GL.

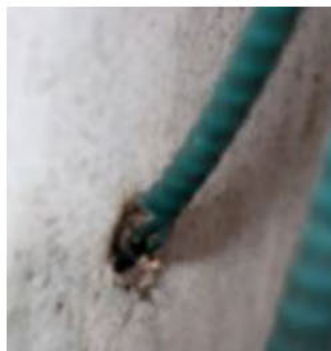
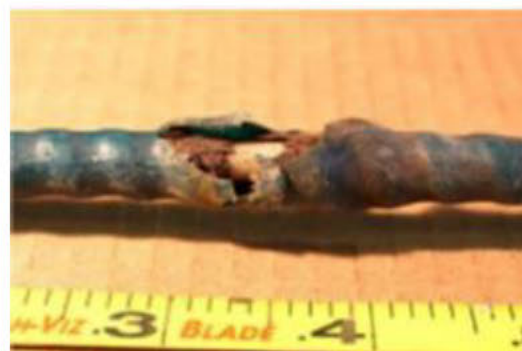
Figures 40 (left) and 41 (right): Photos of Lifeboat No. 7 hydrostat control cable. Credit: CG and DNV-GL.

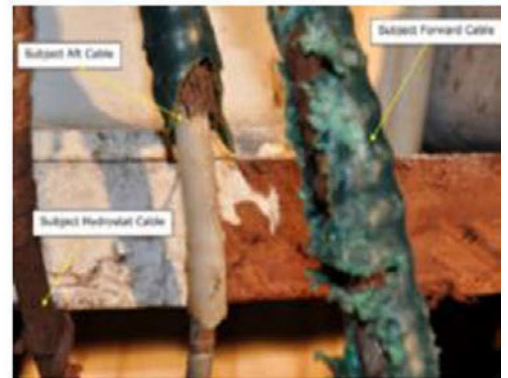
Figure 49: Lifeboat No. 6's aft hook control cable after the casualty. The aft cable is in the center of the picture. Credit: CG.

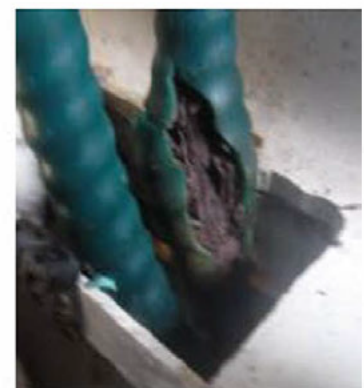
Figure 63: Lifeboat No. 6's aft control cable on June 6, 2019. Credit: Palfinger.
