Final Report on the Investigation of the Macondo Well Blowout

**Deepwater Horizon Study Group
March 1, 2011**

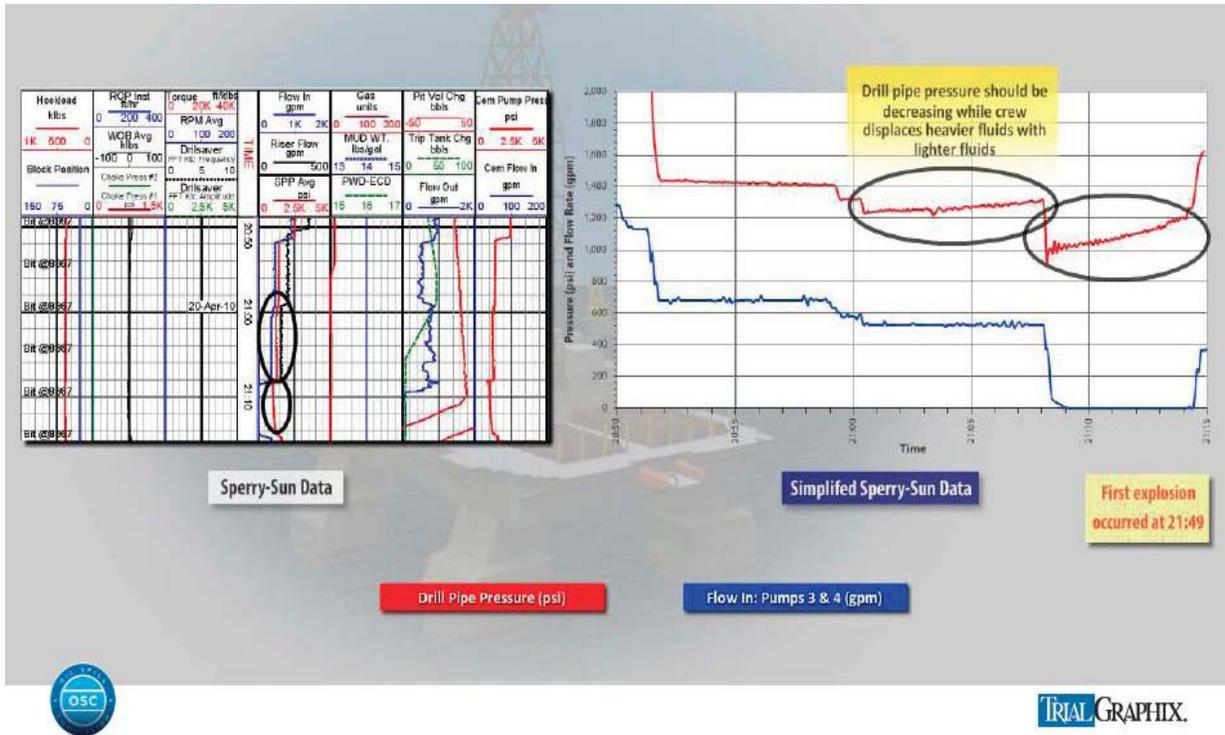
April 20, 9:00 p.m. – Shortly after 9:00 p.m. pressure on the drill pipe increased from 1,250 psi to 1,350 psi. The drill pipe pressure should have decreased due to the removal of the heavier mud (14.7 ppg) and its replacement with the lighter weight seawater (8.6 ppg). This abnormality could have been detected from monitoring the drill pipe pressure data, and could have been the first clear indication of the flow of hydrocarbons into the well, visible to the crew.⁹⁸ Spacer fluid was then observed at the surface.

Figure 1.22 – Drill pipe pressure showing pressure increase.¹⁰⁰

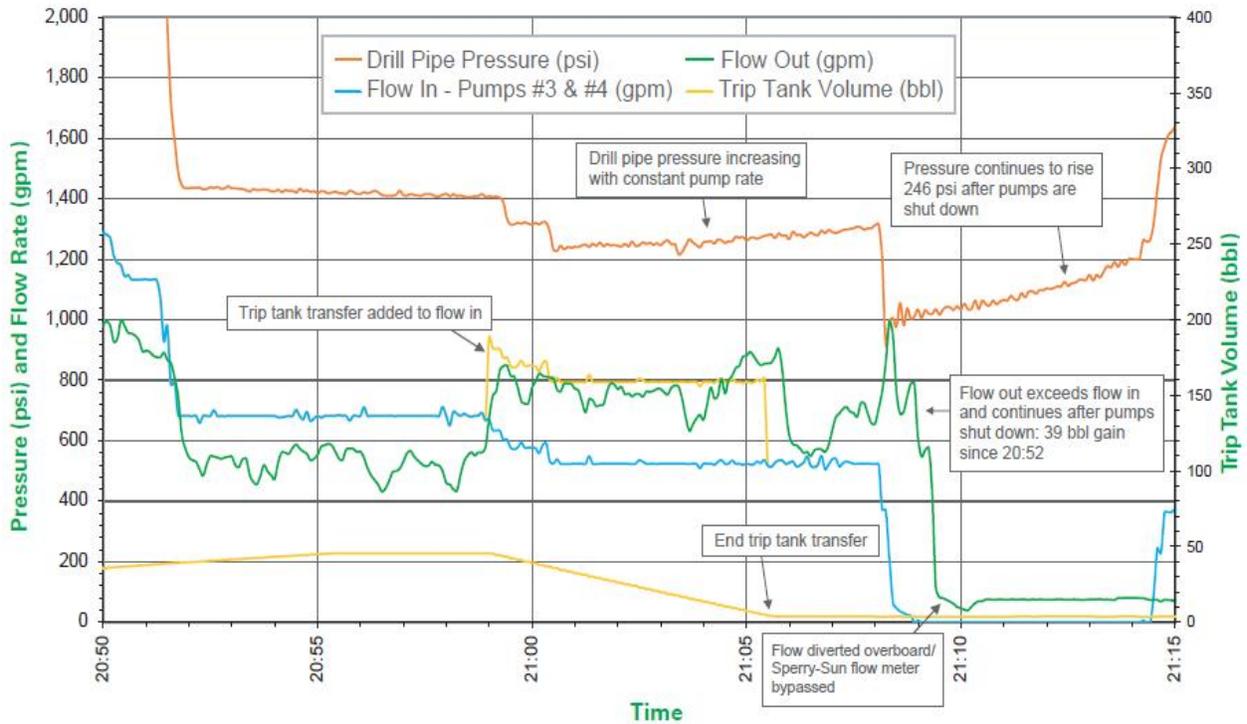
Figure 1.23 – Flow indication graph showing anomalies (real-time data).¹⁰¹

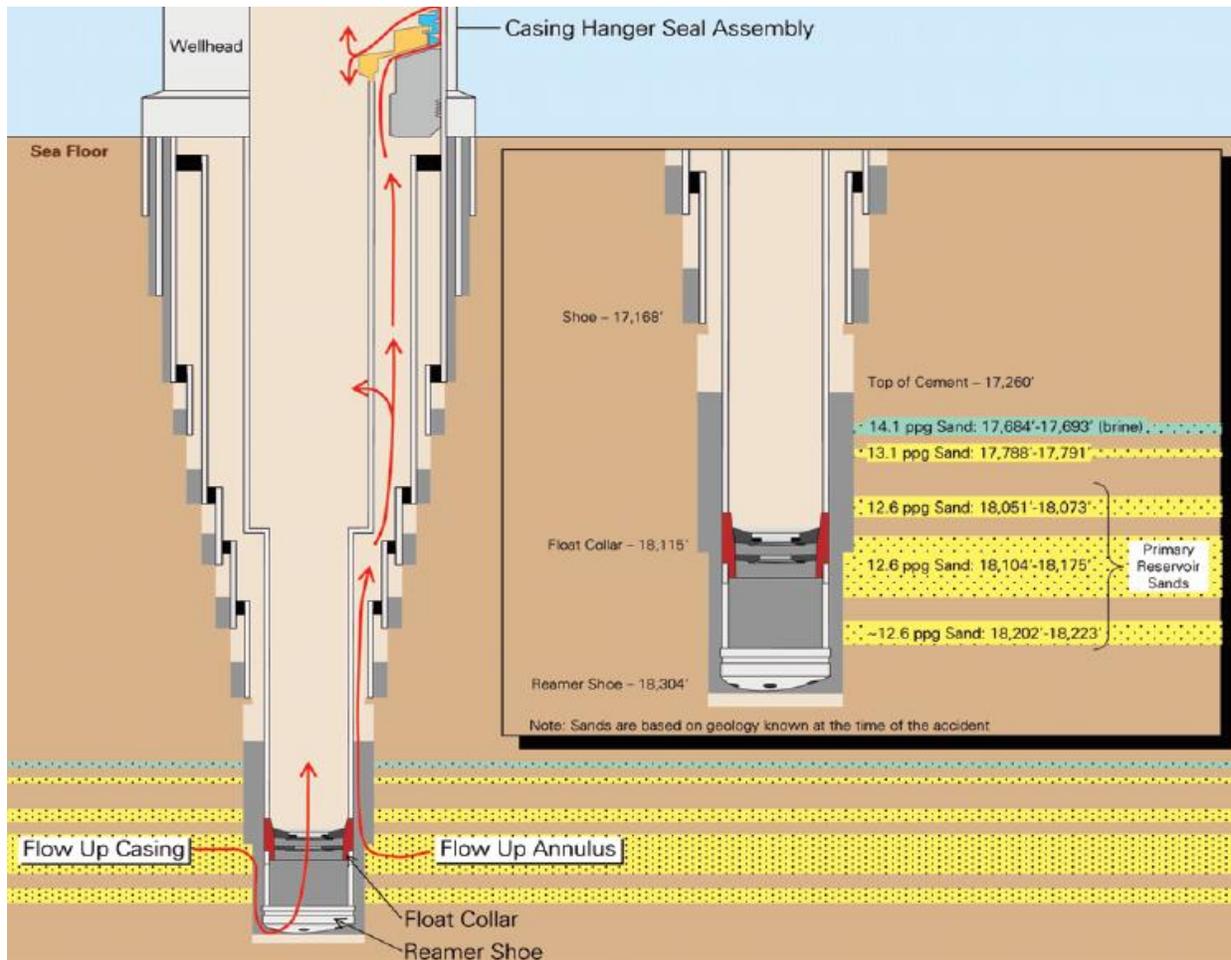
Figure 1.24 – Potential flow paths.¹⁰²

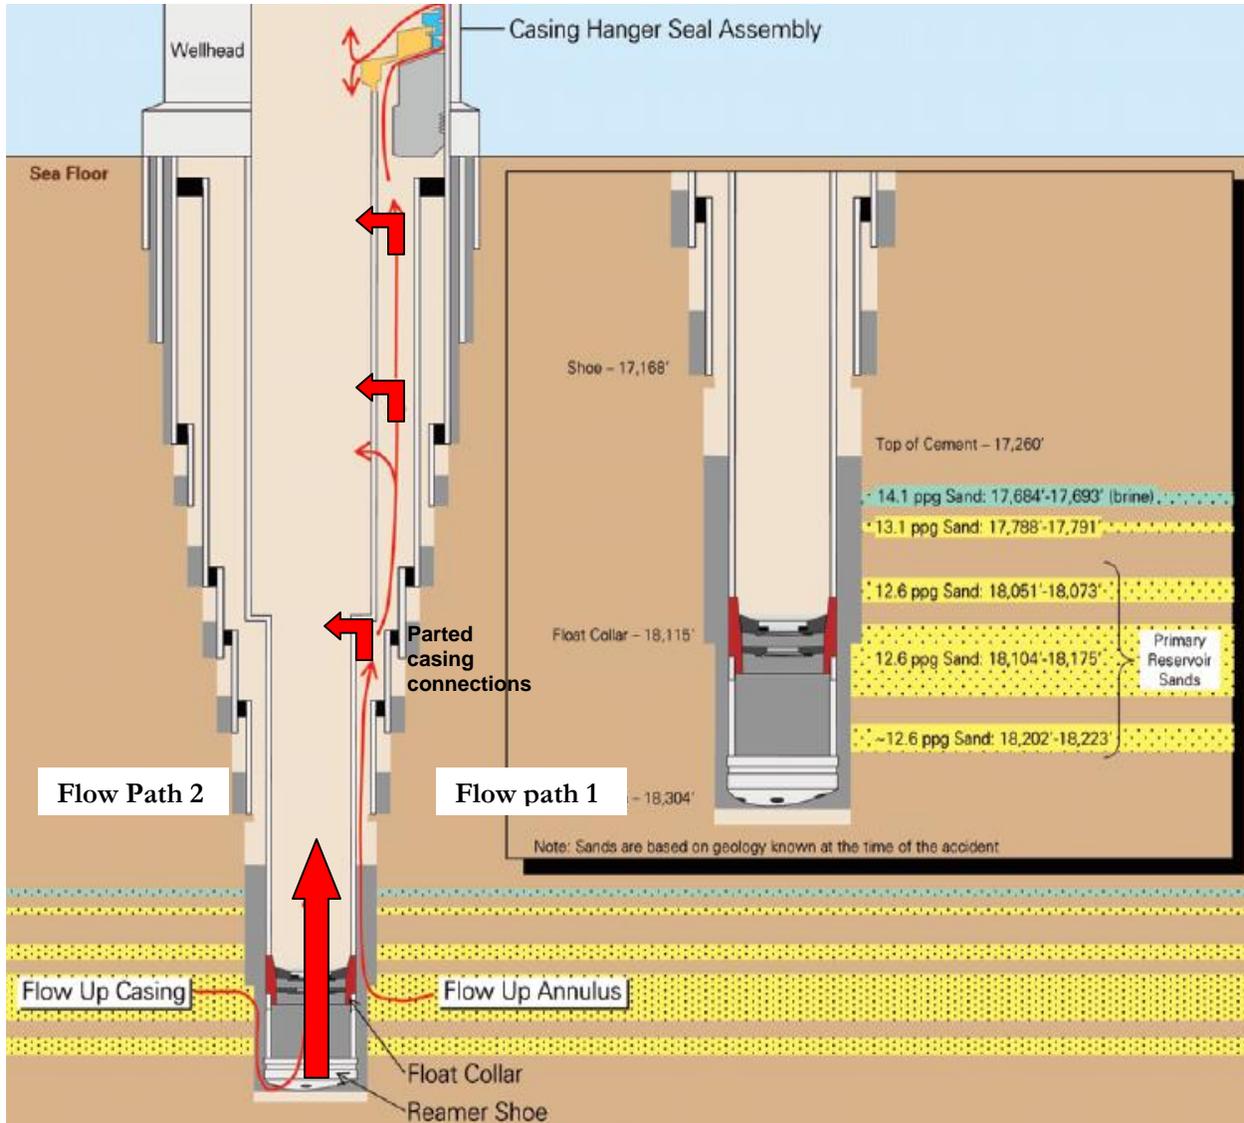
Figure 2.2 - Potential flow paths.¹⁸

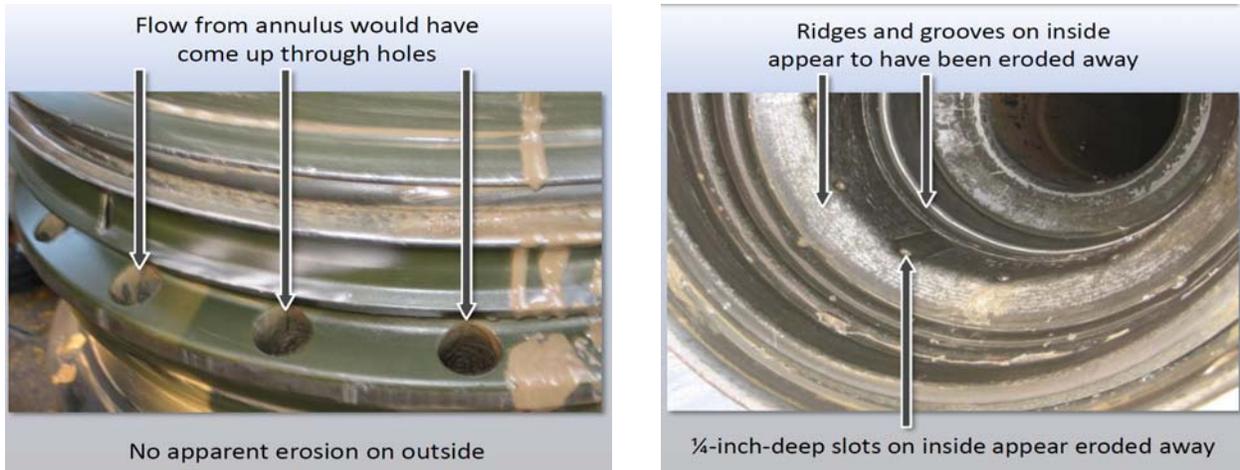
Figure 2.3 – Photographs of exterior (left) and interior (right) of 9⁷/₈ in Hangar Seal Assembly.¹⁹

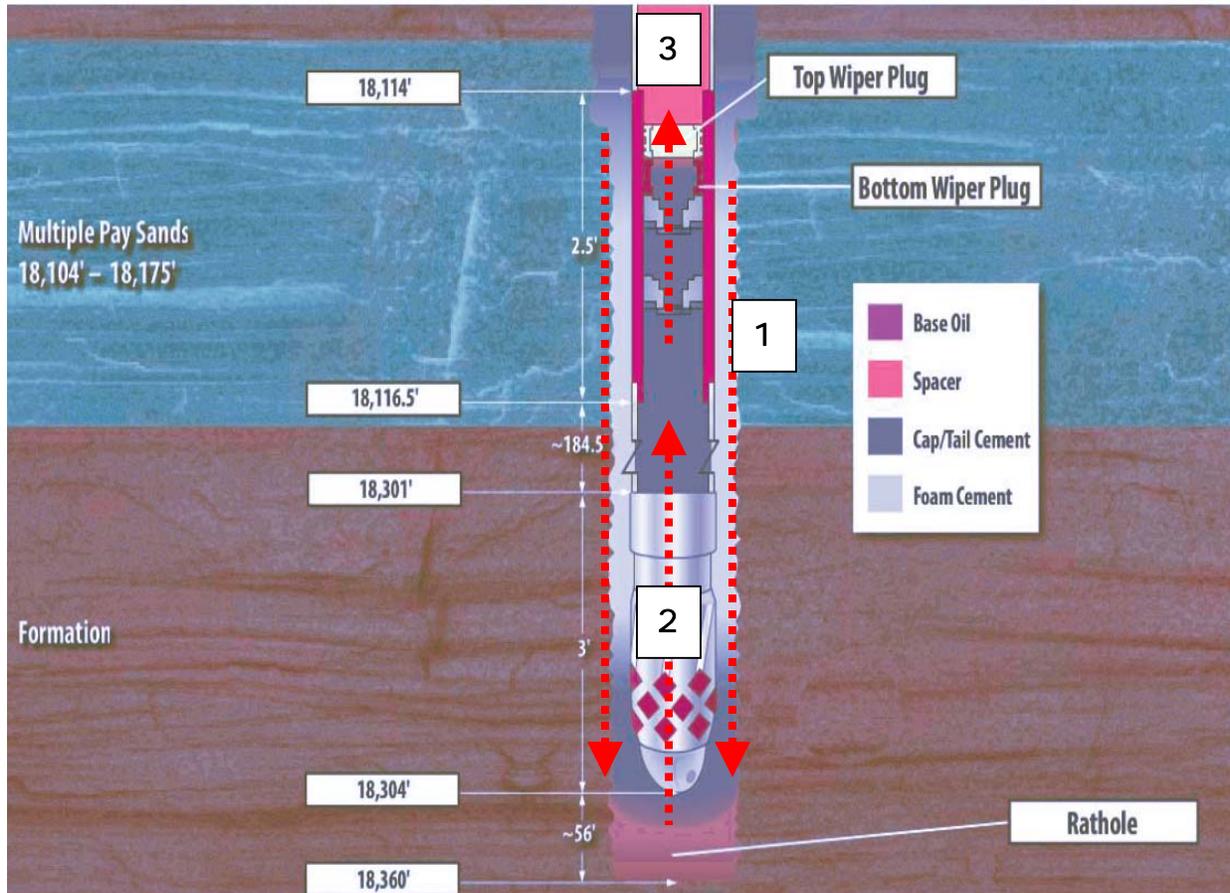
Figure 2.4 – Shoe Track hydrocarbon penetration paths.²⁴

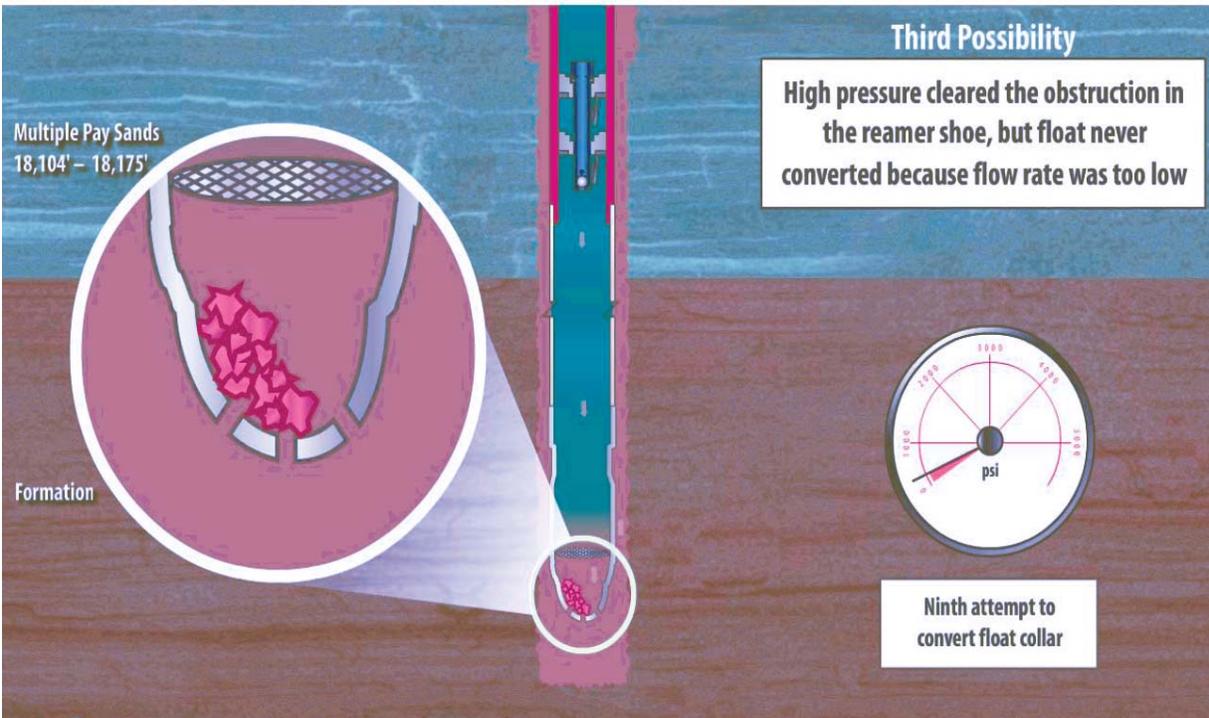
As summarized in Chapter 1, it took nine tries to convert the float collar. There were anomalous flow-pressure conditions during and following the conversion attempts. Analysis of the available information indicates it is plausible that the float collar failed to convert (Figure 2.6). In this condition, hydrocarbons would be able to migrate through the flow tube and open back-flow valves and into the open well bore above. The BP investigations identified three failure modes for the double-valve float collar in the shoe track: 1) it was damaged by the high load conditions required to establish circulation, 2) it failed to convert due to insufficient flow rate, and 3) the check valves failed to seal. The BP analyses were not able to determine which of these failure modes occurred. Similar conclusions were reached by the National Commission. Consequently, as for the annulus and shoe track cement barriers, there are multiple plausible failure modes that can explain how hydrocarbons were able to breach the float collar assembly.

Figure 2.6 – Float collar conversion failure.²⁶

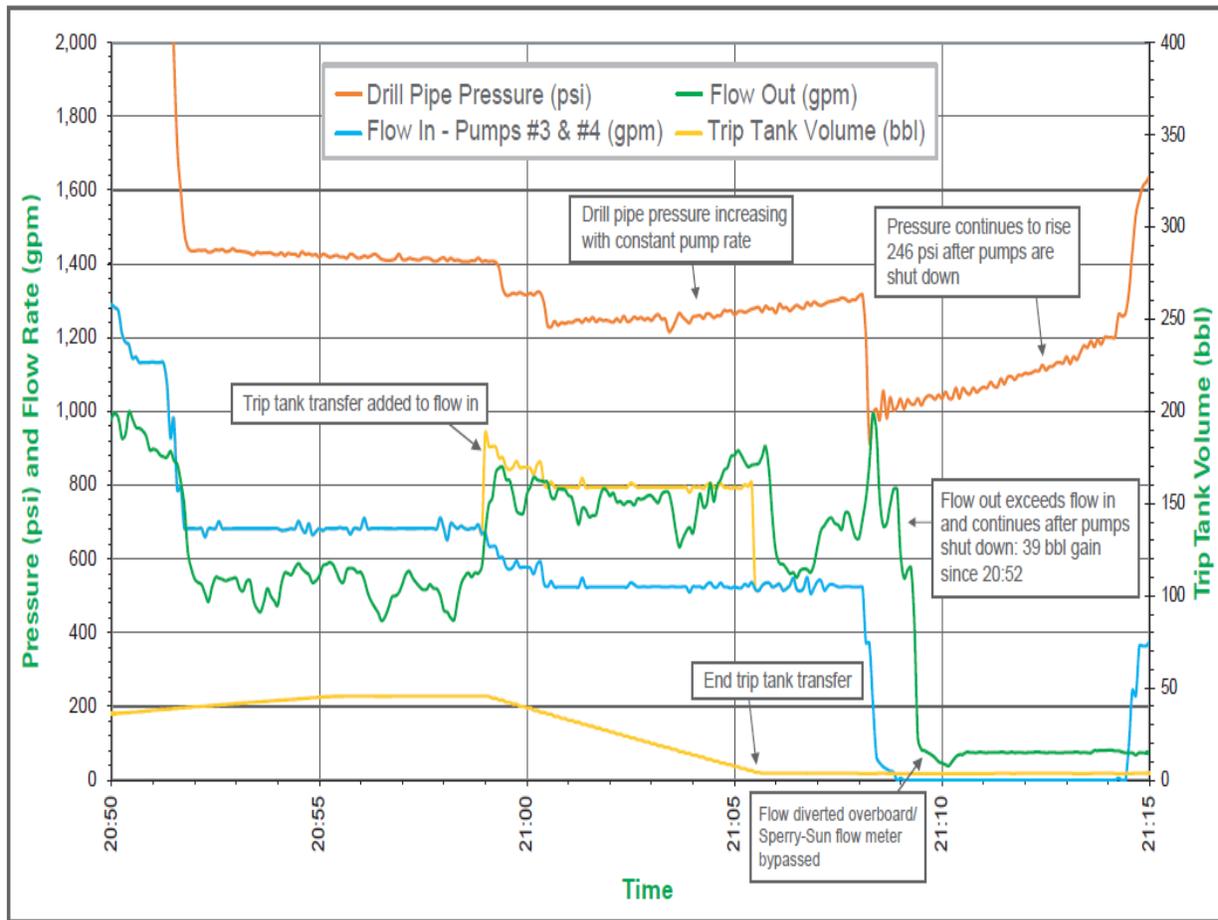
Preparations were also underway to set a cement plug in the well following completion of the displacement operations. Available information and testimony indicates there was no effective monitoring of well flow conditions between about 5:30 p.m. when offloading the mud to the supply vessel began to about 9:00 p.m. (Figure 2.8). The available records indicate the first indication of significant flow from the well would have been shortly before 9:00 p.m. when the well again reached an under balanced condition—the pressures in the reservoir exceeded the pressures in the well bore. The real-time data show the drill pipe pressures were continuing to increase and the flow out exceeded the flow in after the pumps were shut down at 9:08 p.m. Available testimony does not indicate that anyone on the *Deepwater Horizon* recognized these *early warning* signals or took appropriate action to shut in the well.

Figure 2.8 – Real-Time data (April 20, 2010) during last portion of mud transfer operations.³⁵

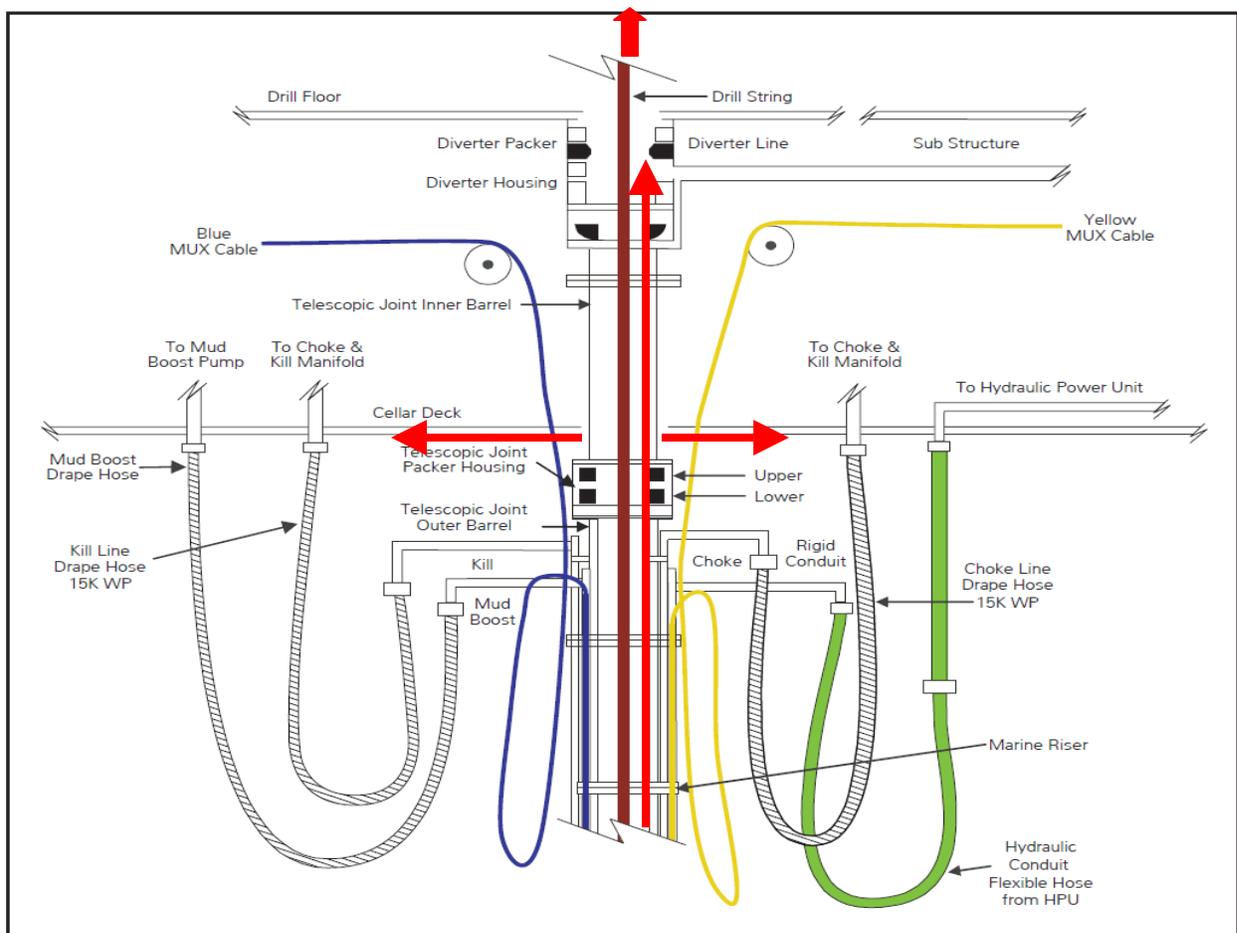
Figure 2.13 – Configuration of drilling riser, drill pipe, and other equipment in Moonpool area.⁴⁴
