REPUBLIC OF THE MARSHALL ISLANDS

DEEPWATER HORIZON MARINE CASUALTY INVESTIGATION REPORT

Official Number: 2213

IMO Number: 8764597

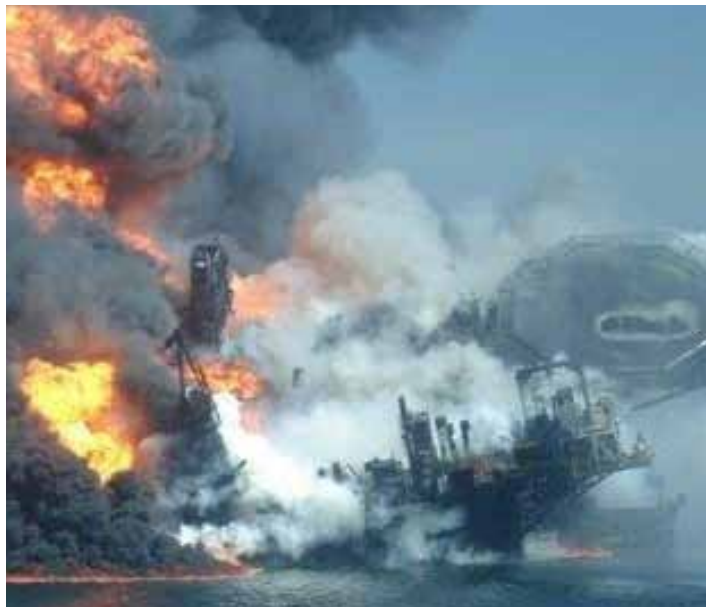
- 2.128 During the incident two sources of fluid made it onto the decks of the Unit. The first is fluid from the well itself; and the second is water sprayed by the reportedly uncoordinated firefighting vessels on the scene.⁴⁵⁵

- 2.129 The DEEPWATER HORIZON's starboard list continued to increase. The USCG reported that the vessels spraying water onto the Unit were "backing off, due to safety concerns."⁴⁵⁶ The Unit was listing 10° and the "fire and smoke were out of control."⁴⁵⁷

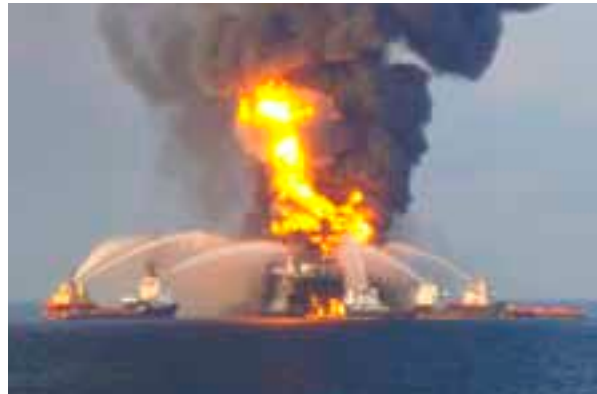
- 3.62 The DEEPWATER HORIZON capsized and sank approximately 36 hours after the ignition occurred. It is probable that decks, bulkheads, ventilators, and weather/water tight doors and windows were damaged and or distorted by falling debris and heat providing paths for fluids to flow below deck. The damage caused by the falling derrick increased the probability that the fluids collected in the Sack Room, causing the Unit to heel to starboard. Once the heel to starboard was established, the flow of fluid continued to favor the starboard side and collect in any accessible space. Once the heel had increased to the point of deck edge immersion, other openings, which would normally be well away from the water, were submerged under the sea's surface and flooding accelerated.
