# National Transportation Safety Board

## Marine Accident Brief

### Collision of Oil Tanker *FR8 Pride* with MODU *Rowan EXL I*

<b>Accident no.</b>	DCA-12-LM-017
<b>Vessel names</b>	<i>FR8 Pride</i> <i>Rowan EXL I</i>
<b>Accident type</b>	Collision
<b>Location</b>	Aransas Pass - Port Aransas/Corpus Christi, Texas 27°49.1' N, 097°00.5' W
<b>Date</b>	May 2, 2012
<b>Time</b>	0718 central daylight time (coordinated universal time -5 hours)
<b>Injuries</b>	None
<b>Damage</b>	Estimated total: \$16 to 17 million ( <i>Rowan EXL I</i> : \$14 to 15 million; <i>F8 Pride</i> : \$2 million)
<b>Environmental damage</b>	Minor – limited spillage of hydraulic oil from damaged hydraulic oil piping
<b>Weather</b>	Clear skies, SE wind at 9 knots, seas 3 feet, air temperature 57° F
<b>Waterway characteristics</b>	Corpus Christi is a principal deep water port in the US Gulf of Mexico. Aransas Pass is the principal approach from the Gulf to Aransas and Corpus Christi Bays and their tributaries.

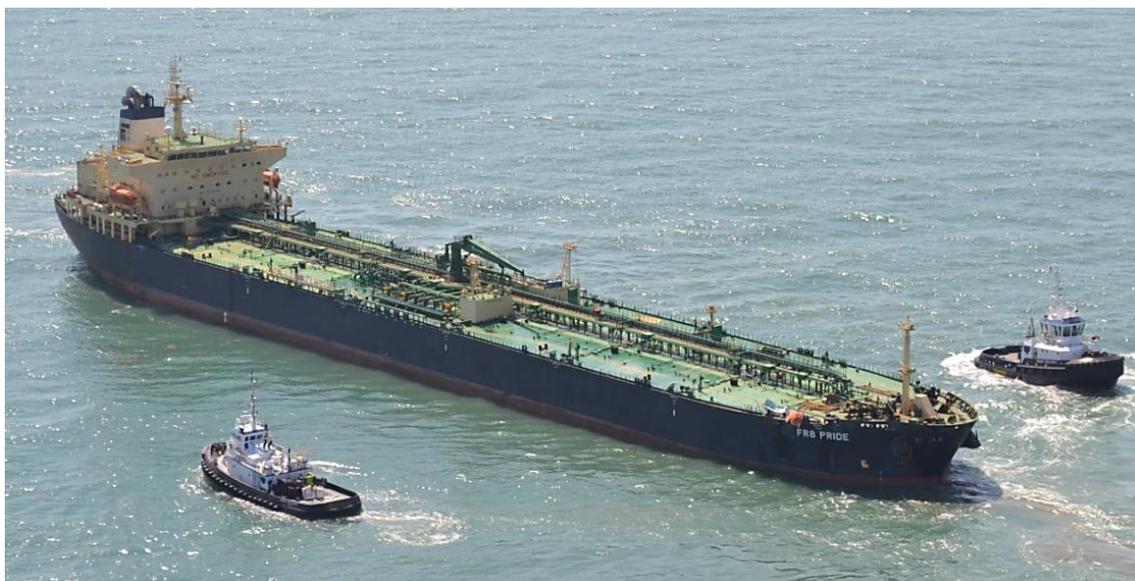
The *FR8 Pride* shortly after the collision. Photo provided by the Coast Guard.

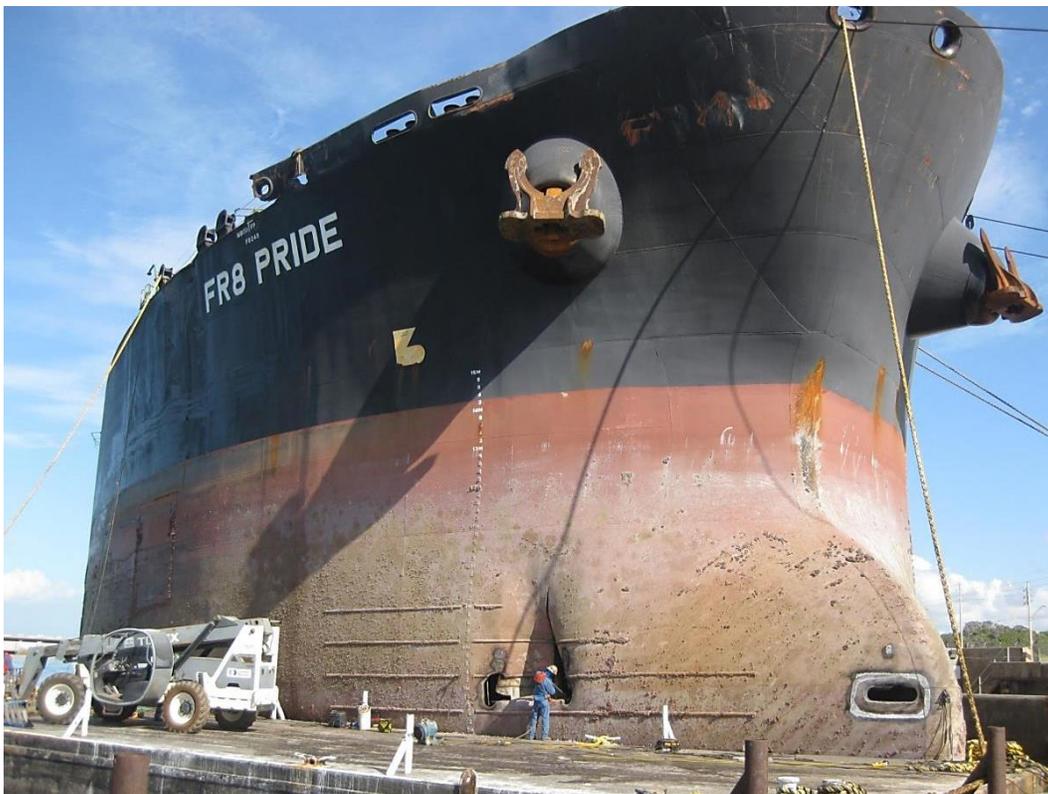
Damage to the *FR8 Pride* consisted of two torn openings in the starboard side of the forepeak tank below the waterline, deformation and holing of the No. 1 wing ballast tank, buckling and deformation of the starboard bulwark from the bow to frame 249 (about 150 feet), damage to the starboard side forward hand rails, and damage to its forward mast.

Damage to the *FR8 Pride*, including the puncture to the hull below the waterline, visible in the lower center of the image. Photo provided by the Coast Guard.

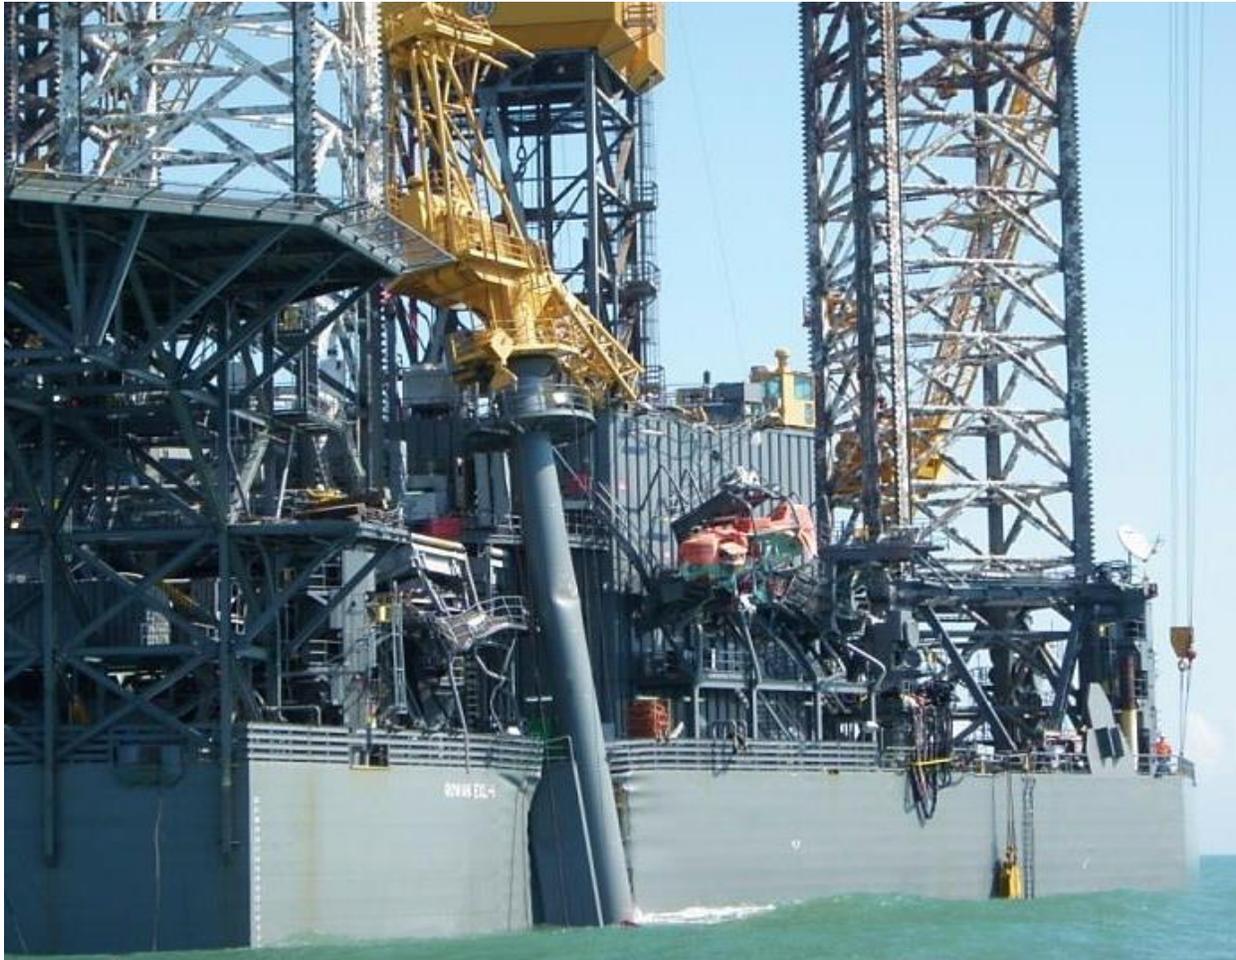
Damage to the *Rowan EXL I* consisted of deformation and tearing of the No. 3 port ballast tank bulkheads, deformation and tearing of No. 5 port ballast tank bulkheads, and buckling of the No. 7 port ballast tank and that tank's bulkhead. In addition, the port forward crane boom, crane support column and adjacent work platforms and piping systems, and the portside survival crafts were damaged.

The extensive damage to the port side of the *Rowan EXL I*, including its destroyed survival crafts (orange-colored) near the center of the photo. Photo provided by the Coast Guard.

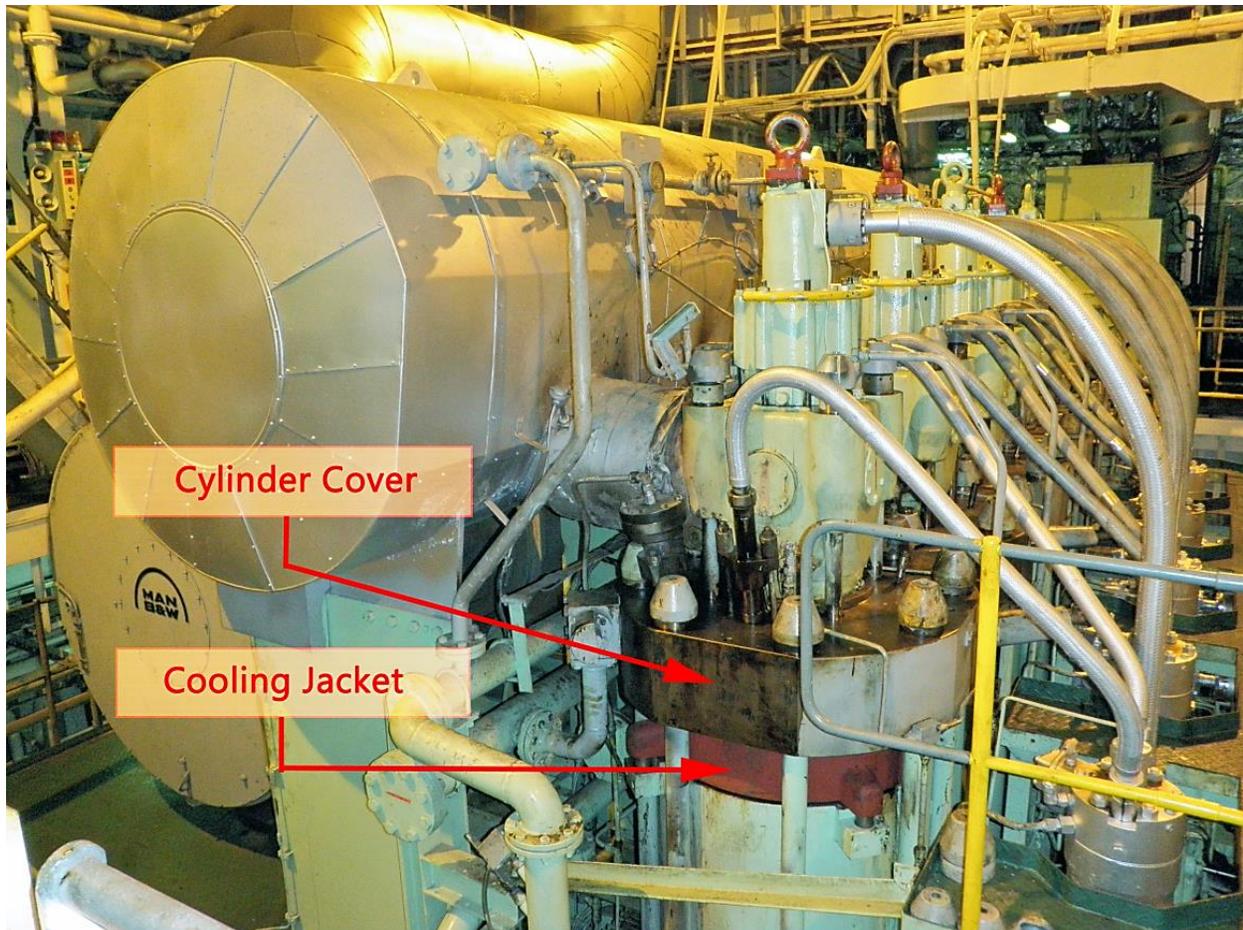
The reason for the automatic slowdown of the *FR8 Pride*'s engine was that the cooling jacket on the engine's cylinder No. 5 had suddenly cracked. Jacket water began leaking from the cracked cooling jacket, and the main engine control system (Kongsberg AutoChief 4)—detecting the resulting pressure loss in the jacket water cooling system—protected the engine by reducing its speed.

The *FR8 Pride*'s main propulsion engine, with the location of the failed engine component (cooling jacket for cylinder No. 5) indicated. Photo by the Coast Guard.

In the weeks before the collision, on two separate occasions, the cooling jackets on two of the *FR8 Pride*'s other cylinders (Nos. 2 and 3) had also cracked, and the ship's crew had repaired them. After cylinder No. 5's cooling jacket failure, which led to the collision, the crew called on the assistance of the engine manufacturer's service engineer, who identified several possible causes for the cracked cooling jackets. According to the service engineer's report, the cracks likely resulted from excessive thermal stresses imposed by rapid application of engine load when the ship's speed was increased from slow ahead to full ahead. However, the Kongsberg AutoChief 4 engine control system, which prevents engine damage from rapid changes in load by limiting fuel rack position according to a pre-set load application curve, was evaluated postaccident and found to be functioning correctly. In addition, the three cooling jackets were metallurgically tested in an attempt to determine why they had cracked. The test found no abnormal conditions such as flaws or defects, preexisting cracks, unusual metal composition, corrosion, or manufacturing defect. The metallurgical test report did express the opinion that the material used in manufacturing the cooling jackets (gray cast iron) might be inappropriate for this design application. However, according to the engine manufacturer, there had not been an unusual number of failures of this engine component within the population of this model engine, suggesting that no design deficiency exists.

During the months before the collision, the engine's jacket water temperature control valve could not automatically maintain a steady water temperature in the engine when load changed appreciably. The crew had, therefore, been manually controlling the jacket water temperature during ship maneuvering. The crew's manual control appeared to have been effective before the failure of the No. 5 cooling jacket; according to the engine alarm system record, no high or low water temperature condition had occurred during the maneuvering period leading up to the collision. Therefore, the cause of the cracked cooling jackets remains undetermined.
