National Transportation Safety Board

Marine Accident Brief

Sinking of Offshore Supply Vessel *Ricky B*

Accident no.	DCA-13-LM-024
Vessel name	<i>Ricky B</i>
Accident type	Sinking
Location	Gulf of Mexico, 24 nautical miles (nm) south of Marsh Island, Louisiana 29° 05.6' N, 091° 59.6' W
Date	May 30, 2013
Time	0702 central daylight time (coordinated universal time – 5 hours)
Injuries	None
Damage	\$520,000
Environmental damage	Sheen reported from an estimated 800 gallons of marine diesel fuel on board, which dissipated due to open water, weather, and sea state in the area. Debris field from on-deck cargo, including empty 600-gallon fuel totes and multiple grocery boxes.
Weather	Winds at 8 knots from the east. Seas at 2–3 feet. Partly cloudy, with 10 nm of visibility. Air temperature 79°F and water temperature 78°F.
Waterway information	North central Gulf of Mexico, populated with numerous offshore oil production platforms and drilling rigs.

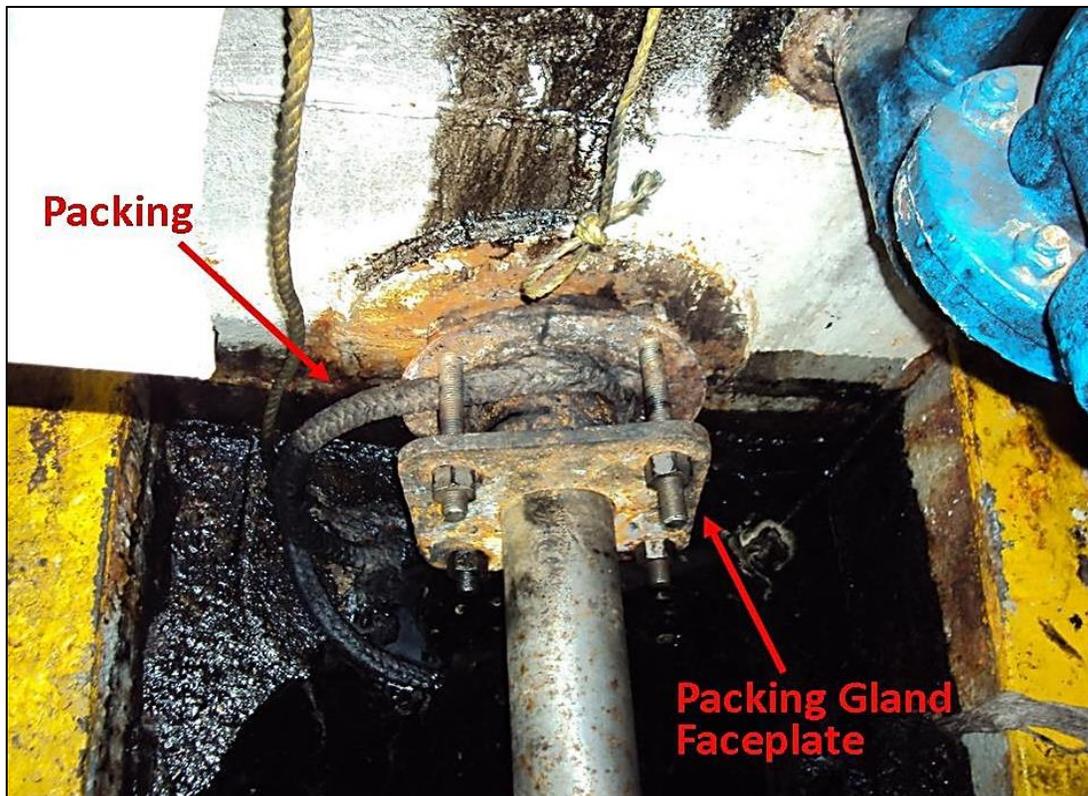
The photo shows the *Ricky B's* starboard shaft seal system after the vessel was refloated. Salvage personnel installed the packing material seen protruding from the shaft seal system, and refitted the packing gland faceplate.

About 2.5 weeks later, on June 17, the *Ricky B* was lifted to the surface by a contracted salvage team for dewatering. On entering the engine room, the salvage supervisor discovered that three of the four nuts that secured the packing gland faceplate to the shaft sealing system were loose, and the plate was offset 3–4 inches, allowing water to flow freely into the vessel. The salvage supervisor removed the packing gland faceplate, installed new packing material, and then reinstalled the packing gland faceplate, effectively making the gland watertight. The vessel was dewatered and then towed to a shipyard in Morgan City, Louisiana, to be examined and repaired or scrapped.

Postsinking toxicological testing was performed on all three crewmembers, and the mate's urine specimen tested positive for cocaine. The mate's use of this illegal drug may have contributed to the sinking because of his decision to engage the starboard propulsion shaft even though he knew that it had been shut down due to a severe seal leak. In addition, although the crewmembers stated that they had tightened the bolts that secured the starboard shaft packing gland faceplate, this was not the condition in which the salvage team found the starboard shaft seal when the vessel was examined immediately after refloating.
