National Transportation Safety Board

Marine Accident Brief

Subsea Pipeline Damage by Tug and Barge *Valiant/Everglades*

Accident no.	DCA15LM003
Vessel name	Tug <i>Valiant</i> and barge <i>Everglades</i>
Accident type	Loss of propulsion/pipeline damage
Location	Gulf of Mexico about 120 nautical miles southeast of Galveston, Texas 28° 14' N, 92° 46' W
Date	November 17, 2014
Time	0600 central standard time (coordinated universal time – 6 hours)
Injuries	None
Damage	Natural gas pipeline: est. \$2 million
Environmental damage	None reported
Weather	Northerly wind 30 knots with gusts to 35 knots, visibility 8 nautical miles, wave height 8–10 feet
Waterway information	Gulf of Mexico, open water, East Cameron production field

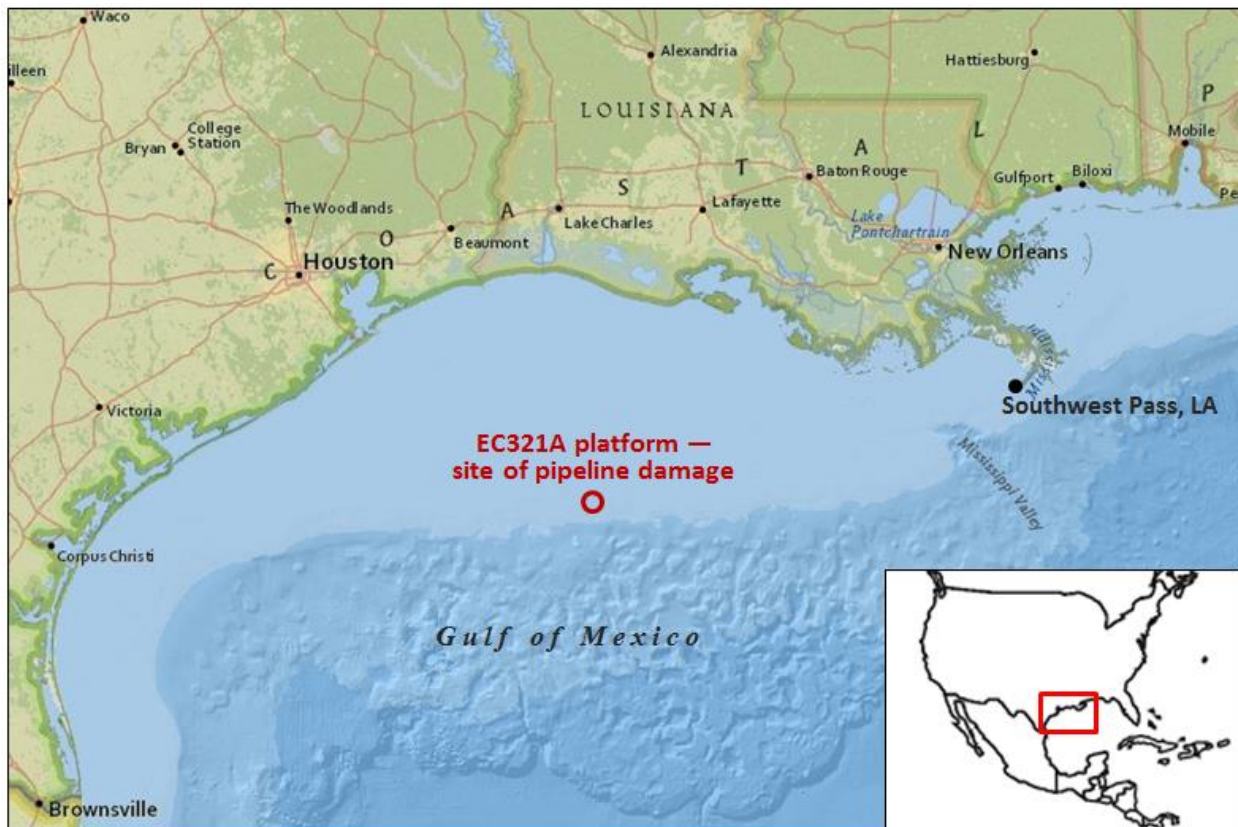
Site of production platform EC321A, where the *Valiant's* anchor damaged a subsea platform. (Background by National Geographic MapMaker Interactive)

A survey carried out by the pipeline owner stated that the anchor had dragged across six subsea pipelines and completely severed one 16-inch natural gas pipeline. The pipeline owner reported that 223,000 mcf of natural gas was released as a result of the rupture. An additional 26,800 thousand cubic feet was later released in a controlled manner to clear the line.

The National Transportation Safety Board determines that the probable cause of the damage to the subsea natural gas pipeline was the anchor from the *Valiant/Everglades* dragging across the pipeline after the vessel lost starting air pressure and propulsion due to the opening of an unprotected air system valve on deck.

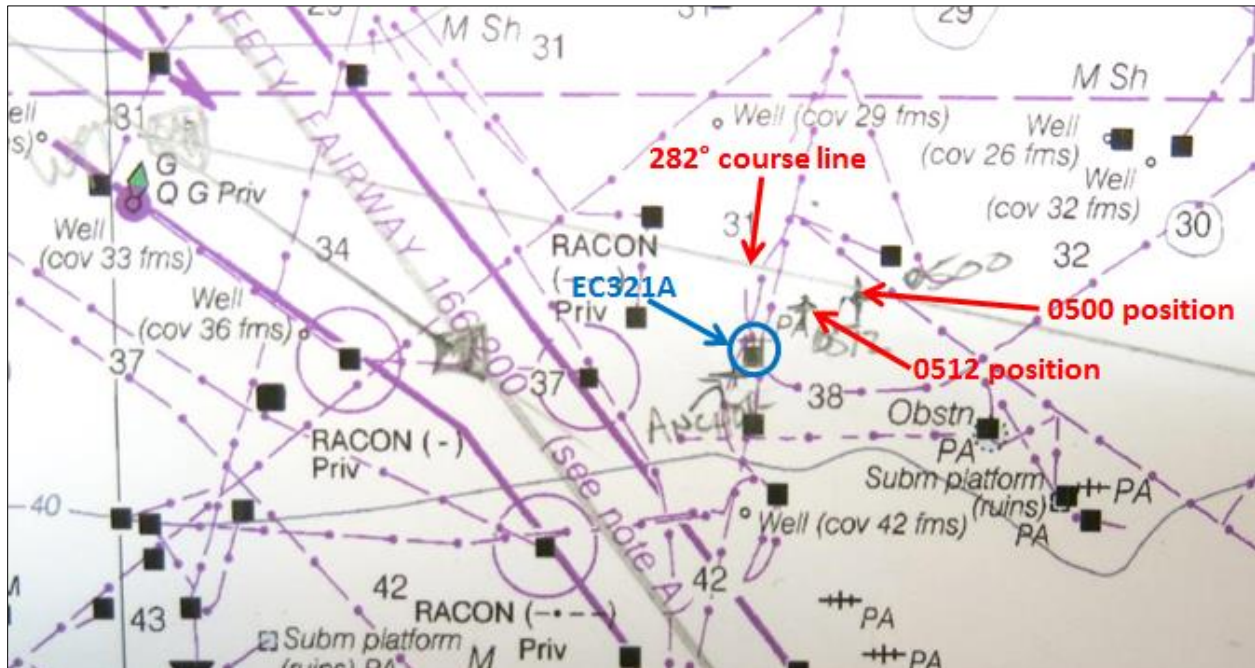
As the tug and barge drifted to within about 1 nautical mile of the platform, both the captain and chief mate used the vessel's electronic chart system (ECS) to determine the water depth and presence of pipelines on the sea floor running to and from the platform. The captain ordered the crew of the barge to prepare the anchor windlass. As the captain was aware of the presence of pipelines in the area and that the crew was making progress in rigging the additional air hoses from the compressor on the barge, he decided to delay letting the anchor go to slow the vessel. He stated the anchor was his last resort as only "one start" of the engines was needed to restore the propulsion.

Portion of NOAA chart 11340 used by the *Valiant* crew, with vessel position at 0500 and 0512 and course line (labeled in red) relative to EC321A.

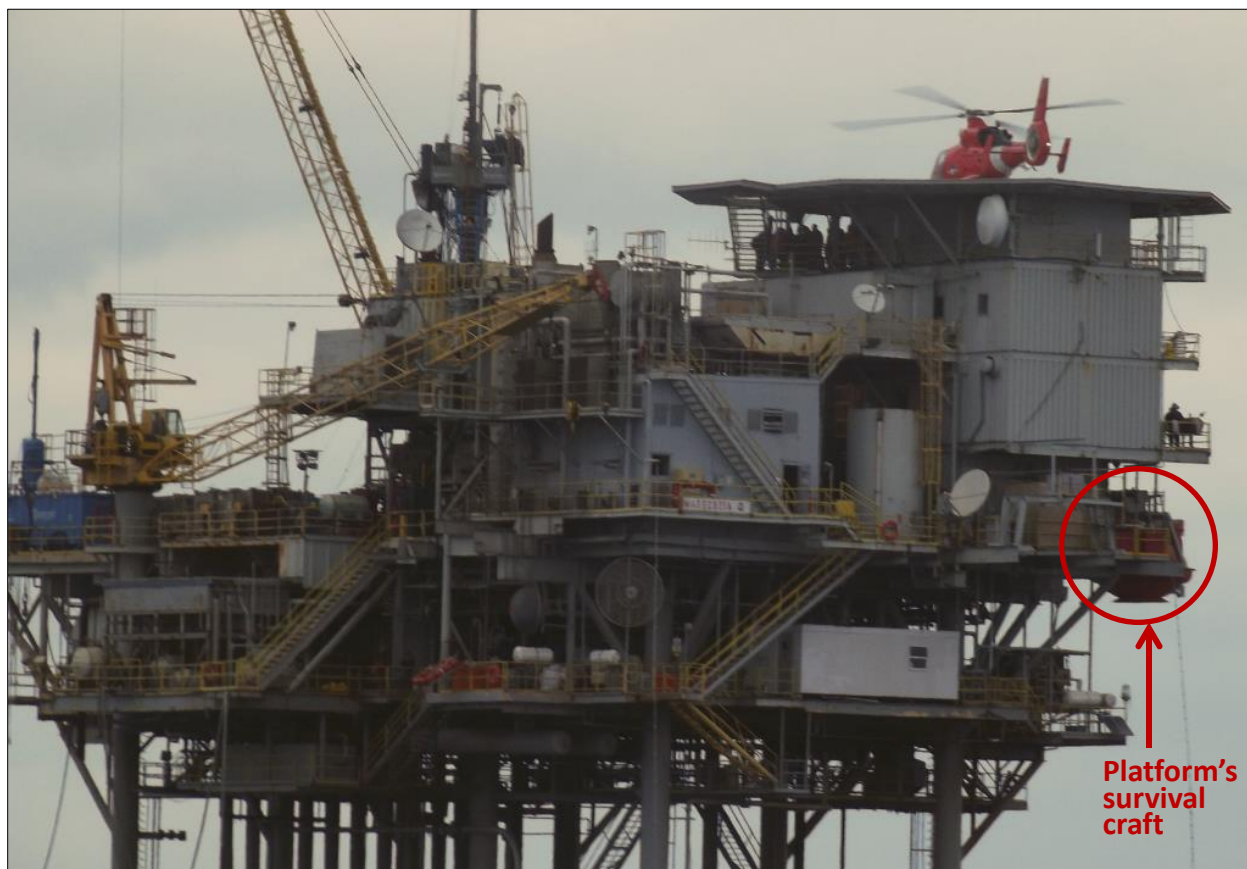
When the *Valiant* was about 500 feet from platform EC321A, the captain ordered the anchor let go. As the anchor began to fetch up on the bottom, the vessel's movement toward the platform began to slow. The captain then noticed air pressure building up and was able to start the port engine in astern propulsion, noting this was the best option to clear the platform. He momentarily ordered the rudders 10 degrees to port, but when this had no effect in clearing the bow from the platform, he went back hard to starboard. The starboard engine started moments later, and he backed on both engines. The anchor chain tightened, and he ordered more chain paid out and continued to back until the ATB was clear of the platform. A witness on EC321A estimated the *Valiant/Everglades* was about 20 yards from the platform at its closest point below the platform's survival craft.

Platform EC321A with Coast Guard HH-65 helicopter on deck and platform's survival craft at right. (Photo by Penny F crew)

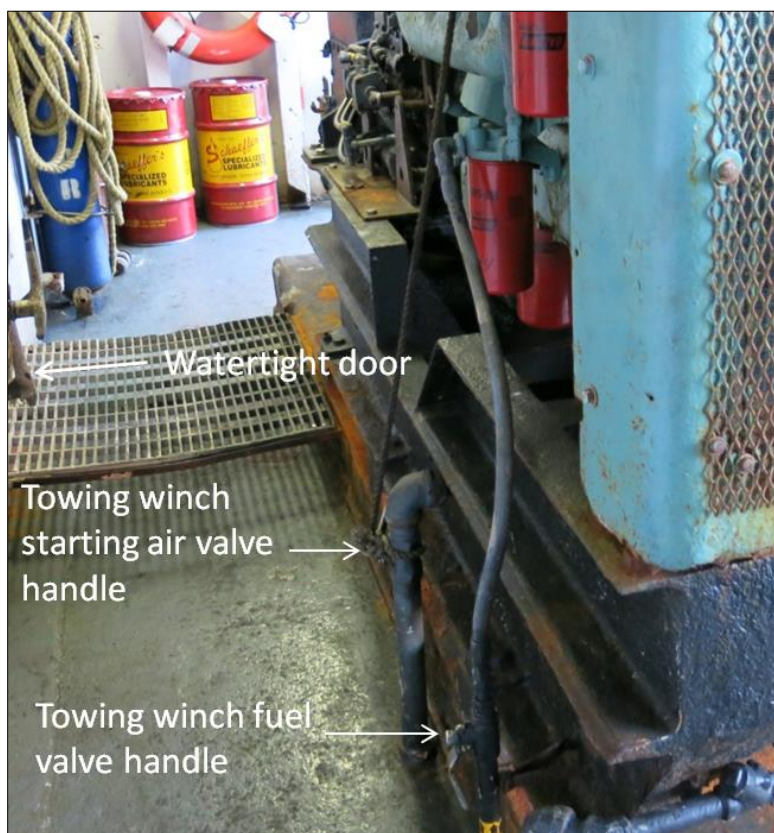
The vessel crew later found the source of the air leak was an air valve that supplied starting air to the towing winch engine on the *Valiant's* aft weather deck. Post-accident inspection and testing indicated the valve was operable but required only minimal force to open it, with no securing mechanism in place to protect it from unintentional opening. The investigation could not determine if the valve had been opened by the force of water on deck or by a loose object hitting the handle. *Valiant* crewmembers said the deck had been awash in the heavy seas. According to one, empty grease drums that had been secured on deck could not be found after the accident, suggesting they had come free. Additional crew statements indicated loose items such as buckets also were missing, but items mounted on the bulkhead directly adjacent to the towing winch appeared to be in place and undamaged. Investigators could not determine if any of these objects had been displaced before the accident, but no crewmembers recalled having to replace any of these objects.

Towing winch motor and locations of starting and fuel valve handles and watertight door into accommodation.

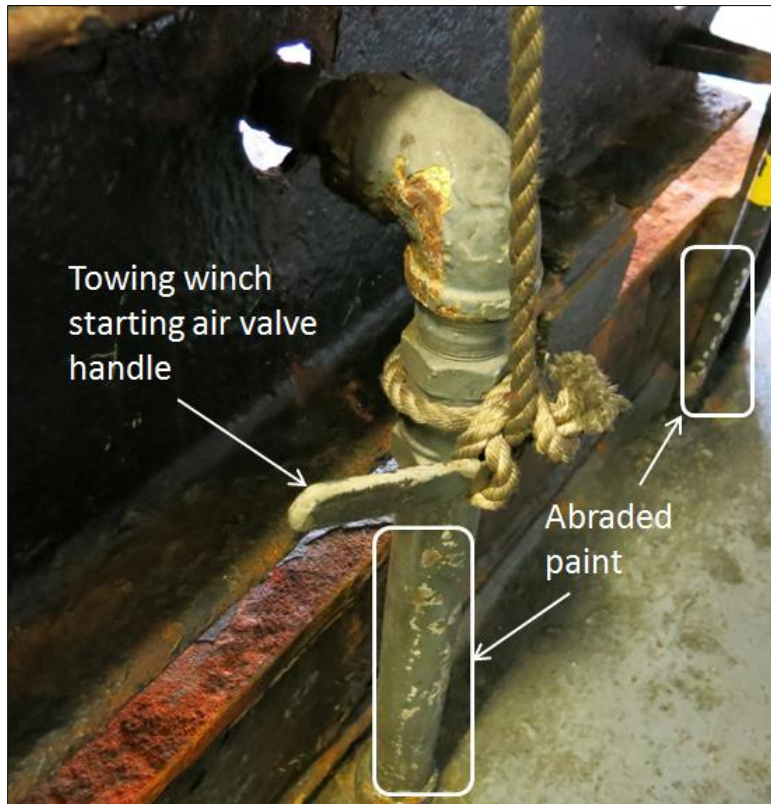
During the post-accident survey, abraded paint was noticed on the starting air pipe, likely due to impact from a solid object, but no loose equipment was found in the area. The investigation did not determine why the valve had moved to the open position.

Close-up of starting air valve (in closed position) for towing winch engine with recent paint damage (rope was not in place at time of accident).
