# National Transportation Safety Board

## Marine Accident Brief

### Allision of Offshore Supply Vessel *Tristan Janice* with Natural Gas Platform

<b>Accident no.</b>	DCA14LM007
<b>Vessel name</b>	<i>Tristan Janice</i>
<b>Accident type</b>	Allision
<b>Location</b>	Ship Shoal 119 W natural gas platform, Gulf of Mexico 28°49.4' N, 90°55.3' W
<b>Date</b>	February 18, 2014
<b>Time</b>	0712 central standard time (coordinated universal time – 6 hours)
<b>Injuries</b>	None
<b>Damage</b>	Platform: \$410,000 Vessel: \$135,000
<b>Environmental damage</b>	Release of more than 22,000 cubic ft of natural gas
<b>Weather</b>	Light wind, calm seas, restricted visibility due to fog. Temperatures at allision site unknown; air temperatures in Houma, Louisiana (54 miles* to the north-northeast) in the upper 60s.
<b>Waterway information</b>	Open waters of the Gulf of Mexico, about 54 miles south-southwest of Houma and about 85 miles southwest of New Orleans, Louisiana

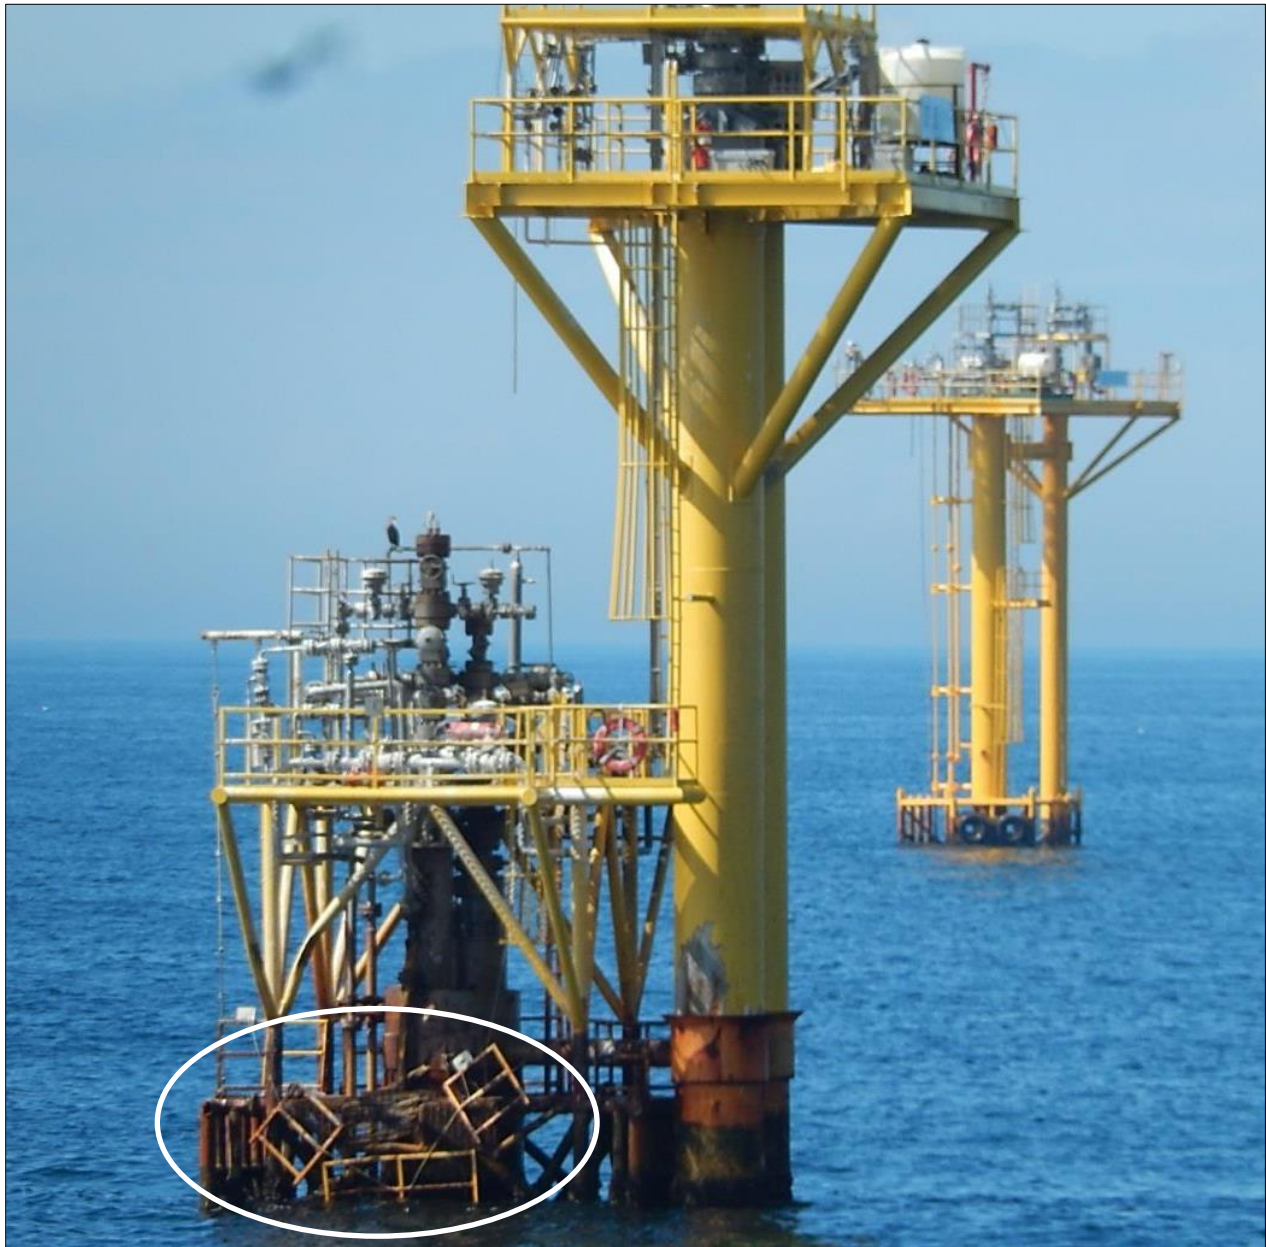
The platform sustained structural damage and its gas service line ruptured. The rupture caused a release of more than 22,000 cubic feet of natural gas into the atmosphere and a 20-day cessation of operations at Ship Shoal 119 W and neighboring platforms.

Displaced rails, catwalk, and risers on natural gas production platform Ship Shoal 119 W. (Photo provided by the Coast Guard)

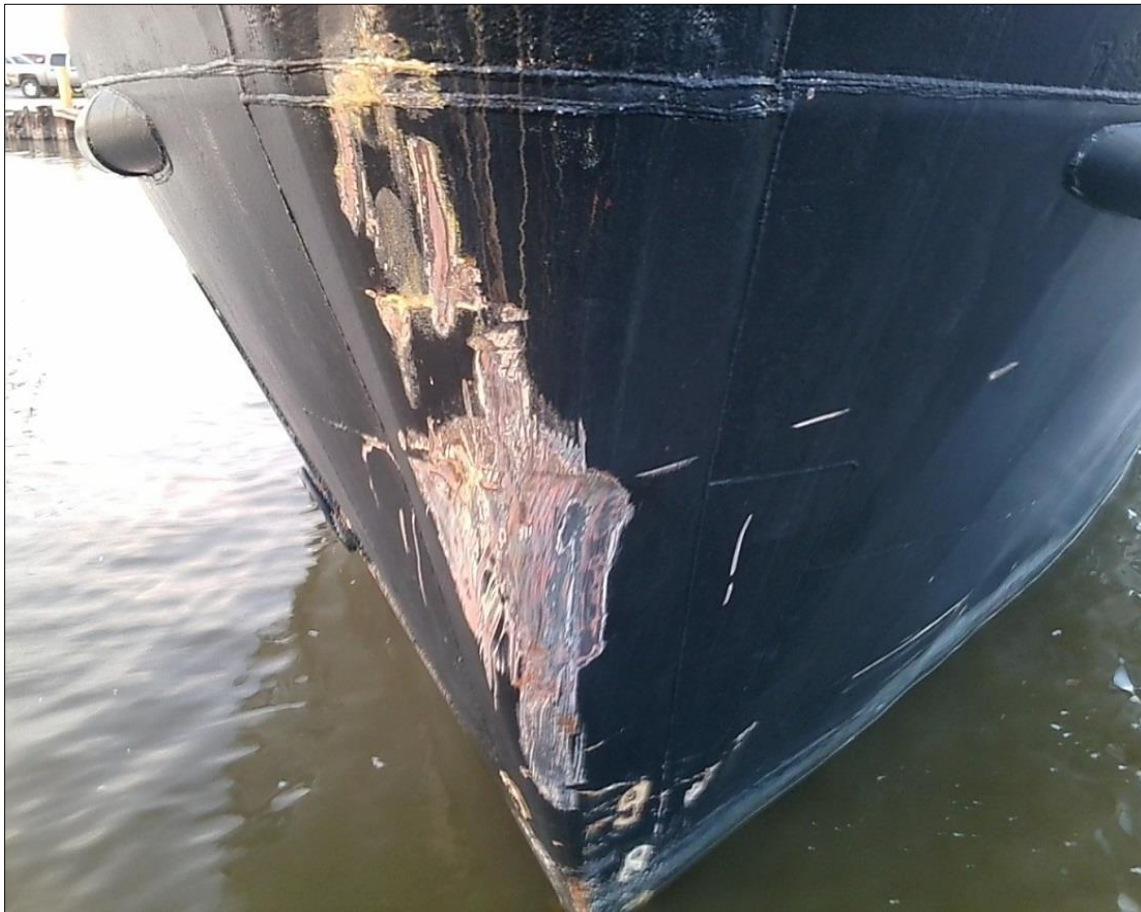
The *Tristan Janice* sustained fractures and indentations to the bow area, broken welds to the port engine exhaust, and a damaged port engine forward main seal.

Damaged bow of the *Tristan Janice*. (Photo provided by the Coast Guard)
