# **NATIONAL TRANSPORTATION SAFETY BOARD**

## **MARINE ACCIDENT REPORT**

**CAPSIZING AND SINKING OF THE  
U.S. MOBILE OFFSHORE DRILLING  
UNIT OCEAN RANGER OFF THE  
EAST COAST OF CANADA  
166 NAUTICAL MILES EAST OF  
ST. JOHN'S, NEWFOUNDLAND  
FEBRUARY 15, 1982**

NTSB-MAR-83-2

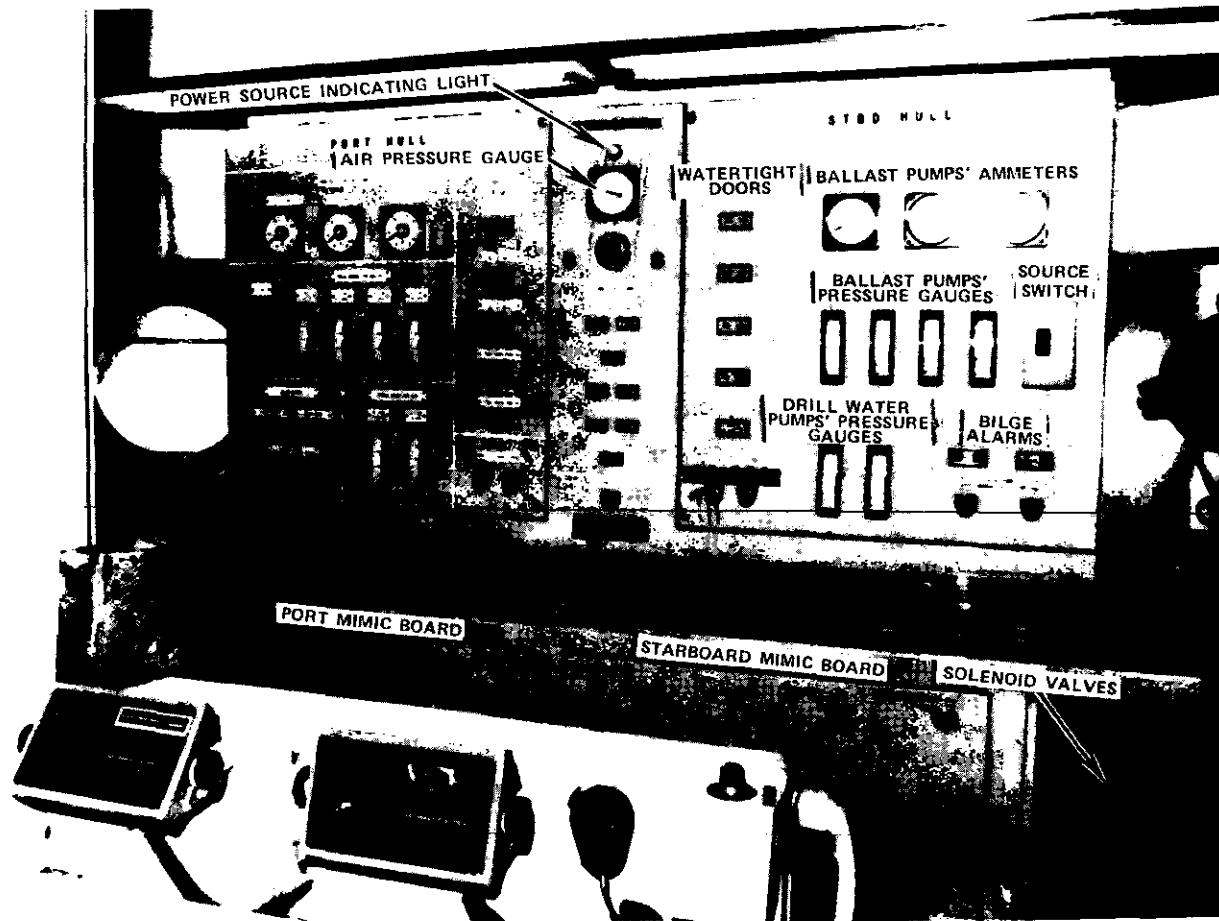
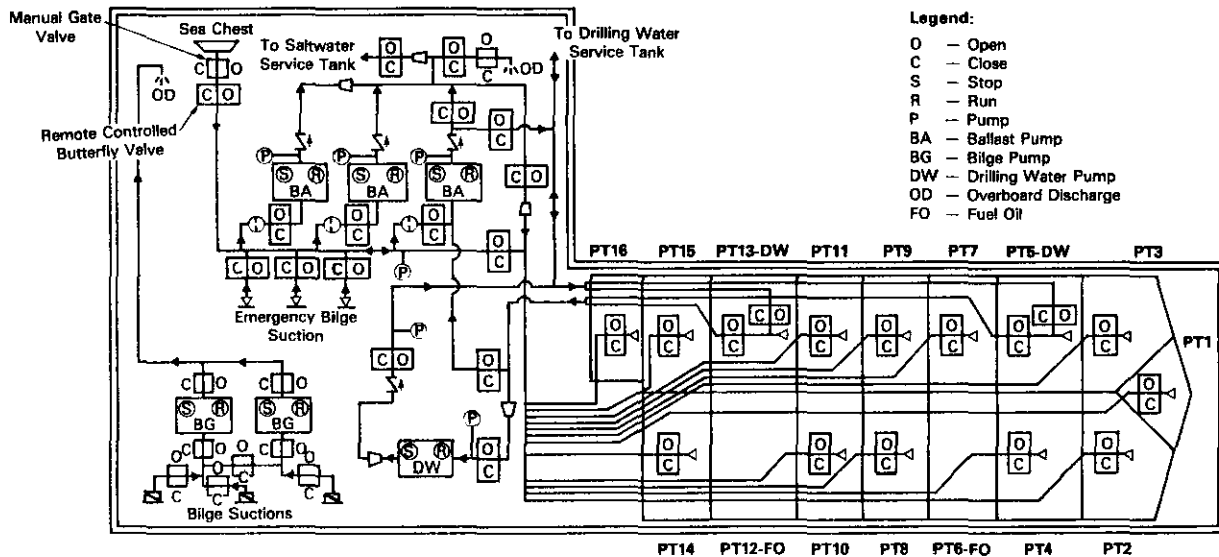
Figure 5.—Ballast control console and details of port mimic board.

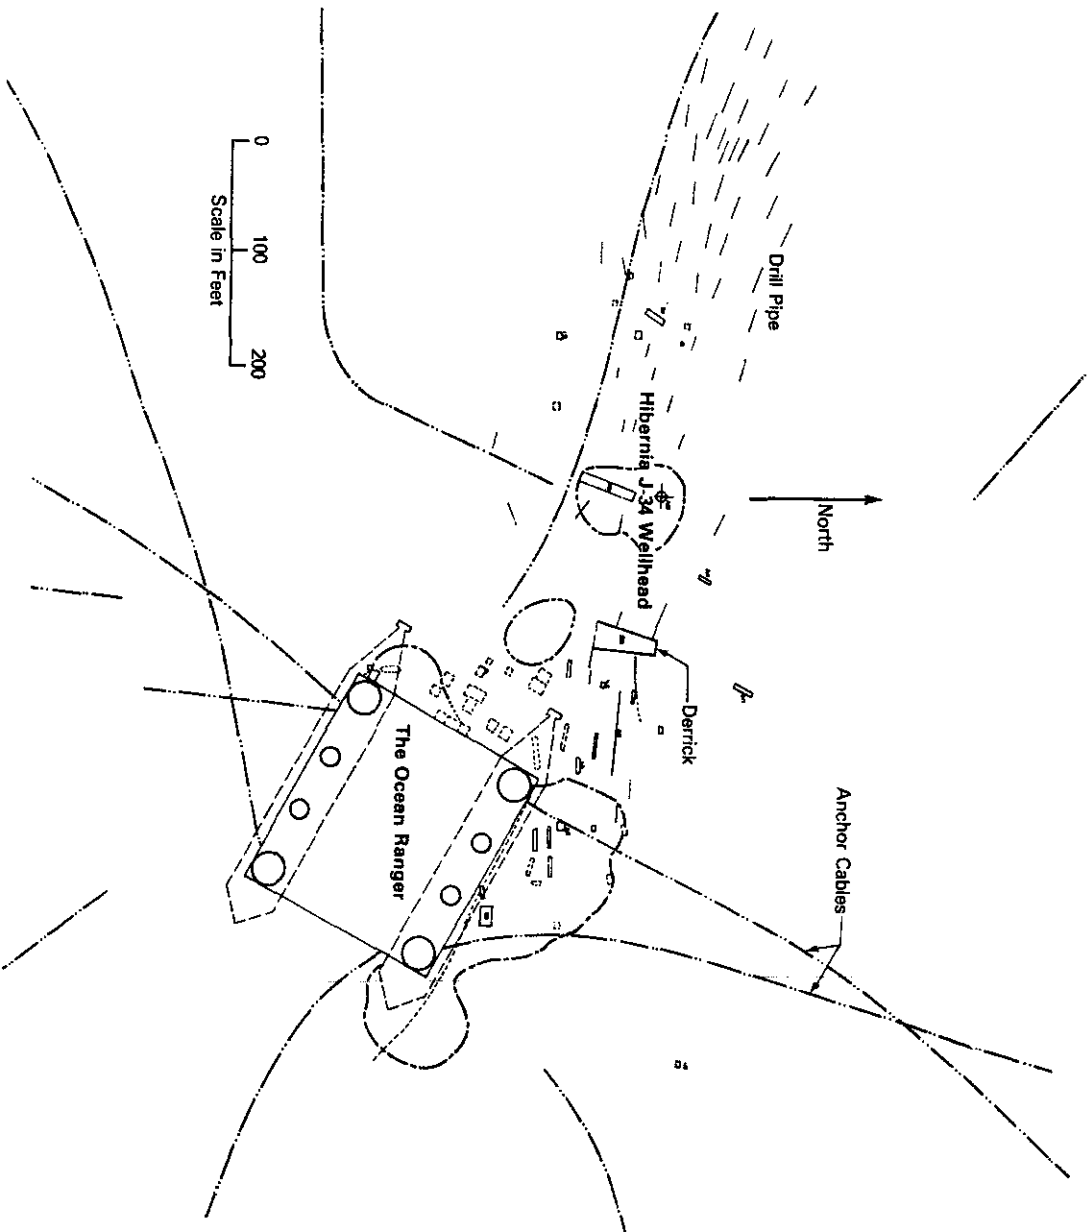
The OCEAN RANGER sank upside down, with its bow on a heading of 117° in about 260 feet of water about 150 yards southeast from its anchored position over the wellhead and is resting on the bottom. Underwater videotapes of the sunken drilling unit were taken in early March 1982 by an unmanned submersible. The videotapes showed minor damage to the bows of both lower hulls, two broken portlights in the control room, and that all four deadlights were closed. The videotapes did not show any other major structural damage to the OCEAN RANGER's columns or lower hulls. A side scan sonar survey, conducted between February 18 and March 2 1982, located drill pipe and other debris scattered up to 300 yards from the sunken drilling unit in a northwest to southeast direction. The value of the drilling unit was estimated at \$125 million.

Figure 6.--March 8, 1982, side scan sonar survey of the OCEAN RANGER.
