MARINE ACCIDENT REPORT

**EXPLOSION AND FIRE ABOARD THE
U.S. MOBILE OFFSHORE DRILLING UNIT
ZAPATA LEXINGTON
GULF OF MEXICO
SEPTEMBER 14, 1984**

NTSB/MAR-85/11

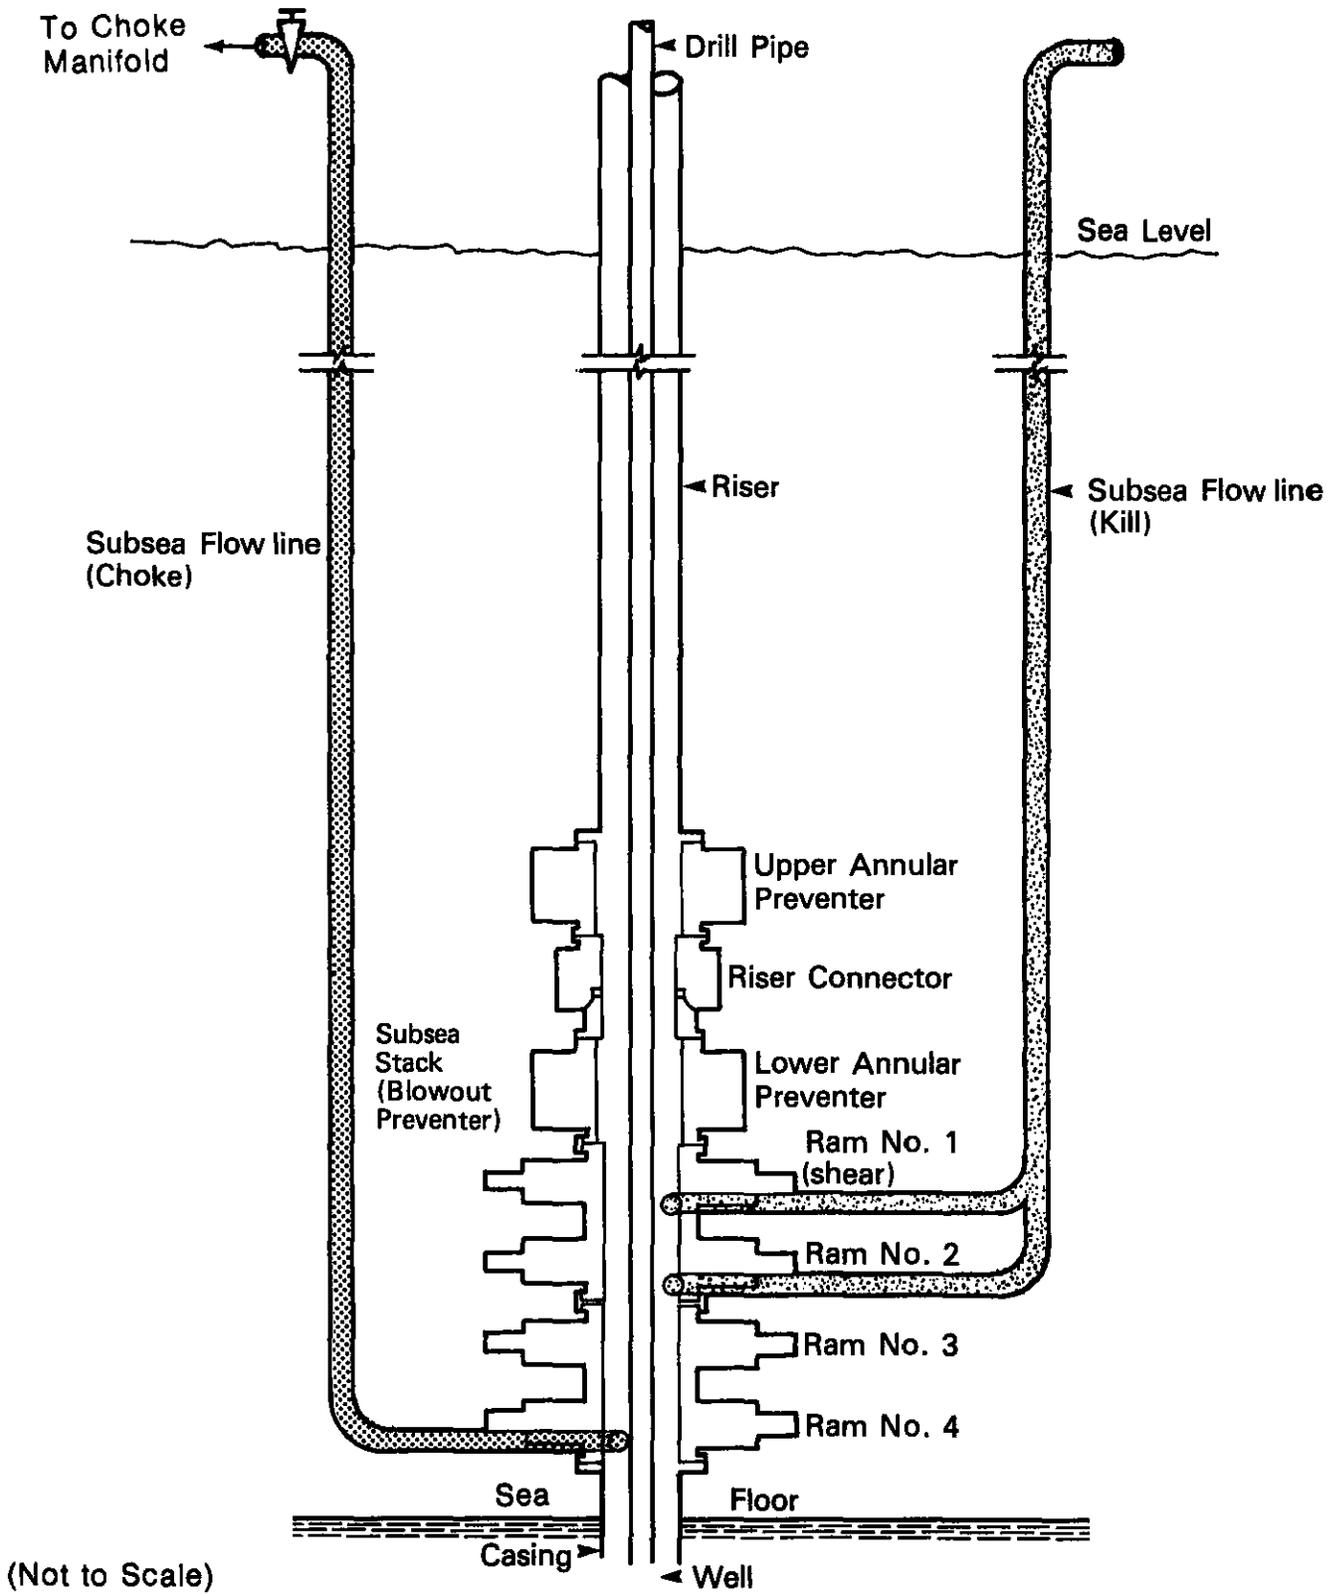
Figure 3.--Diagram of blowout preventer (BOP), marine riser, and subsea flowlines of the ZAPATA LEXINGTON.

The study concluded that the accident occurred when trapped gas in the BOP stack was released to the marine riser during routine operations. The "U-tube" method employed to circulate the trapped gas out of the BOP did not succeed although the procedure has been used before in the industry. The study also stated that if the severity of the situation had been recognized sooner, alternate procedures could have been employed to greatly reduce the hazard, underscoring the need to expand research on the use of the diverter system and to modify the equipment as needed to reduce the volume of trapped gas in the BOP.

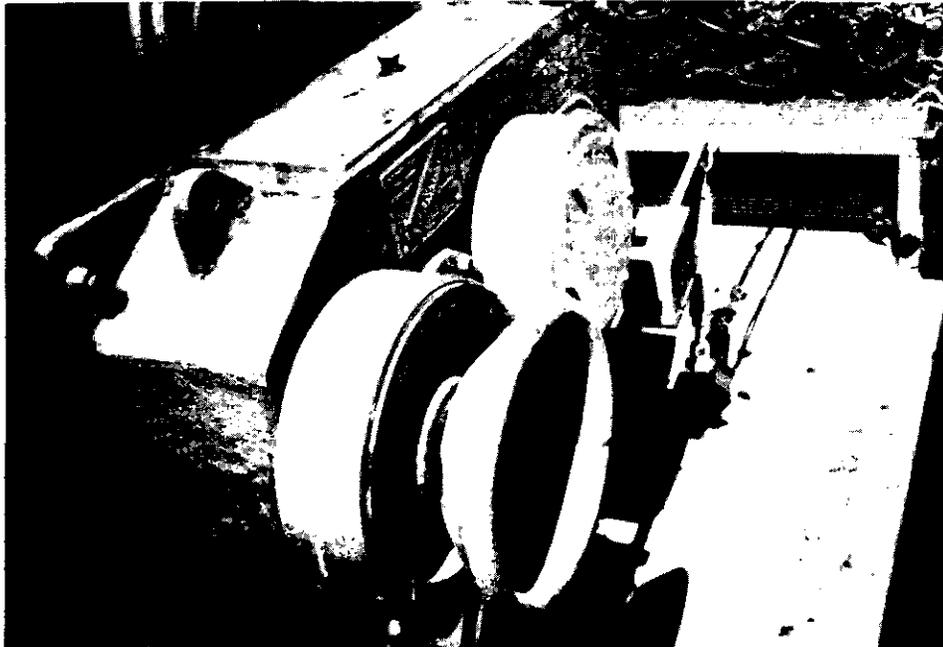
Figure 6.--Brake drum on lifeboat winch.

When the eight persons entered the ZAPATA LEXINGTON's single lifeboat and attempted to launch it by pulling the releasing ring attached to the brake release handle (see figure 5), the lifeboat would not lower. No one tried to turn the brake drum (see figure 6) on the lifeboat winch by hand to release the brake. After several unsuccessful attempts the group moved to the other end of the rig and launched two inflatable liferafts. A postaccident examination of the brake mechanism on the lifeboat winch revealed that several sharp raps on the brake band dislodged an accumulation of rust and allowed the brake to release.

hand grip provided, the lifeboat probably would have lowered. The two USCG-certificated lifeboatmen who were in the area should have tried to release the brake at the winch before accepting an alternate method of abandoning the rig. A primary means of rig evacuation, such as a lifeboat, must be checked at frequent intervals and the lowering mechanism exercised to ensure proper operation. Rig personnel should be knowledgeable about the operation of the lifesaving equipment so that problems such as a stuck brake band can be easily identified and dealt with immediately.
