# **NATIONAL TRANSPORTATION SAFETY BOARD**

## **MARINE ACCIDENT REPORT**

**EXPLOSION AND FIRE ONBOARD  
THE U.S. MOBILE OFFSHORE DRILLING UNIT  
GLOMAR ARCTIC II IN THE NORTH SEA,  
130 NAUTICAL MILES EAST-SOUTHEAST  
OF ABERDEEN, SCOTLAND  
JANUARY 15, 1985**

**NTSB/MAR-86/03**

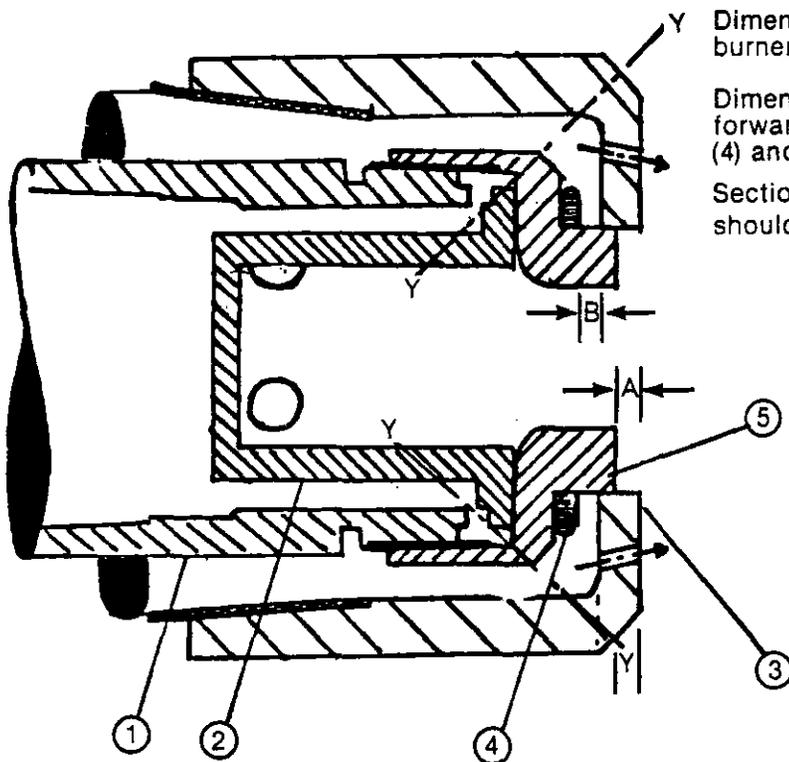
Figure 5A.--Nozzle assembly clearances.

- (a) Prior to disassembly, Dimension A (see figure 5-A), the clearances from the faces of the burner nozzles to the faces of the burner tips, were measured. Nozzle assembly No. 1 showed a clearance of 0.135 inch, No. 2 showed 0.101 inch of clearance, and No. 3 showed 0.254 inch of clearance.

- (b) The Flexitallic compression gaskets, which were located between the underside of the burner nozzles and the front gasket landing surface (see figure 5-A) of the burner tips, were found to be flattened in nozzle assemblies No. 1 and 3 while the gasket in assembly No. 2 was thicker than the other two. Gaps of about 1/5 inch, Dimension B, were found between the forward face of the compression gasket and the under side of the burner nozzle in the Nos. 1 and 3 nozzle assemblies.

- (c) The burner tip on nozzle assembly No. 3 was found to be only slightly tightened onto the fuel body, which failed to hold the fuel disc in its proper position between the fuel body and the burner tip.

Dimension A is the clearance measured between the burner nozzle face (3) and the burner tip face (5).

Dimension B is the clearance measured between the forward face of the flexitallic compression gasket (4) and the underside of the burner nozzle face (3).

Section 'Y - Y' is the sharp radius of the inner shoulder of the burner tip

Stress Calculations.--A simplified finite element analysis <sup>4/</sup> stress model was constructed using an internal static pressure difference of 500 psig. The predicted stress at the inner point of section 'YY' (see figure 5-A) of the No. 3 burner tip was 9.21 t/in<sup>2</sup> (tons per square inch). No exact replica of the geometry of the burner tip could be identified in stress concentration charts, but a similar system was identified and the stress concentration factor at the inner point of 'YY' was conservatively estimated to be 10.6. This would result in a stress of 97.6 t/in<sup>2</sup> at 'YY' of the burner tip. Also impulse loads impacting on the fuel disc could increase the stress at section 'YY' by a factor of 1.5 to a stress level of 146 t/in<sup>2</sup> which is very near the ultimate tensile strength of the thin very hard nitrided surface layer of the burner tip and is in excess of the ultimate tensile strength of the core material of the burner tip.

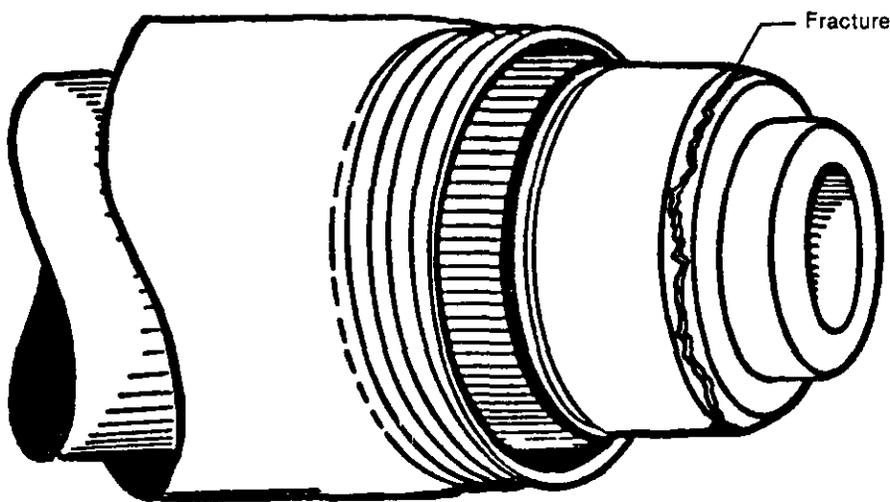
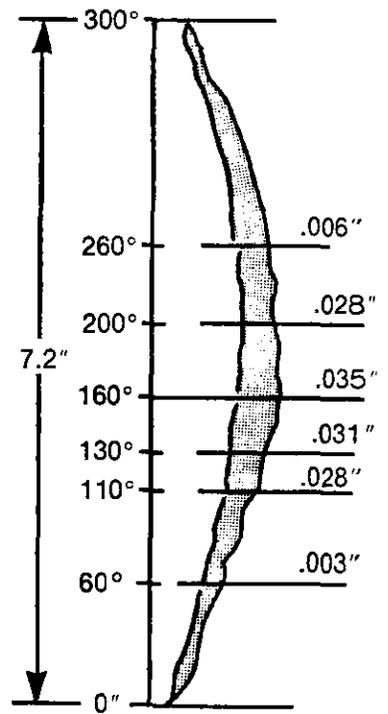
Figure 5-B.--Nozzle assembly dimensions.

Sketch of the No. 3 nozzle assembly (with the burner nozzle and gasket removed) showing the fracture which runs for 300 degrees around the circumference of the burner tip.

- (e) The dimensions of the open crack on the fractured burner tip No. 3 were measured using a micrometer microscope. (See figure 5-B.) The approximate area of the crack opening was 0.15 square inch.

Fracture Examination.--The fracture surfaces were found to have a light deposit of a viscous residue but were otherwise clean and free of corrosion deposits. However, a number of corrosion pits were observed on the surfaces of the inner shoulder radius of the No. 3 burner tip. The fracture was a "fast," or "brittle," fracture which propagated from the inner corner or radius of the No. 3 burner tip shoulder (see section 'YY' figure 5-A). There was no evidence of fatigue or stress corrosion. The burner tip was found to have suffered a complete through-wall fracture, mainly in the chamfered shoulder region with the fracture extremities extending downward into the skirt of the burner tip (see figure 5-B). The fracture ran for approximately 300° of the circumference of the burner tip with the greatest crack opening at the shoulder of about 0.035 inch.

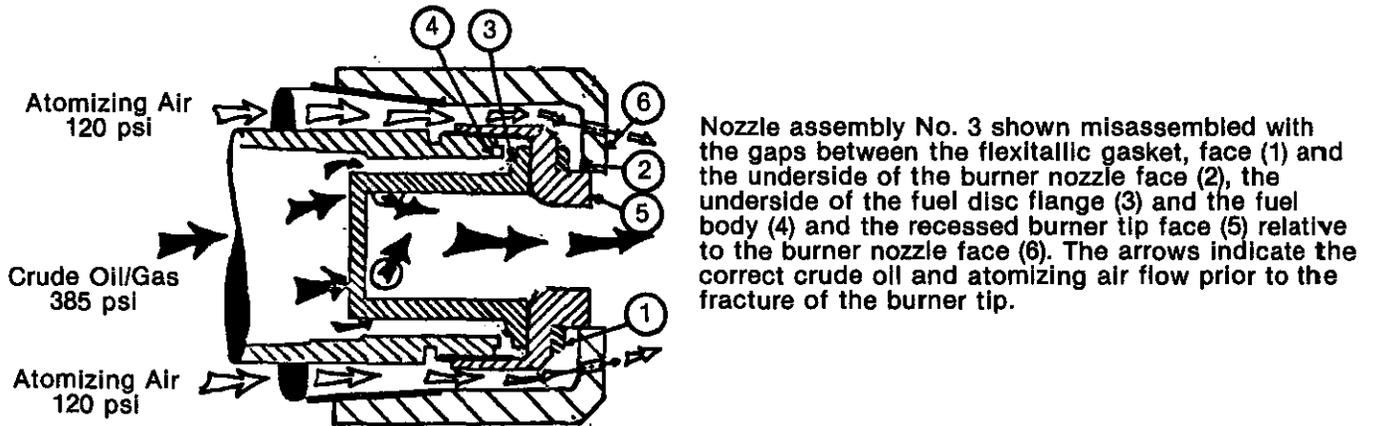
FIGURE 6-B—MISASSEMBLED

Otis Company drawings of the properly assembled burner nozzle unit clearly show that the faces of the burner nozzle and burner tip are flush and level with each other when assembled properly. (See figure 6-A.) The dimensional checks of the nozzle assembly and its components showed that over 1/4 inch of clearance existed between the No. 3 burner nozzle face and the improperly recessed burner tip face, which should have been an immediate visual indication to the well test crew that the compression gasket was not seated properly within the assembly and that the nozzle assembly was misassembled. (See figure 6-B.) With a misassembled nozzle assembly and an improperly seated compression gasket, crude oil/gas pressure against the fuel disc could transfer tensile and bending stresses to section 'YY' of the underside of the burner tip. Although neither the burner tip material nor the sharp inner shoulder radius separately or together probably

Nozzle assembly No. 3 shown misassembled with the gaps between the flexitallic gasket, face (1) and the underside of the burner nozzle face (2), the underside of the fuel disc flange (3) and the fuel body (4) and the recessed burner tip face (5) relative to the burner nozzle face (6). The arrows indicate the correct crude oil and atomizing air flow prior to the fracture of the burner tip.

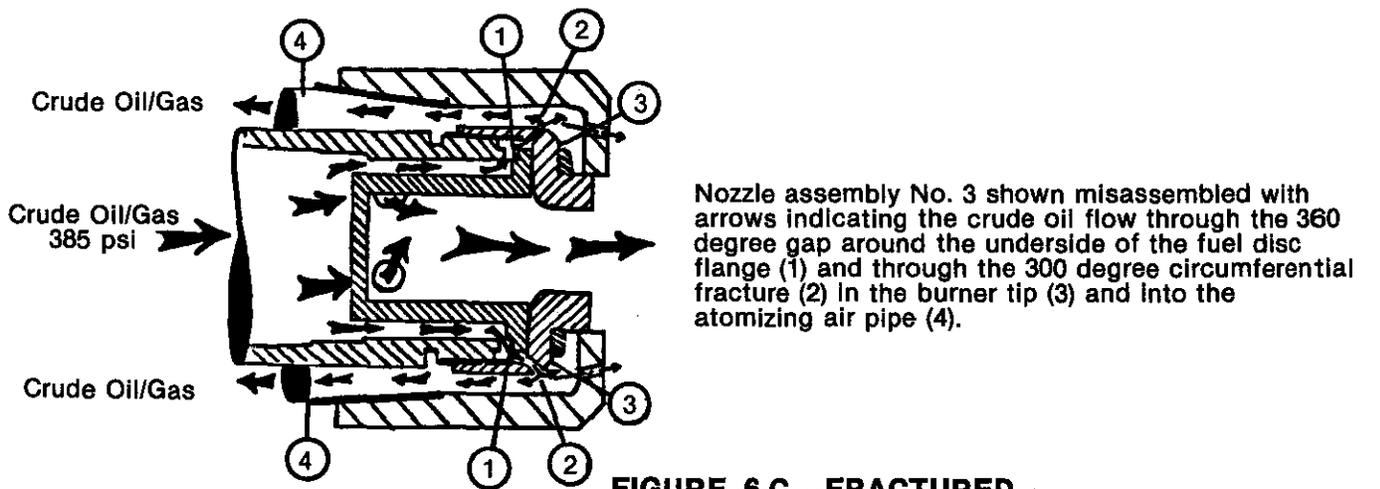
FIGURE 6-C—FRACTURED

Nozzle assembly No. 3 shown misassembled with arrows indicating the crude oil flow through the 360 degree gap around the underside of the fuel disc flange (1) and through the 300 degree circumferential fracture (2) in the burner tip (3) and into the atomizing air pipe (4).

The flow test conducted by R.G.I.T. verified the path created by the fracture between the normally isolated crude oil supply piping and the atomizing air piping of the nozzle assembly. (See figure 6-C.) Due to the lightly tightened No. 3 burner tip, the most probable flow path of the crude oil was between the fuel body and the underside of the fuel disc flange and through the fracture. The underside of the fuel disc flange had a clearance created when crude oil supply pressure against the fuel disc exterior moved the fuel disc forward against the underside of the lightly tightened burner tip which opened a flow path from the crude oil supply pipe to the fracture. Once through the fracture, the crude oil entered the atomizing air side of the nozzle assembly where wax and other solids in the crude oil obstructed 9 of the 20 atomizing air outlets in the burner nozzle. The crude oil pressure of 385 psig was more than three times the 120 psig atomizing air pressure. With nearly half of the atomizing air outlets blocked, the route of the crude oil inside the air piping was back through the atomizing air piping and into the rig compressed air piping system leading to various areas, including the purge compressed air system and the valve remote control compressed air (tank) receiver in the port pontoon pumphoom. The excessive crude oil pressure within the air receiver caused the pressure relief valve on the air receiver to open and release the crude oil vapor into the atmosphere of the pumphoom. The crude oil vapors created an explosive hydrocarbon atmosphere in the port pumphoom. This explosive atmosphere could have been ignited by any of a number of possible ignition sources because under the design standards used, the pumphooms and the propulsion rooms were considered as "nonhazardous" unclassified locations and, therefore, did not require explosion-proof enclosures on electrical equipment.

The point of interconnection of the industrial crude oil piping system and the marine rig compressed air system was at the crude oil burner. To prevent the possible hydrocarbon contamination of a MODU's rig compressed air system, atomizing compressed air supplied to the crude oil burners should be furnished from a dedicated, separate, compressed air source. Furthermore, steps should be taken to prohibit the backflow of high pressure hydrocarbons that may enter the dedicated, separate, atomizing compressed air piping system. This could be accomplished by installing a device, such as a nonreturn (check) valve, in the atomizing compressed air piping.
