NATIONAL TRANSPORTATION SAFETY BOARD

MARINE ACCIDENT REPORT

**CAPSIZING AND SINKING OF THE
MOBILE OFFSHORE DRILLING UNIT
ROWAN GORILLA I
IN THE NORTH ATLANTIC OCEAN
DECEMBER 15, 1988**

1. Report No. NTSB/MAR-89/06	2. Government Accession No. PB89-916406	3. Recipient's Catalog No.	
4. Title and Subtitle Marine Accident Report--Capsizing and Sinking of the U.S. Offshore Drilling Unit ROWAN GORILLA I in the North Atlantic Ocean, December 15, 1988		5. Report Date September 12, 1989

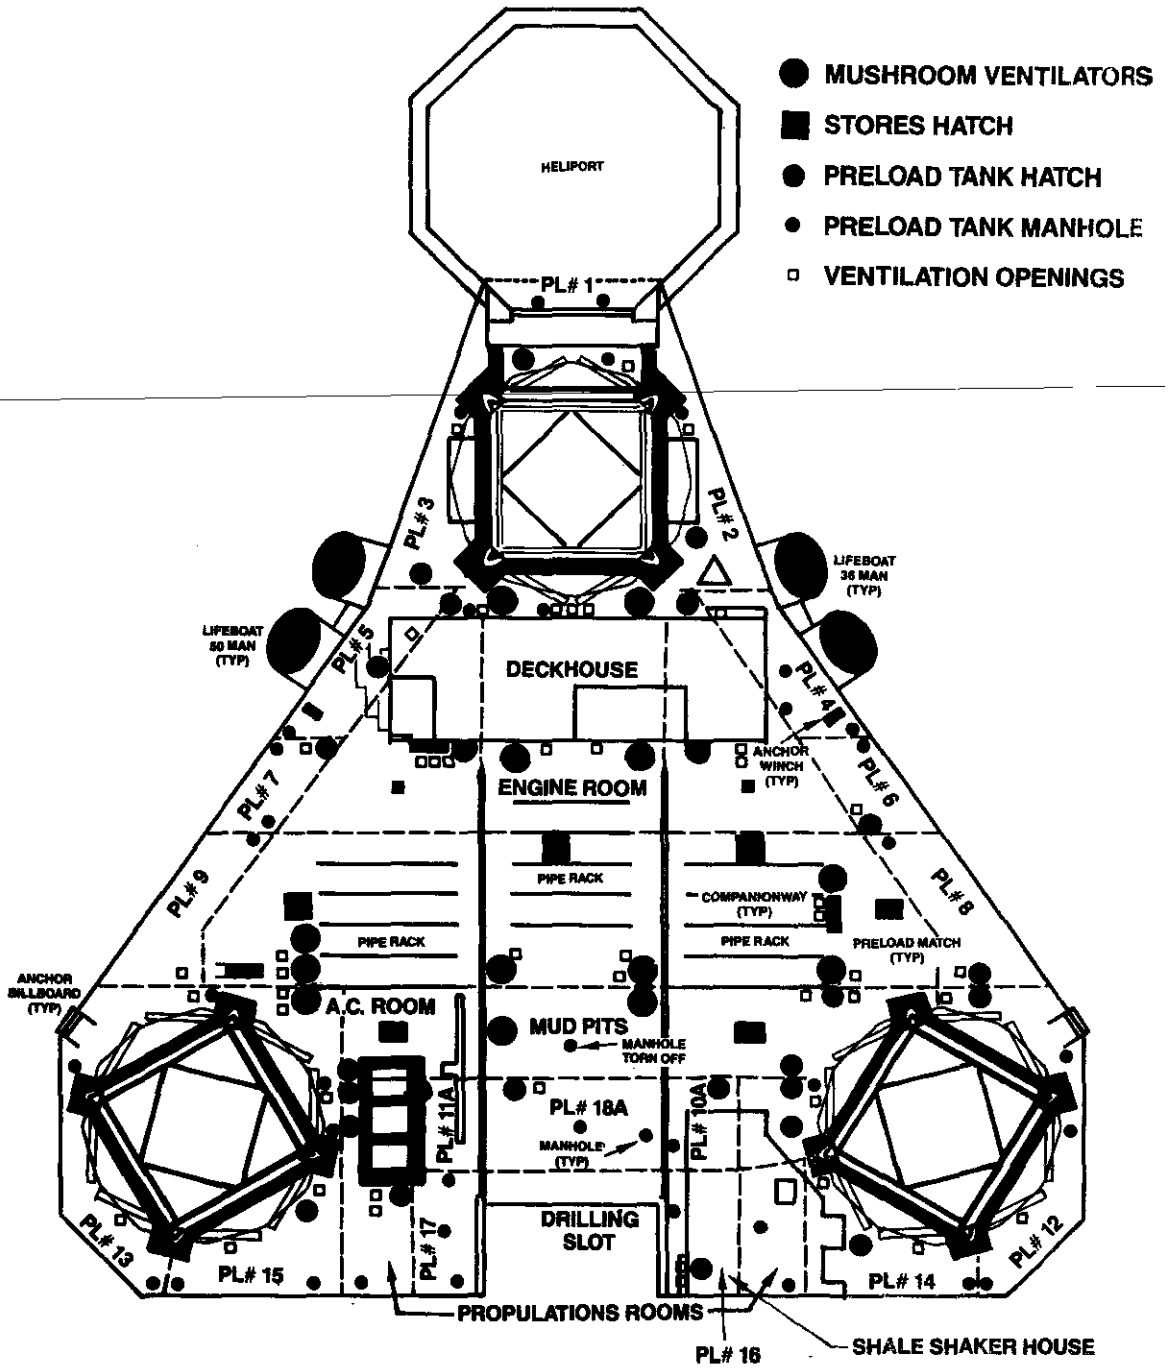
Figure 6.--Plan view of ROWAN GORILLA I main deck showing machinery deck and pre-load tanks.

1. Preload Tank No.15 - Two 7-inch-long horizontal cracks. These cracks were located approximately 23.5 feet below the main deck, near the connection of a 7/16-inch-thick longitudinal bulkhead and a 36-inch-wide by 7/16-inch-thick web frame.

2. Preload Tank No.14 - One 12-inch-long vertical crack. This crack was located along the port aft corner of the tank where the transom bulkhead connects to a longitudinal bulkhead about 22 feet below the main deck. The transom bulkhead plating was 5/8-inch thick while the longitudinal bulkhead plating was 7/16-inch thick. The two bulkheads were connected with 5/16-inch double continuous fillet welds.

3. Preload Tank No.13 - One small crack which yielded a negligible amount of water. This crack was located near the inboard aft corner of the tank along the connection of the transom bulkhead and a 45-inch-wide by 1/2-inch-thick web frame. The plating in this area was 5/8-inch thick.

6. Preload Tank No.16 - One small crack. This crack was found along the overhead (main deck) of the tank near the crack on the inboard gear unit boundary plate of the aft starboard leg. The main deck plating in this area was also 1/2-inch thick.

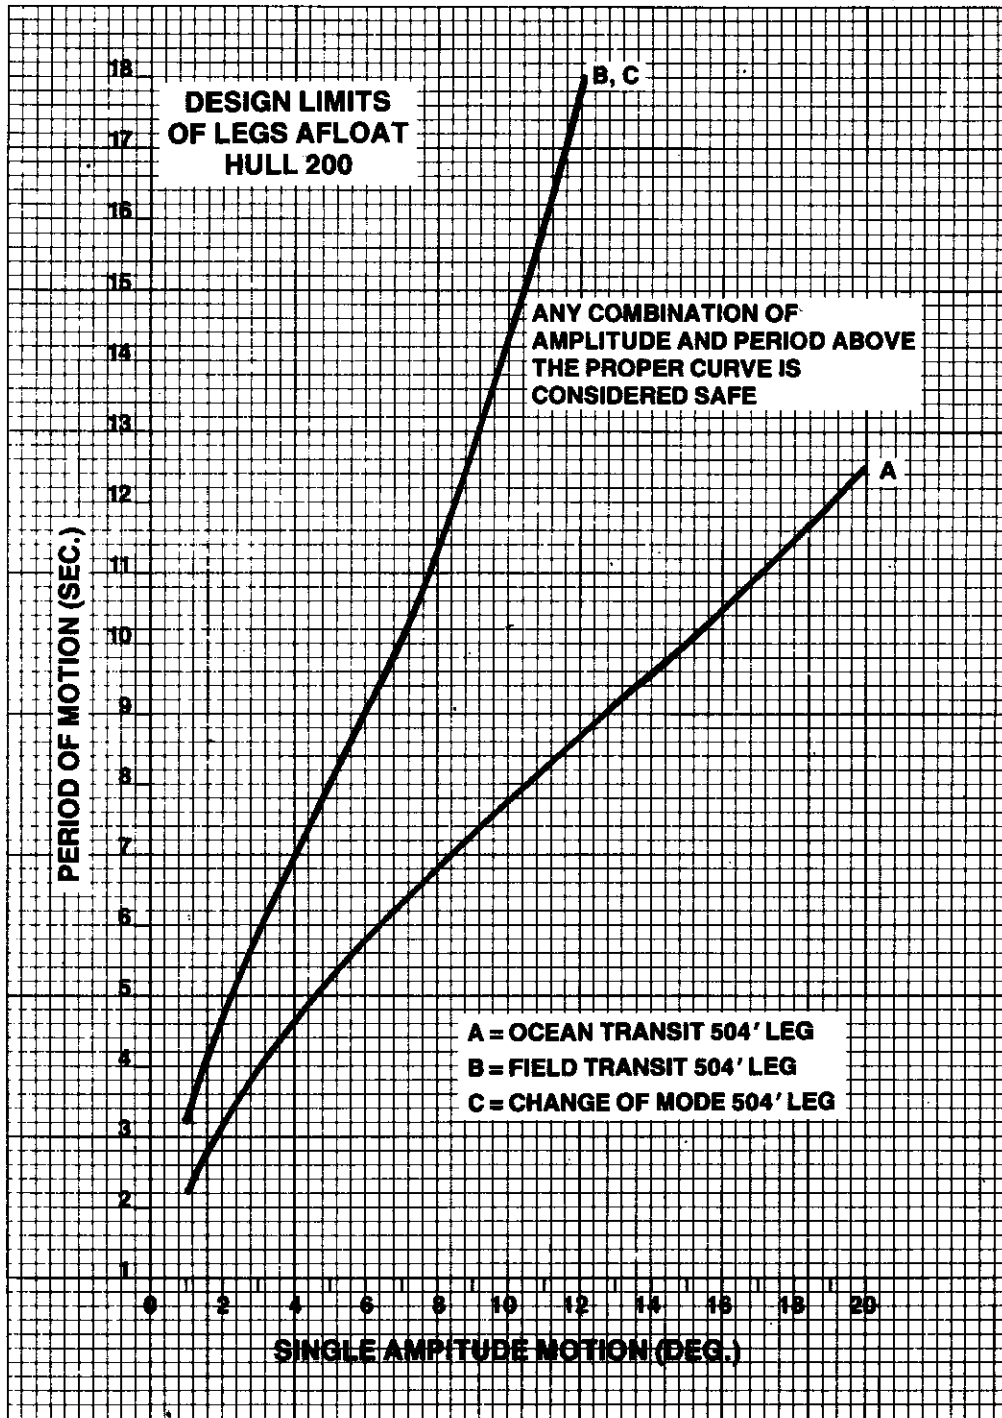
Figure 7.--Design limits of legs afloat graph.

The Marathon vice president further stated that the ROWAN GORILLA I legs were not designed to be lowered beyond the 25-foot level while in transit. The legs are specifically reinforced at the 12.9- and 25-foot levels. Lowering the legs beyond the 25-foot level would be "jeopardizing the

integrity of the leg...if you continue to lower the leg and dampen the motion, then you're going to take more green water over the deck." The Rowan vice president stated that the rig superintendent was responsible for ensuring that the rig did not exceed the design limits of the legs afloat graph. He further stated that if the rig motions were exceeding the design limits with the legs at the 25-foot level, the only option for the rig superintendent would be to attempt to change heading to reduce the motions and that the rig superintendent should never lower the legs below the 25-foot level.

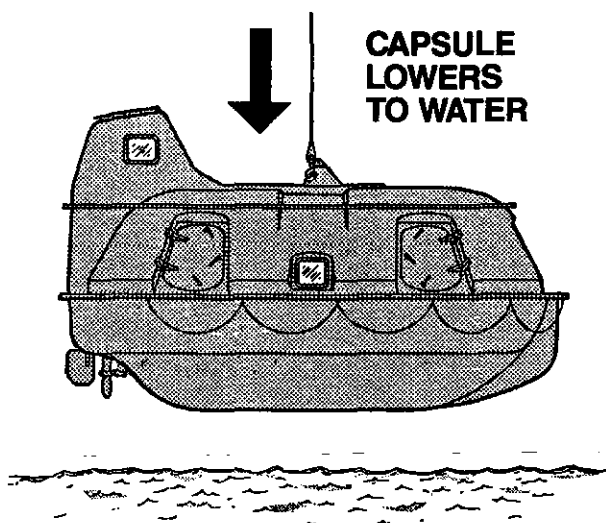
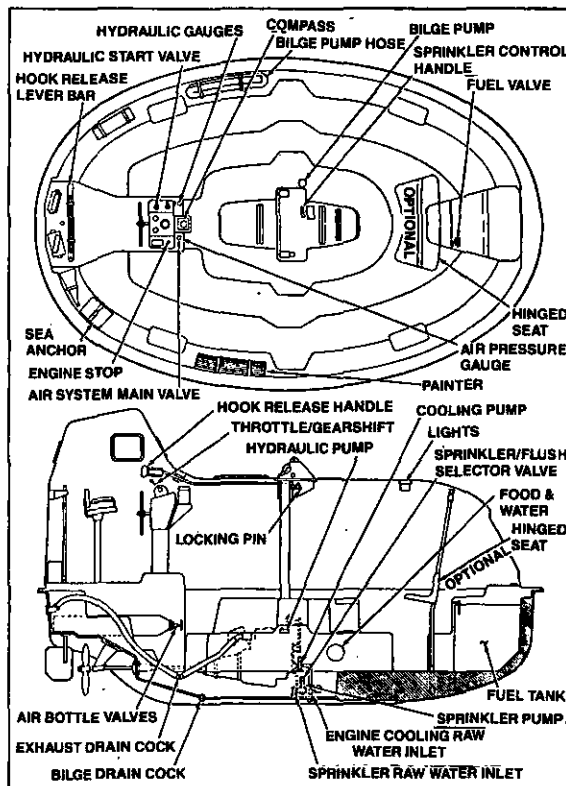
Figure 8.--Drawings of the type of survival capsule used aboard the ROWAN GORILLA I.
(Courtesy of Survival Systems International)

- o the adequacy of the design of the survival capsules aboard the ROWAN GORILLA I regarding external lighting, radar reflectors, and capacity when survivors are wearing immersion suits.
