Issued August 9, 2022

MIR-22/18

# Contact of Bulk Carrier *Ocean Princess* with Oil and Gas Production Platform SP-83A

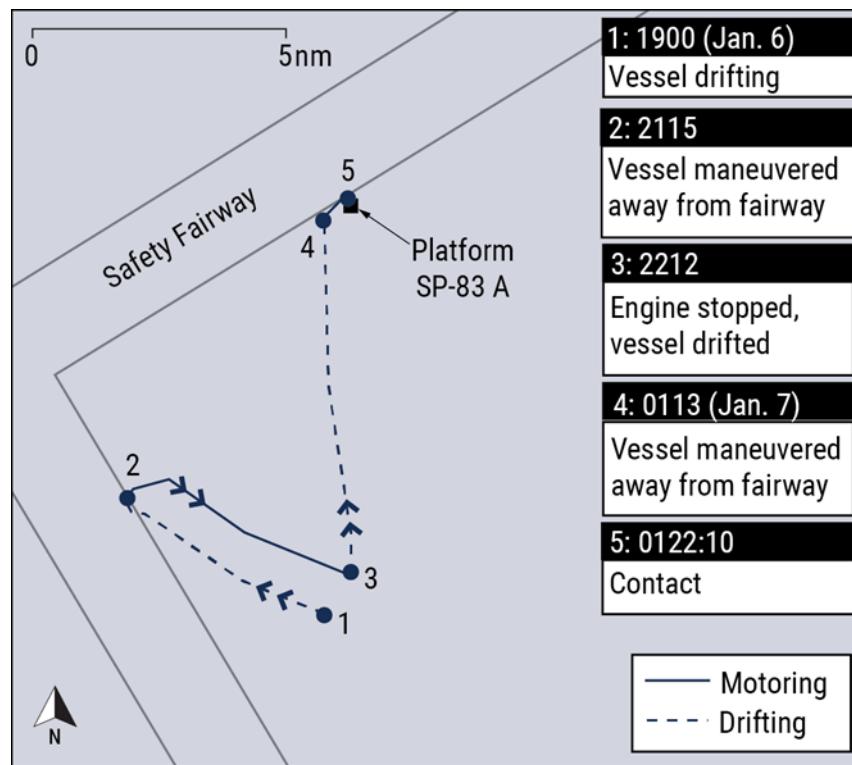
**Figure 3.** Plot of the *Ocean Princess* automatic identification system history shows the vessel's path from 1900 until the time of the casualty.

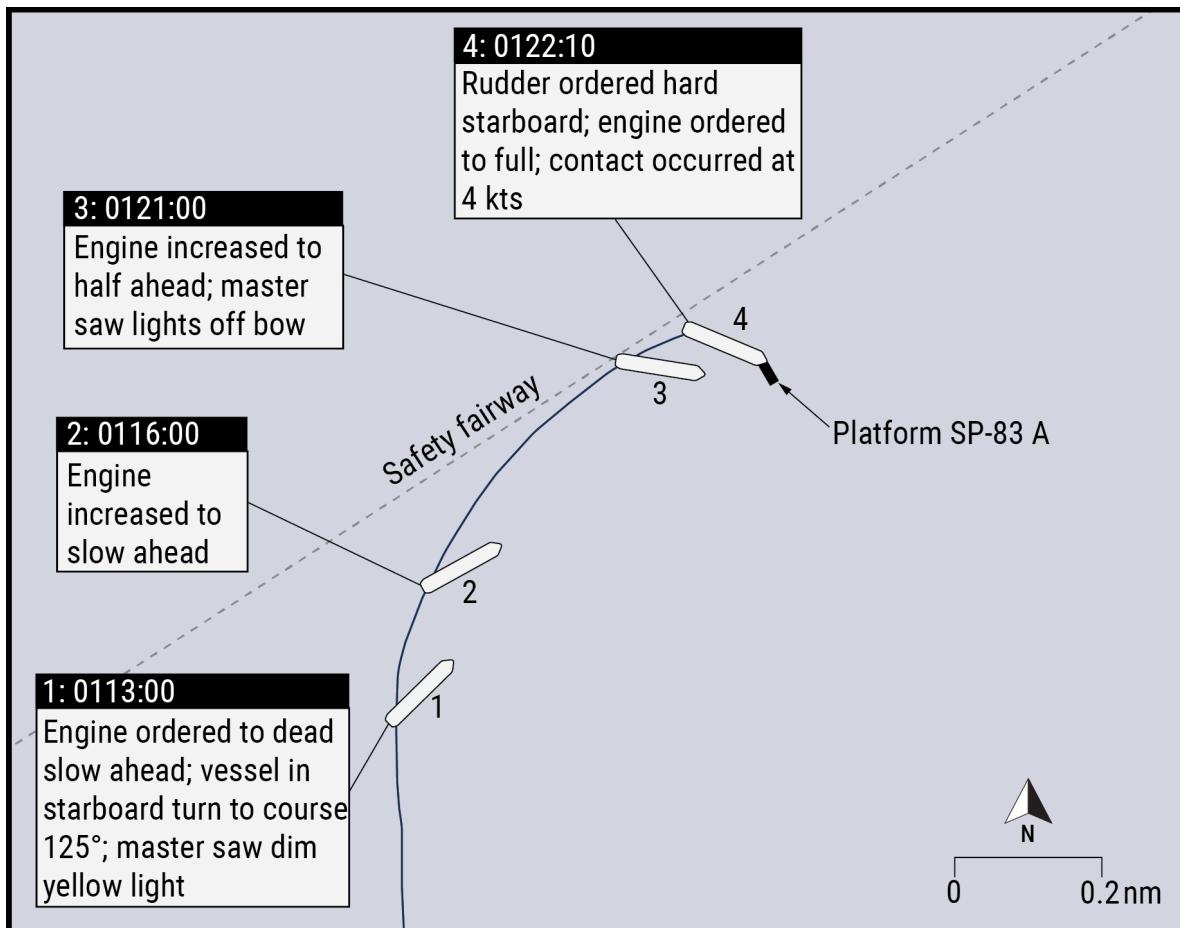
When the vessel struck the platform, the anchor flukes and the anchor windlass were both affected. The starboard anchor became caught in the platform upon contact. Because the starboard anchor was on the brake rather than secured for sea, once it became entangled with the platform, the chain was pulled out as the vessel attempted to maneuver away from the platform.

**Figure 4.** The final events leading up to the *Ocean Princess* contact with platform SP-83A.

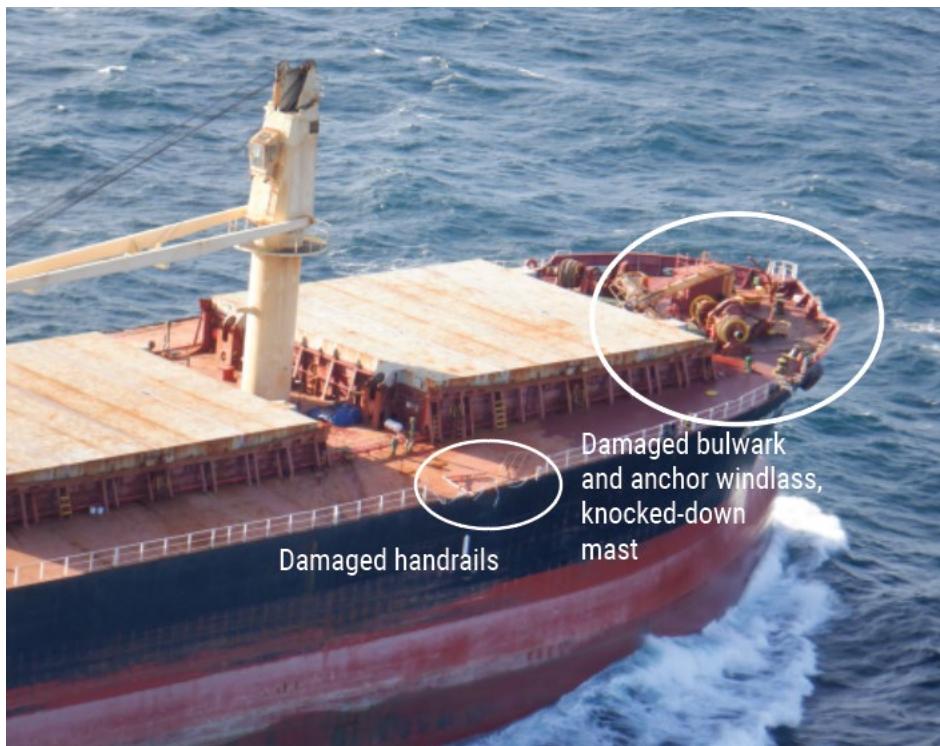
The *Ocean Princess* sustained damage to the starboard bow, including starboard-side handrails, the starboard anchor windlass, and the bulwark. The forward mast was knocked down. There was also damage to portside handrails. Damage to the vessel was estimated to be over \$500,000.

**Figure 5.** The damaged *Ocean Princess* after the casualty. (Background source: Bureau of Safety and Environmental Enforcement)

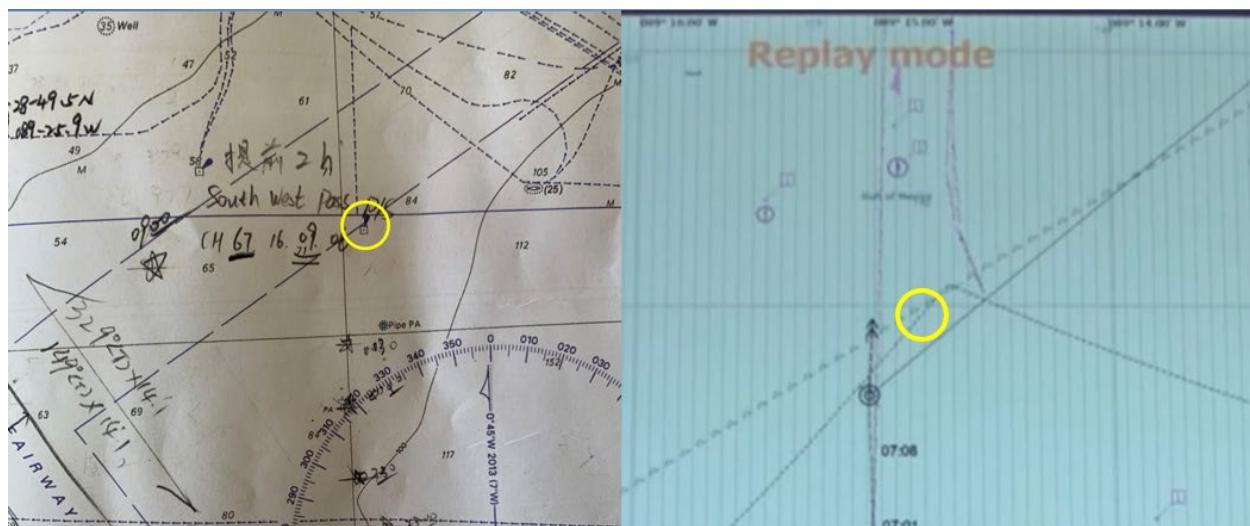
After the casualty, the master and the second officer noted that platform SP-83A was on the paper chart used on the bridge by the mate on watch, but SP-83A did not appear on the ECDIS. The second officer stated that during the time leading up to the casualty he did not notice SP-83A was missing on the ECDIS. The paper chart used on the bridge was British Admiralty chart 3857, *Southern Approaches to the Mississippi River*, 5<sup>th</sup> edition, December 20, 2012. The chart was up to date and corrected with the most recent British Admiralty weekly notice to mariners.

In the casualty location, the ECDIS drew its electronic navigation chart (ENC) information from the National Oceanic and Atmospheric Administration (NOAA) Nautical Information System (NIS) database. When reviewing the vessel's ECDIS correction record for the previous year, investigators found that the automatic updates to the electronic navigation charts were received and loaded weekly to both ECDIS units aboard the *Ocean Princess*. The last update before the casualty was 53/21 (January 1, 2021). Neither of the two applicable NOAA ENC vector charts covering the area where the casualty occurred contained platform SP-83A. Although the *Ocean Princess* ECDIS unit was up to date with chart corrections, the two ENC vector chart updates did not contain platform SP-83A, and therefore SP-83A was not shown on the *Ocean Princess* ECDIS unit.

**Figure 6.** Navigation aids used by the *Ocean Princess* bridge team, with the location of platform SP-83A shown annotated by NTSB with a yellow circle (images are at different scales). A photo of the British Admiralty chart 3857 (*left*) and ECDIS screenshot from the *Ocean Princess* fed by NOAA ENCs (*right*), which were up to date at the time of the casualty. The British Admiralty chart shows SP-83A while the ECDIS image does not.

After the casualty, Coast Guard District 8 (CGD08) issued a Broadcast Notice to Mariners via VHF radio from January 26 to February 9, which provided platform SP-83A's position and notified mariners that the platform was not displayed on electronic charts. On February 3, CGD08 issued weekly Local Notice to Mariners 05/21 with the chart correction to add "Platform (Arena Offshore-107-1)" to the two large-scale paper NOAA charts covering the area where the casualty occurred. On February 11, NOAA released the automatic corrections that added platform SP-83A to the two ENC vector charts covering the casualty area.
