## **MARINE SAFETY ALERT**

Safety Alert 02-16

### ***Worn Thin*** **Vibration Abrasion, a “Short” Summation**

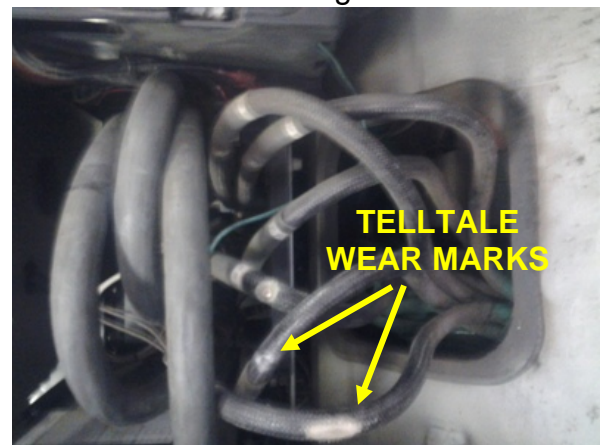
The casualty involved a diesel-driven generator, which grounded out and tripped off line when one of the primary leads exiting the generator housing chafed against its steel enclosure. Investigators determined that other vessels operated by the same company had similar generators and wiring arrangements. Inspection of those generators showed similar signs of chafing and abrasion, but the wiring had not yet reached the point of failure.
