MARINE SAFETY ALERT

Safety Alert 07-22

UNEXPECTED DANGERS: LIFEBOAT REMOTE CONTROL WIRES

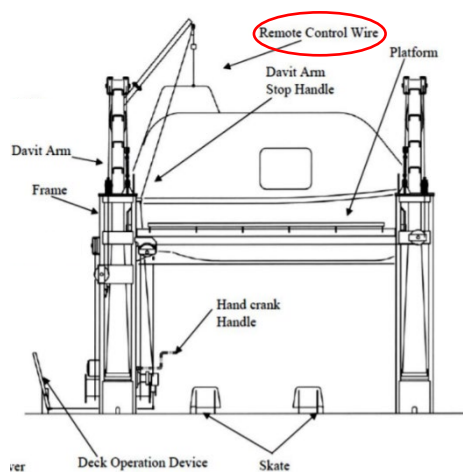
Figure 1 - Davit Launched Lifeboat Arrangement.

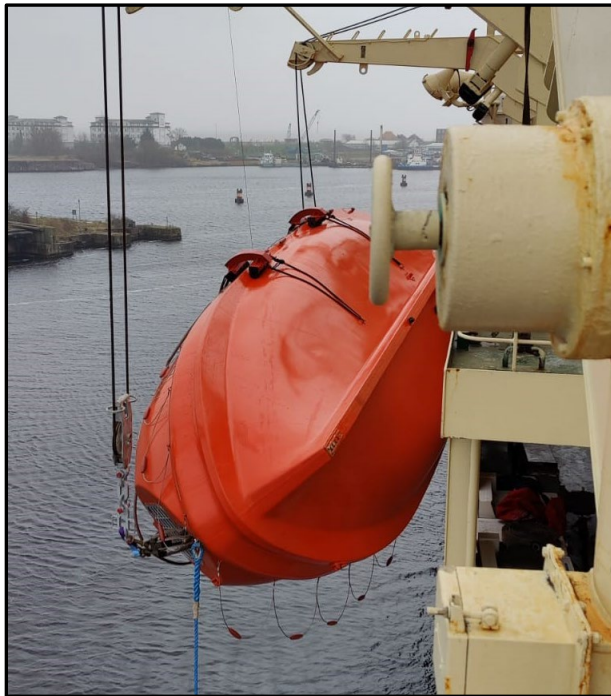
- (2) The second occurred a day later after the replacement remote control wire was hand spooled from extra wire found on board. While testing with crew on board using the remote control wire to lift the brake, an unexpected pay out of wire led to the winch brake prematurely engaging, which made the lifeboat stop lowering and swing erratically above the embarkation deck. Seconds later, the movement caused the wire to regain tension, which lifted the winch brake arm and caused the lifeboat to lower again. While lowering in a swinging motion, the skeg of the lifeboat caught on the knife-edge of the ship's deck, causing the lifeboat to list more than 90 degrees. Without the quick action of a crewmember who activated the winch brake lever from the deck, the lifeboat could have inverted further and led to catastrophic outcomes.

Figure 3 - Lifeboat listing more than 90 degrees w/ crew inside.

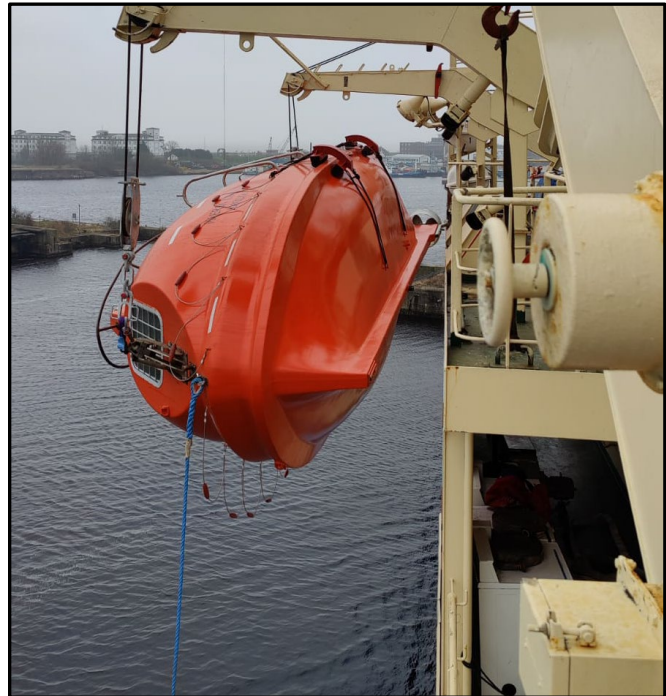
Figure 4 - Lifeboat skeg caught on deck edge.
