MARINE SAFETY ALERT

Safety Alert 08-21

VERIFY PRODUCTS FROM SOUTHWEST WIRE ROPE COMPANY Incorrect Terminations Can Lead to Catastrophic Failure

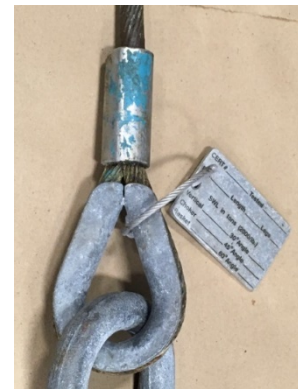
Figure 1: Fitting has a uniform appearance

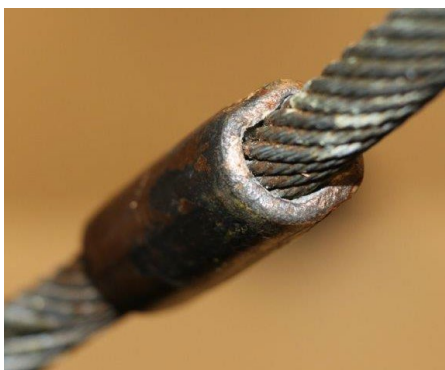
Figure 2: Completed fitting is not "round" nor within manufacturer specifications

- Compare fitting dimensions against the manufacturer's specifications/tolerances for the completed fitting (i.e., does the length and diameter fall within fitting manufacturer specifications?);

- If any abnormalities in the wire rope are detected, immediately remove the wire rope from service and make an appropriate replacement.

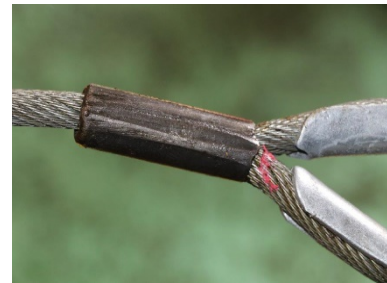
Figure 3: Fitting is deformed with "ridges" of extra material present from over-crimping.

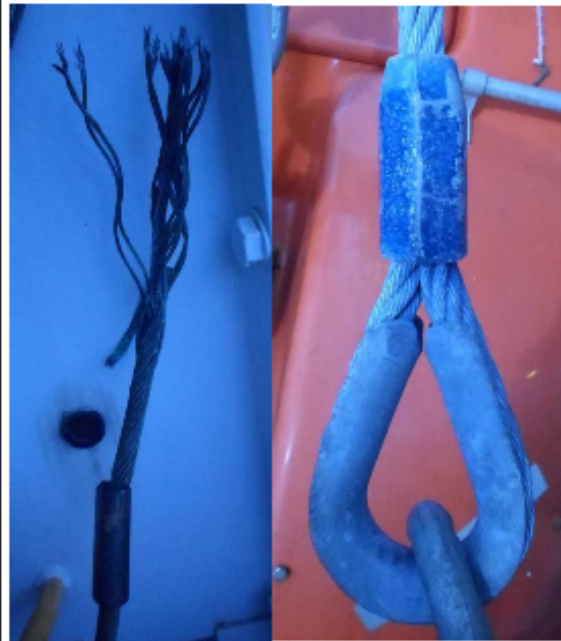
On Jan 4, 2021, 3 offshore personnel were retrieving marine debris by using the Fast Rescue Craft (FRC). The task was completed and the FRC hoisted back up into position. After the 3 personnel exited the FRC, the wire rope assembly (wire rope, thimble, and crimp) broke, and the FRC fell 135 feet to the Gulf of Mexico.

- Incorrect wire rope was used in the construction of the wire rope assembly loop
 - The wire rope ordered was 35x7 with a 12 mm diameter and 30,875 lbs breaking strength
 - The wire rope received was 19x7 with a 0.5 in (12.7 mm) diameter and 21,600 lbs breaking strength
 - Improper swaging procedure includes failures within a quality management system in which material are improperly selected and do not match the specifications of the original equipment manufacturer
 - The cable/wire rope diameter was sized at 0.5 in (12.7mm) and the crimp/swage was specified for a 12mm diameter Wire
- Wire rope supplier failed to conduct a positive verification to ensure the correct material was used to fabricate the assembly loop.
- The larger diameter wire rope contributed to an improper termination of the assembly and was damaged inside the crimp during the crimping process.

- The similarity in diameters between a 0.5 in cable (12.7mm) and a 12mm cable creates a possibility for confusion regarding use of the appropriate cable.
- Verify that the construction of the wire rope ordered is the same as the wire rope received before installation
