# United States Coast Guard

**Report of the Investigation into the  
Circumstances Surrounding the Capsize of  
the Liftboat SEACOR POWER (O.N.  
1115290) Approximately 7 Nautical Miles  
South of Port Fourchon, LA in the Gulf of  
Mexico Resulting in the Loss of 13 Lives on  
April 13, 2021.**

**THE CAPSIZING OF THE COMMERCIAL LIFTBOAT SEACOR POWER (O.N. 1115290) RESULTING IN MULTIPLE LOSSES OF LIFE APPROXIMATELY SEVEN NAUTICAL MILE SOUTH OF PORT FOURCHON, LA IN THE GULF OF MEXICO ON APRIL 13, 2021**

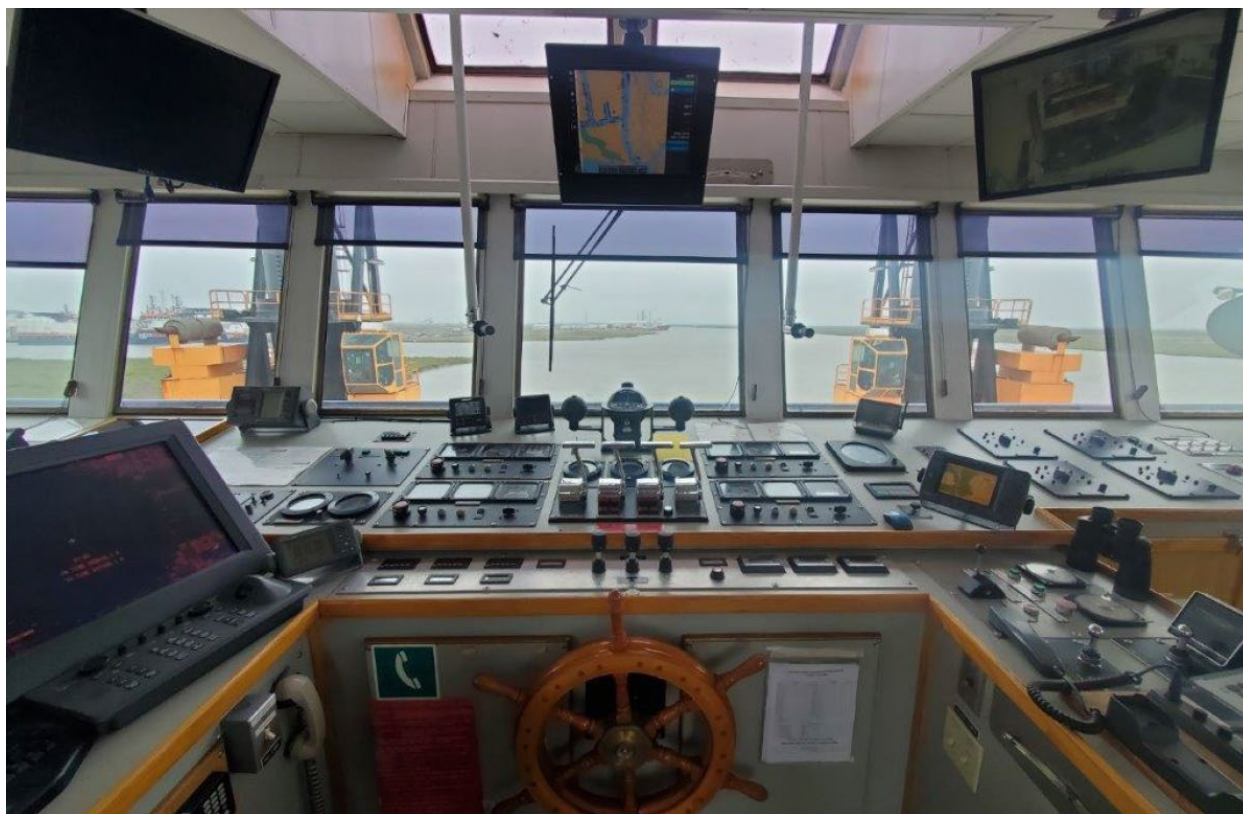
Figure 10: Wheelhouse Image of SEACOR POWER (from Exhibit 202)

8.1.35. The First Mate observed SEACOR POWER heel 5 degrees to starboard, and he felt like the vessel was "going over." The Master took over at the controls of SEACOR POWER and attempted to steer the vessel back to starboard. The Master used the Gai-tronics public address system to instruct everyone to put on lifejackets. The First Mate activated the vessel's tilt alarm, which was located on the port side of the forward control console.

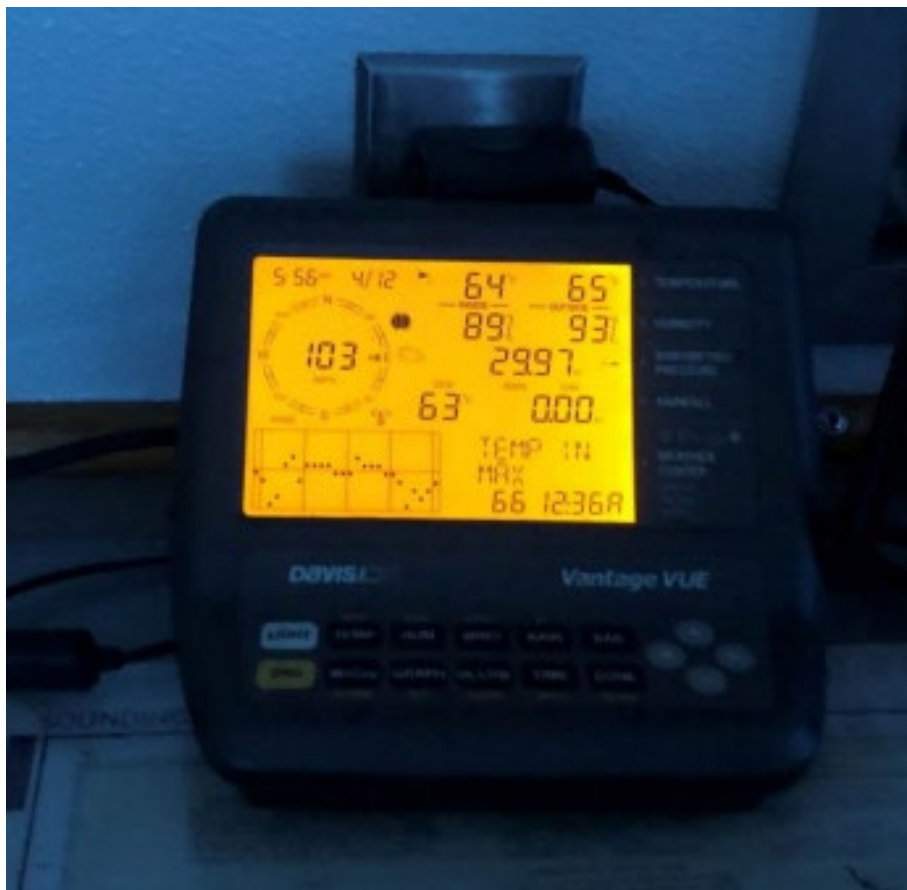
Figure 12: Liftboat VANESSA Anemometer displaying 103mph winds at 1537

- 8.1.38. At 1537, the Liftboat VANESSA Master observed a wind speed of 103 mph. Approximately 3 minutes later he observed a 113 mph wind gust.<sup>22</sup> The vessel was located 4.5 nautical miles west-northwest of SEACOR POWER.<sup>23</sup>

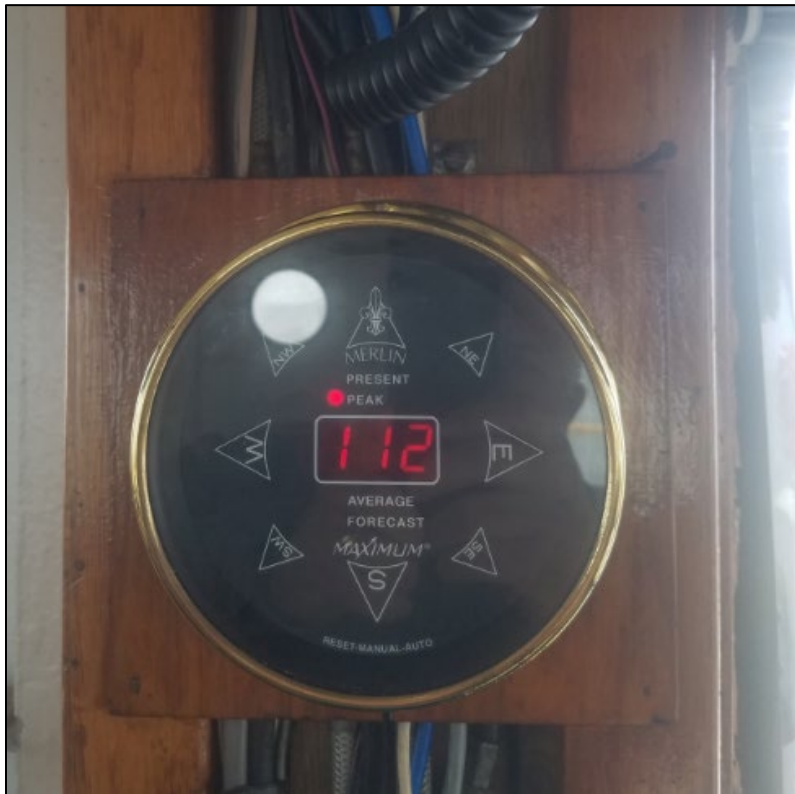
Figure 16: Liftboat ROCKFISH anemometer reading of 112 knots on April 13, 2021 (Exhibit 144)

- 8.1.53. During the hearing the Master of Liftboat ROCKFISH reported that his anemometer measured a wind gust of 112 mph on the date of the incident. The Master did not know what time this gust occurred, but provided a photo of the anemometer reading.<sup>30</sup> He stated that if he had known that type of weather was coming, he would have waited to move his vessel that day. He also stated that if he had moved the ROCKFISH 15 minutes later, then his vessel would have capsized as well.

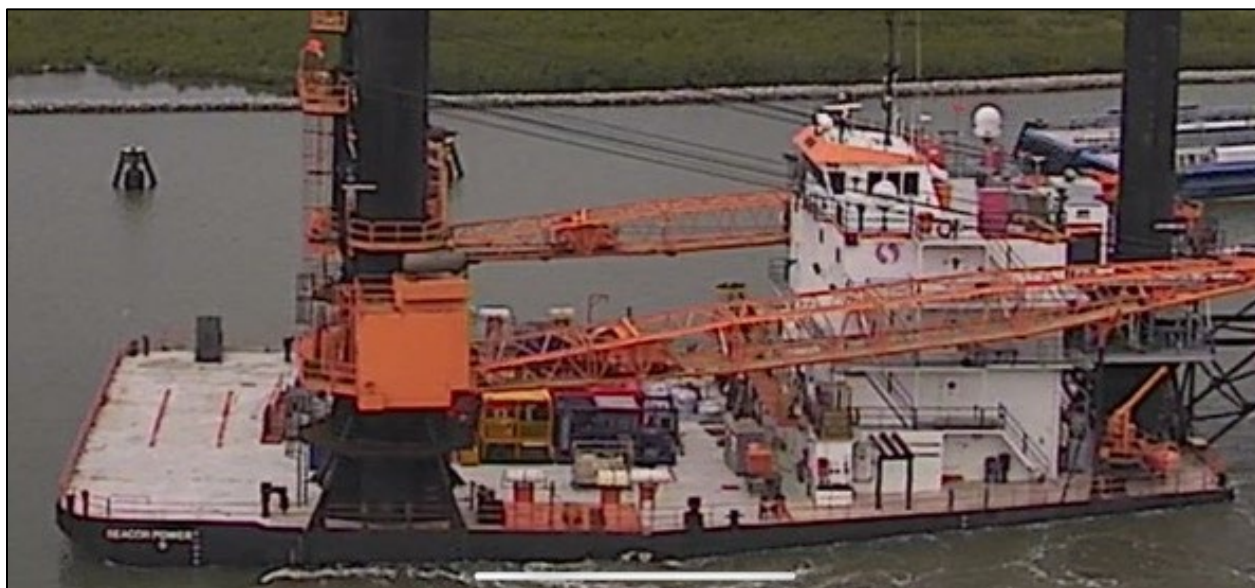
Figure 28: SEACOR POWER Departing Port Fourchon on April 13, 2021

- 8.4.23. Cameras in Port Fourchon recorded SEACOR POWER's departure on April 13, 2021. SEACOR POWER's observed draft was 9.25 feet at the Plimsol mark (the waterline was at the bottom of the ring). SEACOR POWER had approximately 2.5 feet of aft trim as observed using the number of forward and aft draft marks visible on the port side. Heel angle could not be observed from camera angles.<sup>131</sup>

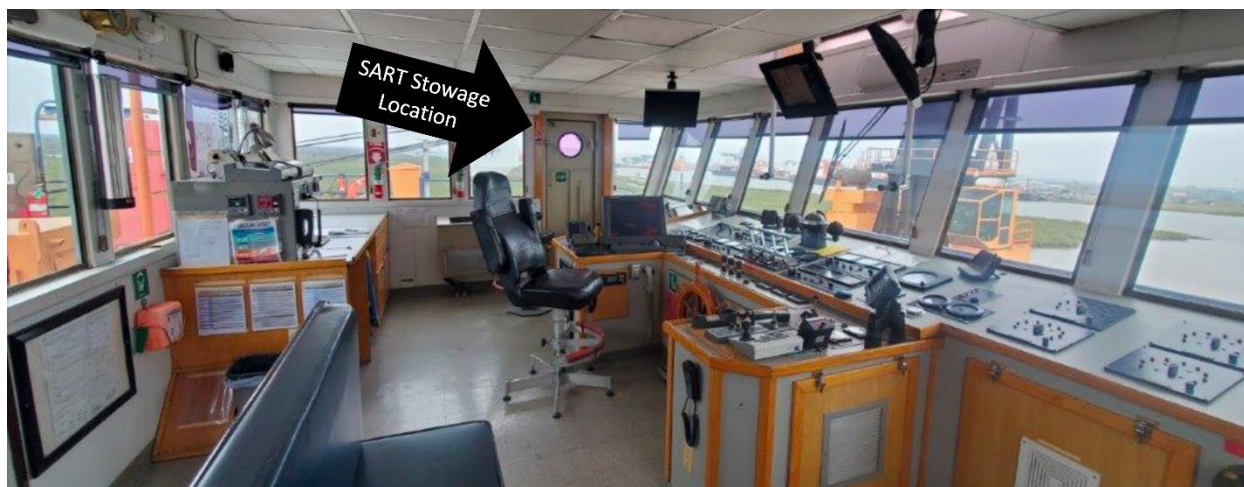
Figure 48: SART stowage location in wheelhouse

- 8.9.7. There were two radar SARTs stored on SEACOR POWER's bridge, located on the aft side of the port and starboard wheelhouse doors.<sup>236</sup> The SARTs were manufactured by Jotron.<sup>237</sup> The First Mate stated that the SARTs were recently replaced. He also stated that there were no SART poles on SEACOR POWER.

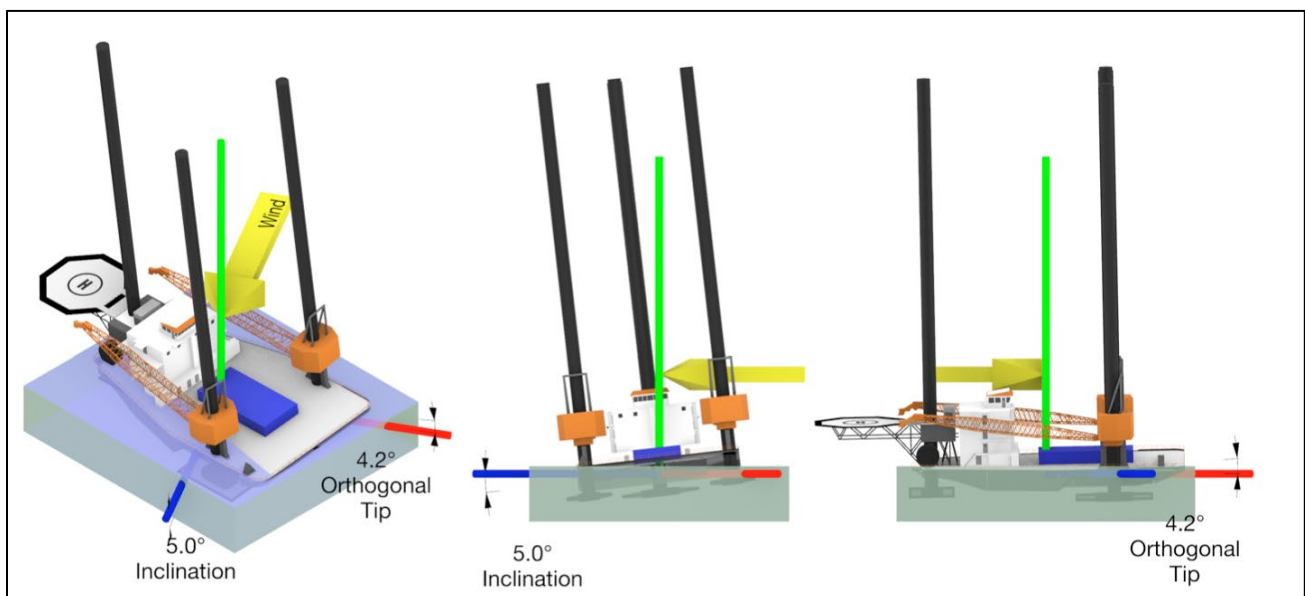
Figure 52: Sketch of SEACOR POWER inclined 5° in still-water from wind at 240° relative (Exhibit 246)

- 9.1.16. Immediately prior to the capsizing, the First Mate observed a 5 degree list. At that angle, part of SEACOR POWER's main deck would be submerged, as noted in the figure below. If any doors or vents on the starboard side of the main deck were open, this would have caused downflooding. There was no evidence to indicate that downflooding was a causal factor in the capsizing.
