**REPORT OF THE INVESTIGATION  
INTO THE  
FIRE ON BOARD THE OFFSHORE SUPPLY  
VESSEL HARVEY ENERGY (O.N. 1243697) IN  
PORT FOURCHON, LOUISIANA ON APRIL 28,  
2023**

**MISLE ACTIVITY NUMBER: 7681968**

## **FIRE ON BOARD THE OFFSHORE SUPPLY VESSEL HARVEY ENERGY (O.N. 1243697) IN PORT FOURCHON, LOUISIANA ON APRIL 28, 2023**

**INVESTIGATING OFFICER'S REPORT**

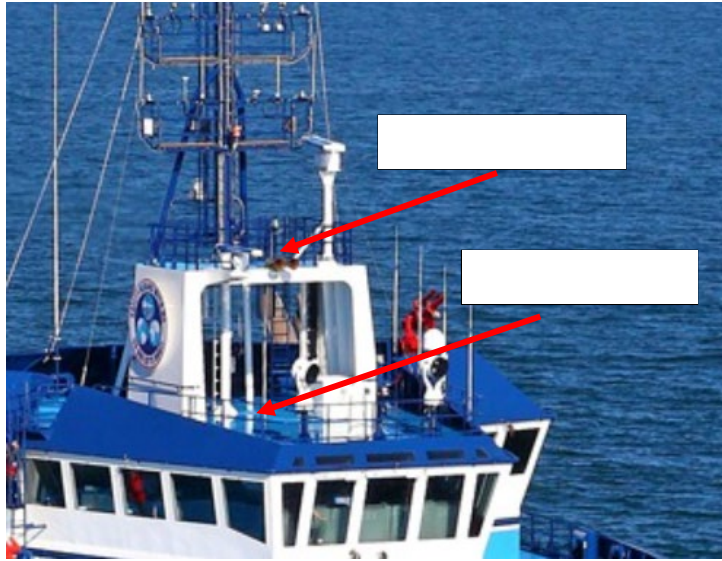
Figure 2. HARVEY ENERGY bridge structure, date unknown. Source: VARD Marine.

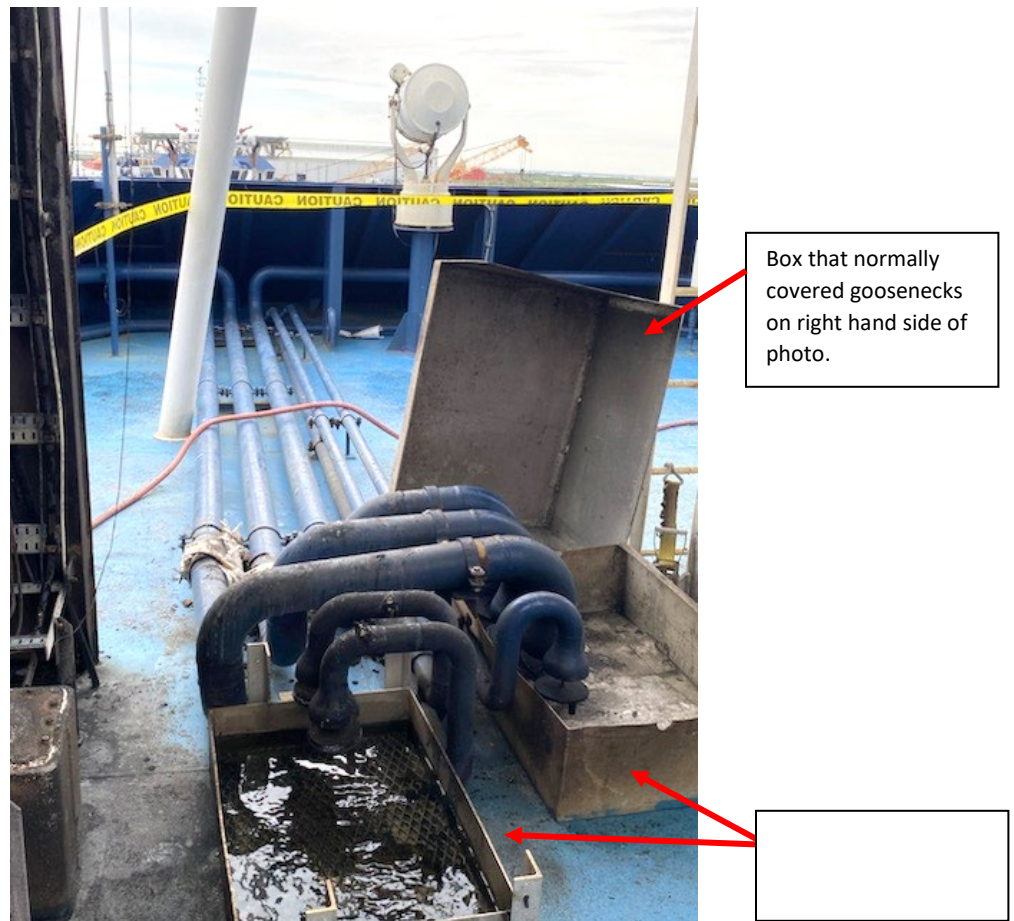
4.2.9. The main engine purge lines and crankcase vents terminated approximately 2' off the air castle main deck making the area a hazardous zone. There were two containment boxes directly underneath the goosenecks. One purge line and all crankcase ventilation piping were also covered by a metal box. No explanation was provided for this arrangement. The flame screens were also blown out and ineffective on the goosenecks but appeared to have been in this condition prior to the fire.

4.2.10. The manufacture openly acknowledges that its equipment is subject to methane slip, and that methane slip is more significant when operating the vessel at low loads. At the time of the incident, crew members and Harvey Gulf employees estimated the vessel was operating at 10% load. Methane was therefore likely present in the crankcase ventilation in addition to the changeover purge pipe.

Figure 3. HARVEY ENERGY crankcase ventilation and purge piping arrangement. Source: U.S. Coast Guard.

**5.3. Ineffective construction of ventilation design and purge vents.** At the time of the incident, the venting arrangement for both the methane purge piping and the crankcase ventilation terminated in the vicinity of the main air castle deck with gooseneck vents approximately 2 feet above the deck. Additionally, both ventilation arrangements were surrounded by containment boxes, further increasing the possibility of natural gas settling on the air castle main deck. All crankcase ventilation piping and one of the methane purge valves were covered by an unsecured metal box with three sides that fit over the crankcase ventilation and one methane purge vent. The box was not approved by the Coast Guard or the American Bureau of Shipping (ABS) and there was no provided explanation from the company for the installation of this box, but it likely contributed to the accumulation of flammable vapors in the vicinity of the air castle main deck. The engine manufacturer openly acknowledges that methane slip occurs into the crankcase of its dual fuel engines, and further explains that the rate of methane slip is increased when the generators are operating on low loads. The Chief Engineer estimated the generator to be operating on roughly 10% load at the time of the incident, which likely means methane could have been present in the crankcase ventilation fumes. If the crankcase ventilation and the purge vents terminated higher above the deck and away from the structure of the air castle, it is reasonable to assume that natural gas would not have accumulated to as significant of a degree on deck and within the superstructure of the air castle.

6.1.1.2. Design of ventilation and purge vents which allowed flammable gases to accumulate in one area of the vessel.

Recommend Commandant reassess the vessel’s current vent heights and locations. The current height of the engine purge and crankcase vents is approximately 2’ off the deck and located under the vessel’s air castle. While this configuration is in compliance with The International Code of Safety for Ships Using Gases or Other Low-Flashpoint Fuels (IGF Code), the current height of the vents and position of the vents do not allow for proper venting of gases and allows for the accumulation of flammable methane gas in that area. This could lead to additional fires onboard the HARVEY ENERGY, and on other vessels with the same design. Changing the vent heights and/or location would allow the gases to more freely vent into the atmosphere, greatly reducing the possibility of methane accumulation onboard the vessel.
