UNITED STATES COAST GUARD

**REPORT OF INVESTIGATION INTO THE
CIRCUMSTANCES SURROUNDING THE MULTIPLE
RELATED MARINE CASUALTIES AND
GROUNDING OF THE**

MODU KULLUK

ON DECEMBER 31, 2012

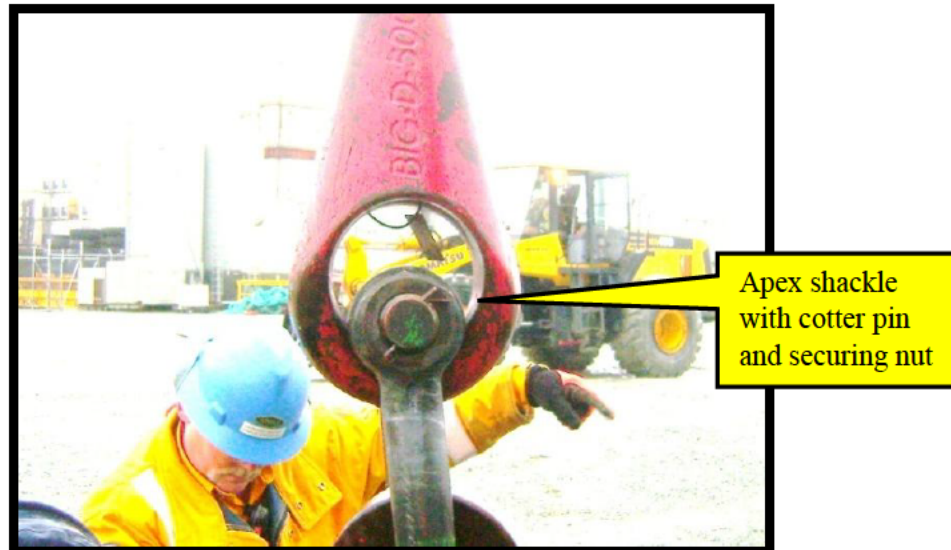
inspection. Additionally, the cotter pin was not removed or replaced.⁵¹ It is assumed that this is the same cotter pin that was installed for the July 2012 tow at the beginning of the season. Figure 13 shows a photo provided by the warranty surveyor that shows the “apex” shackle and cotter pin.

Figure 13: OSI Terminal workers hoist the tow plate and pennant wire. The photo shows the 120 ton shackle (original photo brightness adjusted) with the cotter key. The shackle (described as apex shackle) connects the tow plate to the 100' tow pennant socket. (Photo courtesy of GL Noble Denton, Mr. █████)

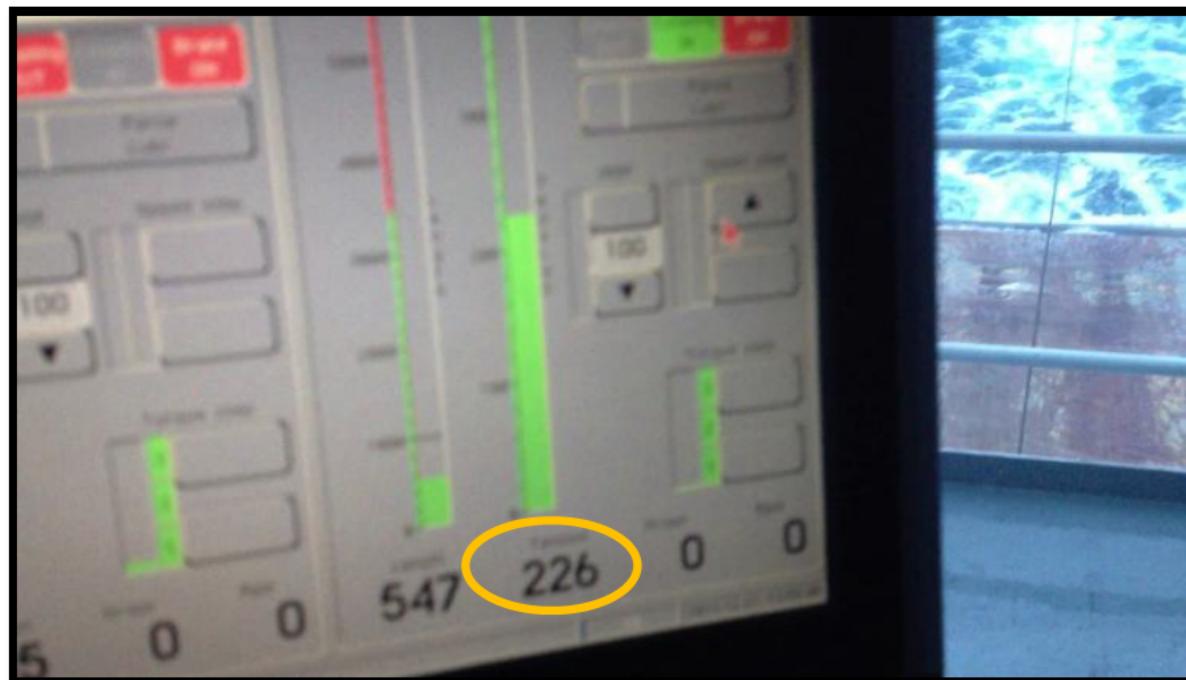
Figure 19: Screen capture from video showing tension reading of 226 tons on main tow drum. (Cell phone video screen capture provided by Mr. [REDACTED] AIVIQ Mate)

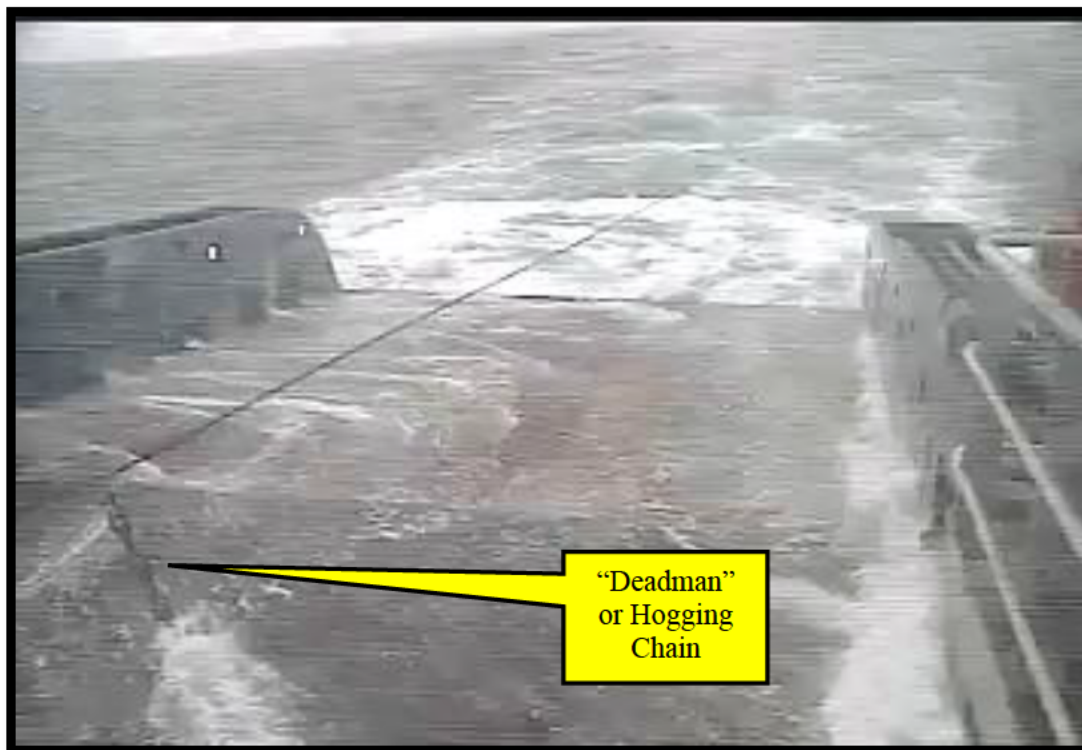
Figure 20: Screen capture of towline moments before failure of the shackle on the morning of December 27, 2012 *(From AIVIQ CCTV recording and provided by ECO)*

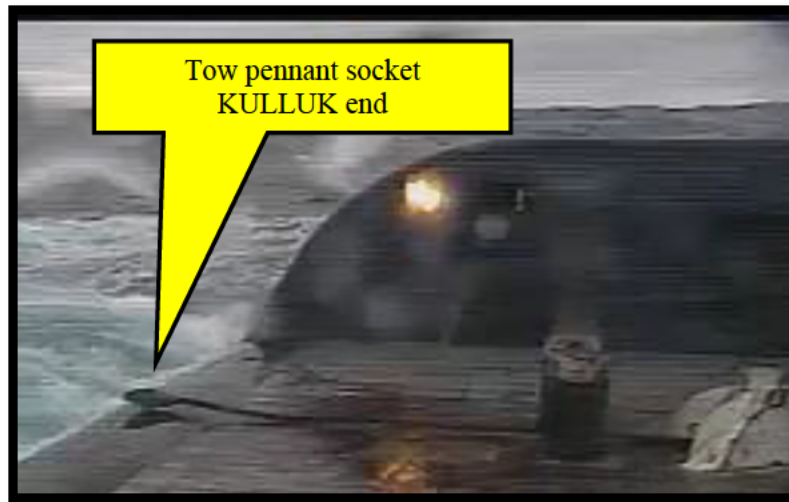
Figure 22: Screen capture showing retrieved pennant wire and socket, missing shackle later in the morning of December 27, 2012. (From AIVIQ CCTV recording and provided by ECO)

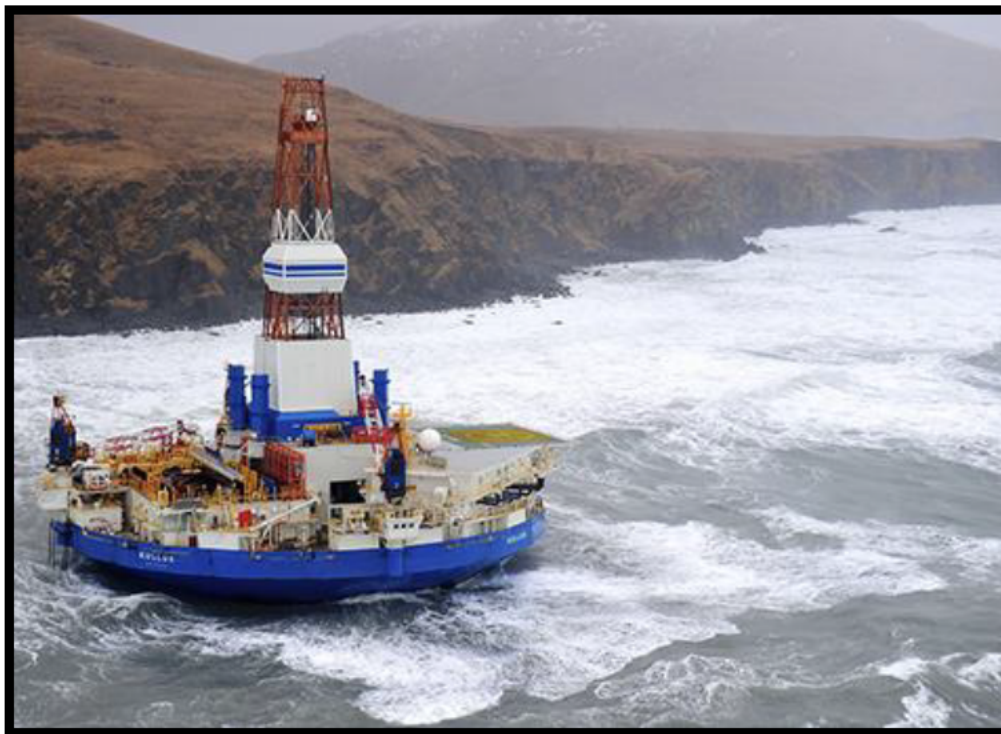
Figure 44: KULLUK grounded in Oceans Bay, Alaska. (USCG Photo)

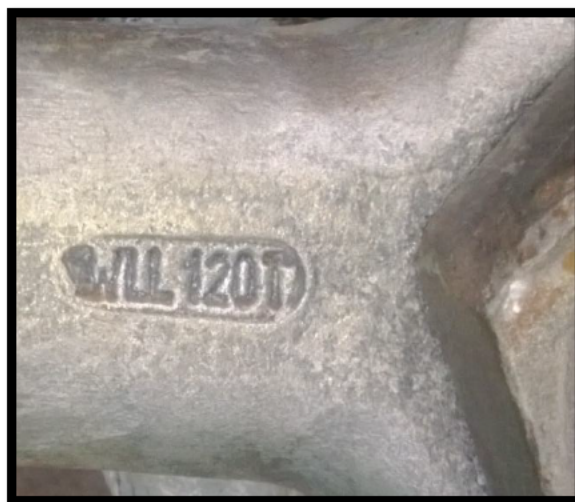
Figure 55: Photo of Working Load Limit Stamped on Bow of 120 Van Beest Green Pin® Super Shackle. (USCG Photo)

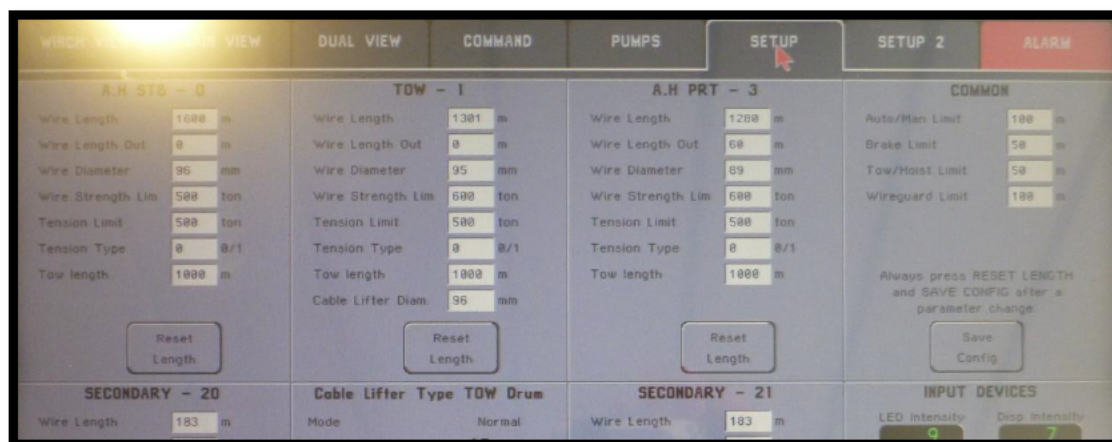
Figure 58: Photo of Towcon Setup screen showing “wire strength limit” for main towing drum is set at 600 tons. (USCG Photo)

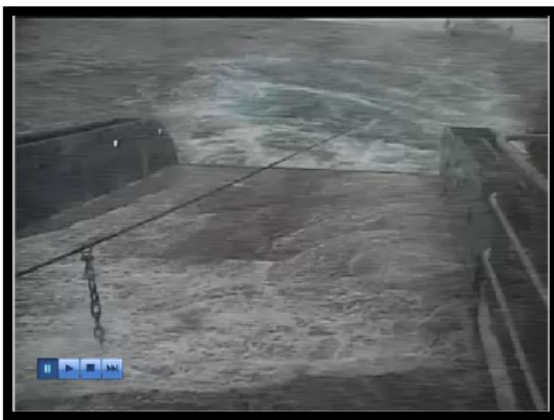
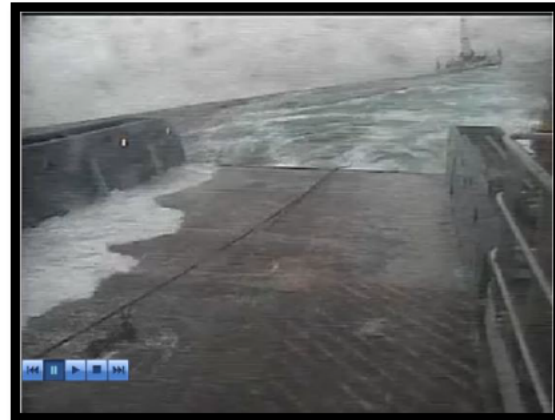
Figure 65: Port Forward CCTV stills showing fluctuations in towline tension. Still on left shows high tension at 10:54:48, demonstrated by the stiffness of the hogging chain (bottom right of still) and towline appearing to lead nearly horizontally toward KULLUK. Still on right shows low tension at 10:54:52, a mere 4 seconds later, with a slack Deadman chain and towline on the deck. *(AIVIQ CCTV Provided by ECO)*

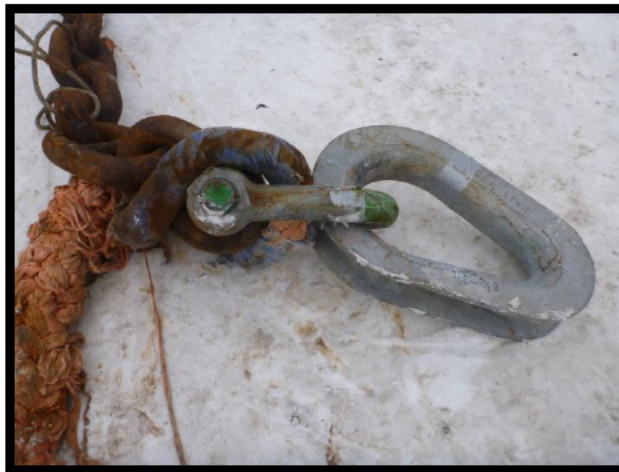
Figure 75: Photo of recovered emergency towline (eye on the KULLUK end of the emergency towline) showing missing thimble lashings allowing towline to separate from hard thimble. Blue Cordura® protection is also damaged. (*USCG Photo*)
