# **MARINE CASUALTY REPORT**

**Capsizing and Sinking  
Of The  
MOBILE OFFSHORE DRILLING UNIT  
ROWAN GORILLA I  
In The North Atlantic Ocean  
On  
15 December 1988**

**U.S. COAST GUARD  
MARINE BOARD OF INVESTIGATION REPORT  
AND  
COMMANDANT'S ACTION**

**REPORT NO. USCG 16732/02 HQS 92**

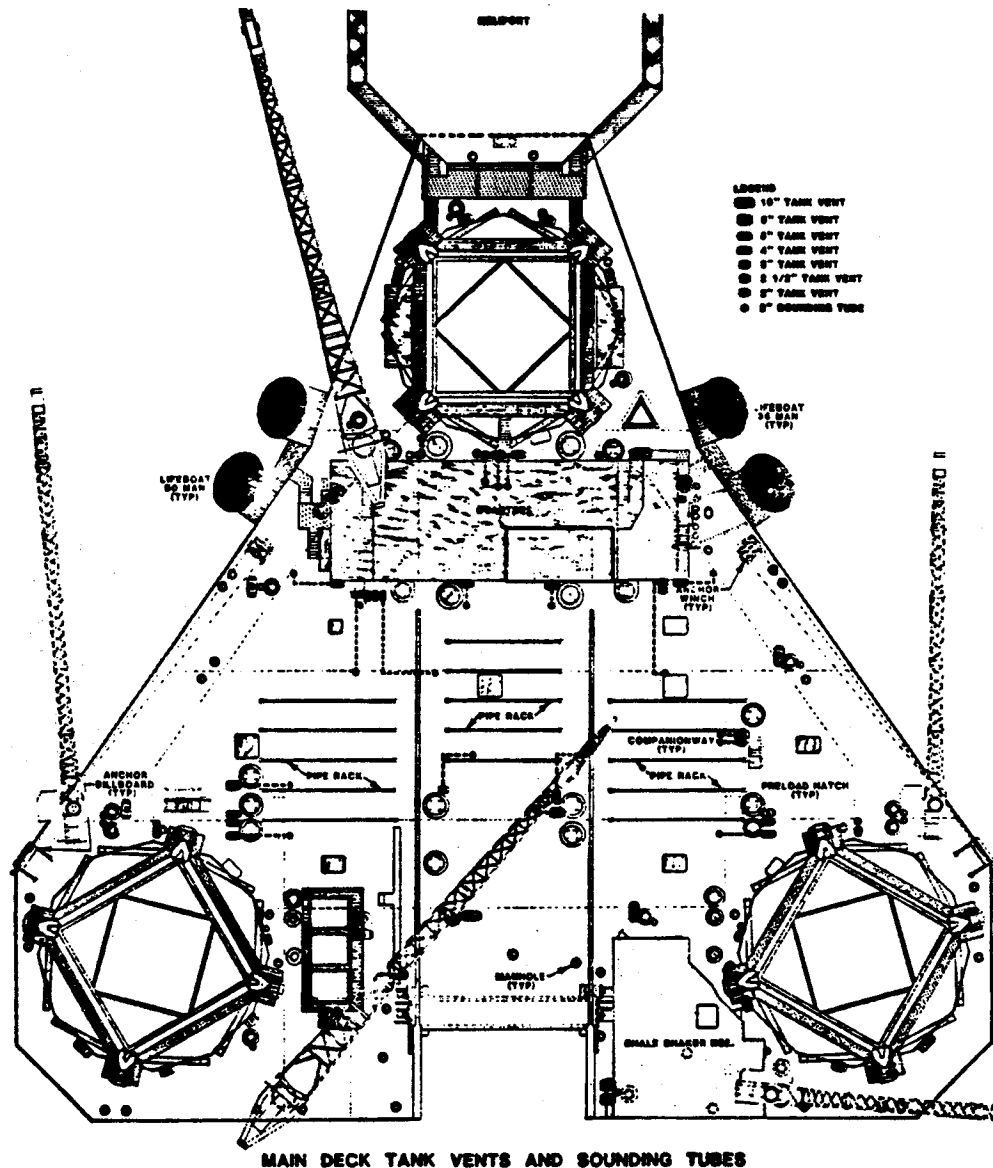
Figure 2

Aboard the ROWAN GORILLA I, one of the crewmen detected flooding in preload tank 14 during a routine sounding. The only means of determining the condition of the preload tanks was through two inch sounding tubes located on the main deck (See figure 2). Secondary or remote means were not provided. The tank was opened and inspected and a vertical fracture was discovered in way of the stern, permitting a steady spray of water to enter the tank. Preload tank 15 was also entered and a horizontal fracture was discovered in way of the stern, though only "weeping". The Rig Superintendent directed that the eductor system take suction on preload tank 14. The Senior Barge Engineer observed the fractures in both tanks. He stated the crack in preload tank 14 seemed to open and close as the stern was struck by waves.

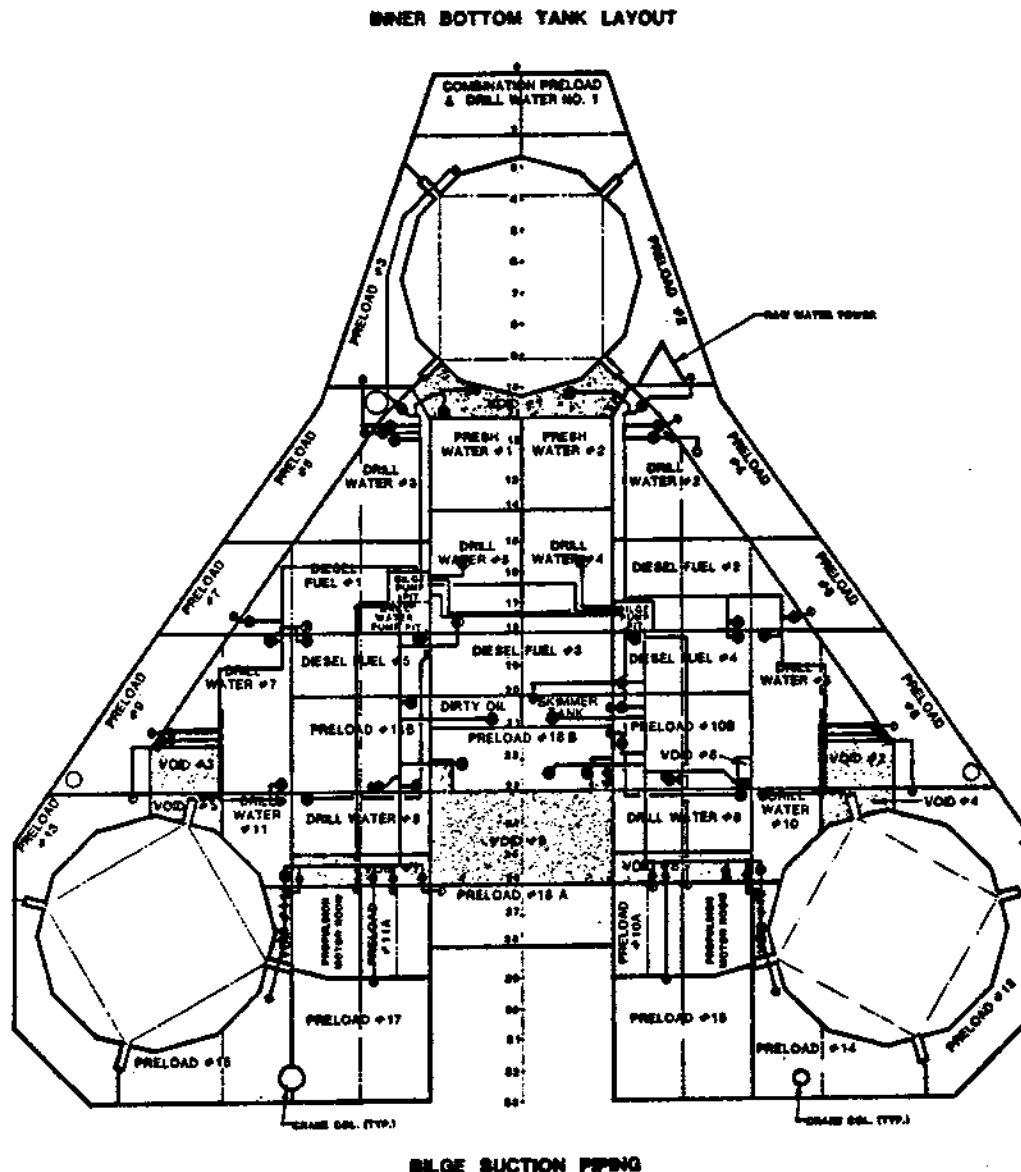
Figure 3

The eductor system (see figure 3) consists of four inch diameter piping and runs to all internal spaces of the unit. During normal operations to elevate the unit, a calculated amount of preload ballast water would be pumped into the tanks to drive the spud cans and legs securely into the seabed. Preload would then be dumped through large skin valves located in the bottom of hull while the unit was slightly elevated. The eductor piping served to strip preload ballast that remained in the tanks. It was not intended to effectively de-ballast large amounts of water from internal spaces.

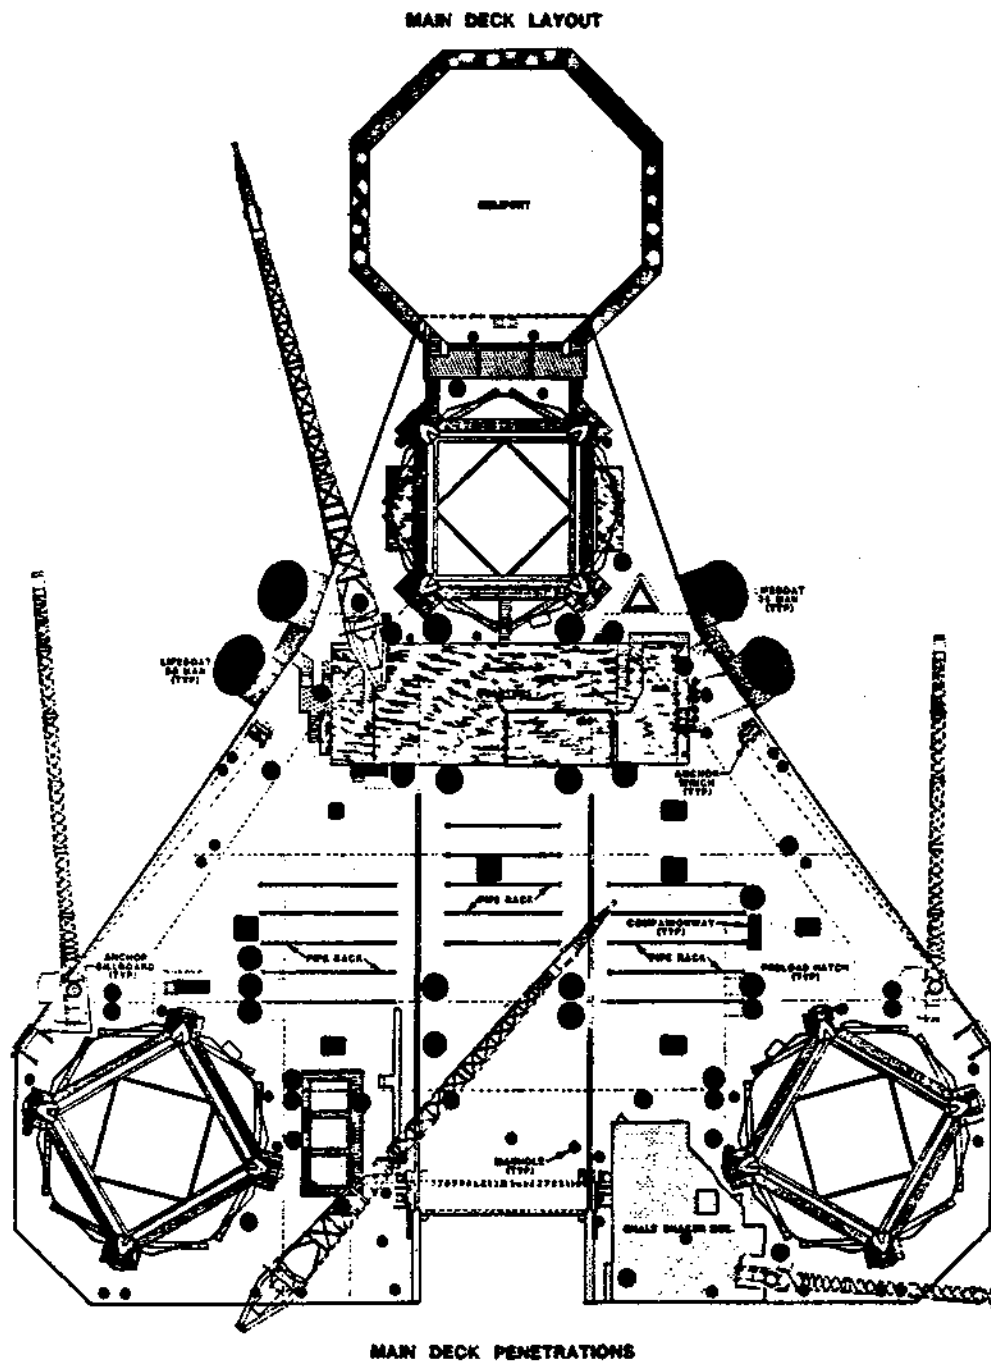
### Figure 4

The ROWAN GORILLA I had a series of internal passageways and spaces below the main deck which were accessible through a number of hatches and covers installed in the main deck (see figure 4). Crew members on watch reported to the Rig Superintendent that some hatches were leaking. On the afternoon of 14 December, the storm abated

slightly and a work crew went on deck to tighten hatches. However boarding seas over the stern hampered the crews ability to check the tightness of the cover for preload tank 14. This was the last time personnel could safely get on deck to check hatch covers or sound tanks.

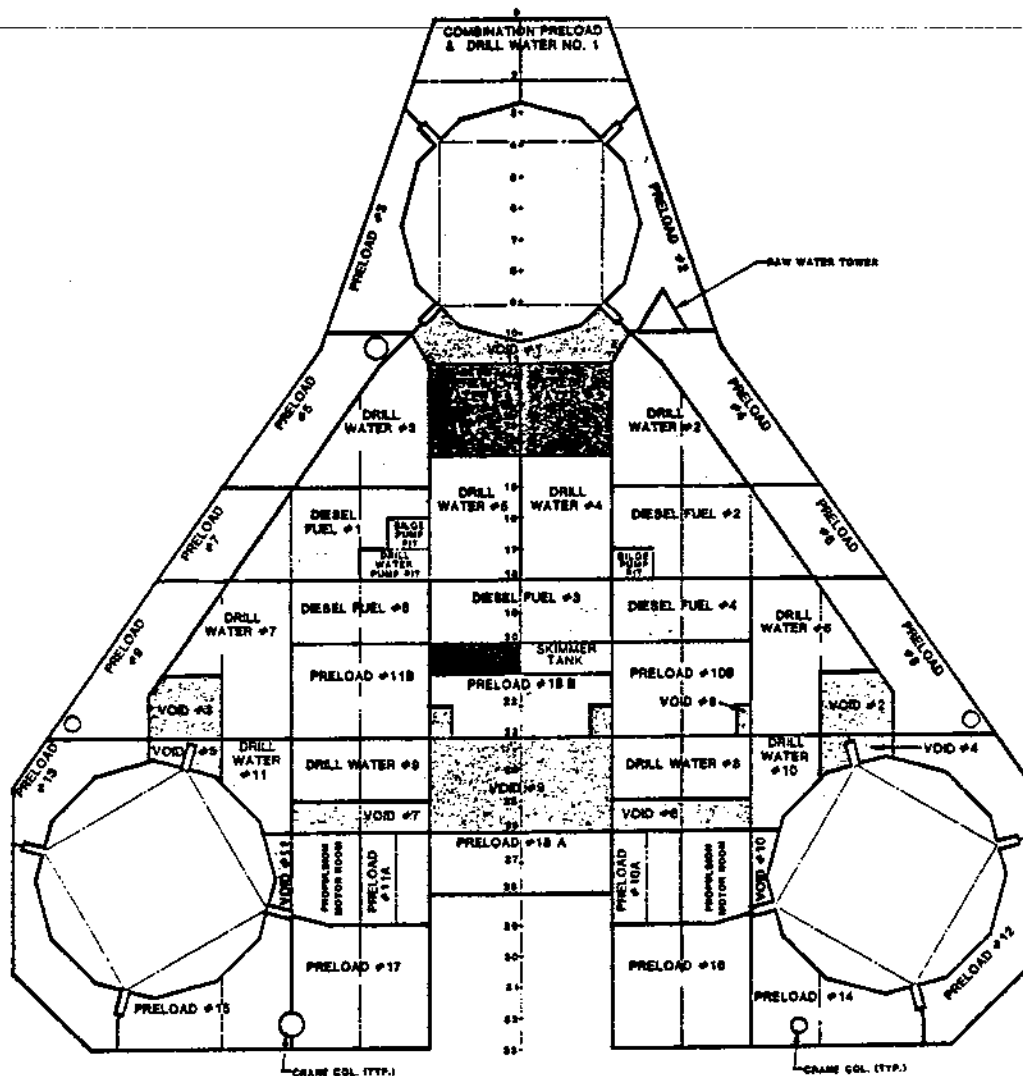
Figure 5

In the early morning, the Rig Superintendent and Senior Barge Engineer both detected that the ROWAN GORILLA I was getting heavy by the stern. The Rig Superintendent stopped the thrusters which resulted in a less turbulent ride. He requested the Senior Barge Engineer to run a damage stability calculation assuming 16 feet of water in preload tank 14. The Tow Rider was also aware of the increased stern trim and discussed the matter with the Rig Superintendent. The Senior Barge Engineer suggested that pumping out of drill water tanks 8, 9, 10 and 11, which were all full at the time of departure from Halifax, would help the trim (See figure 5). This was accomplished, but the effect was minimal. Both of them suspected that perhaps other stern preload tanks were also flooding. However, there were no means available for them to verify additional flooding as the main deck was now constantly awash from the breaking seas. There was no attempt to establish suction on other preload tanks with the eductor system to determine if they were flooding.

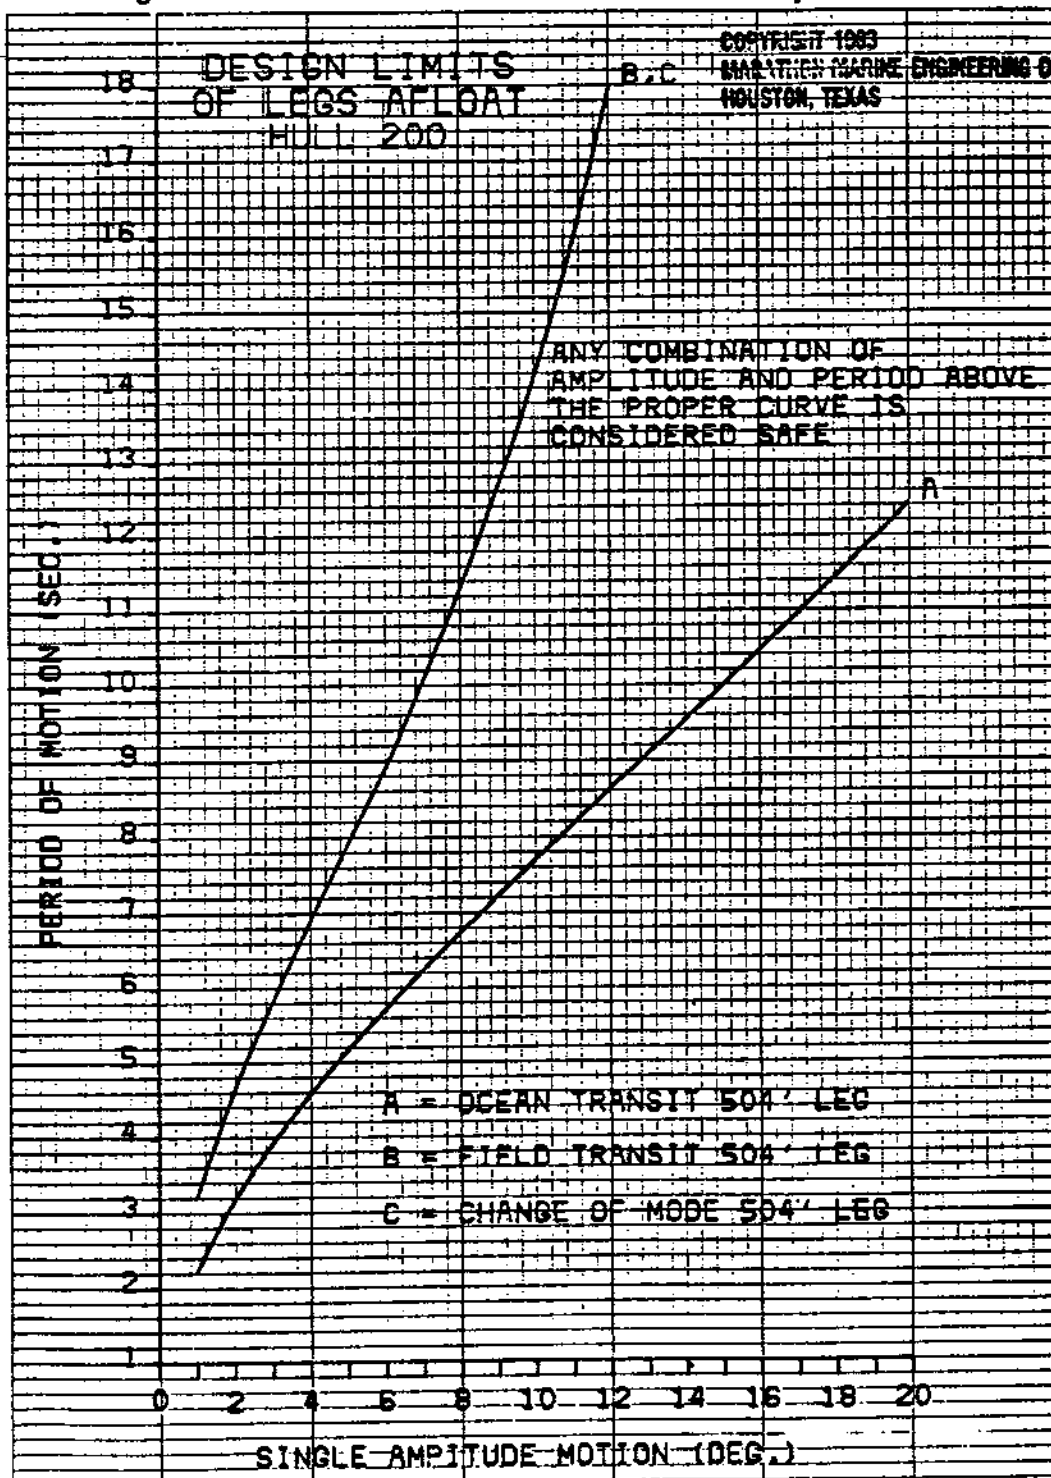
Figure 6

The following is a table of the roll, pitch, and period of the ROWAN GORILLA I, as extracted from the testimony and exhibits to this investigation. All numbers are maximums for the days and times listed.

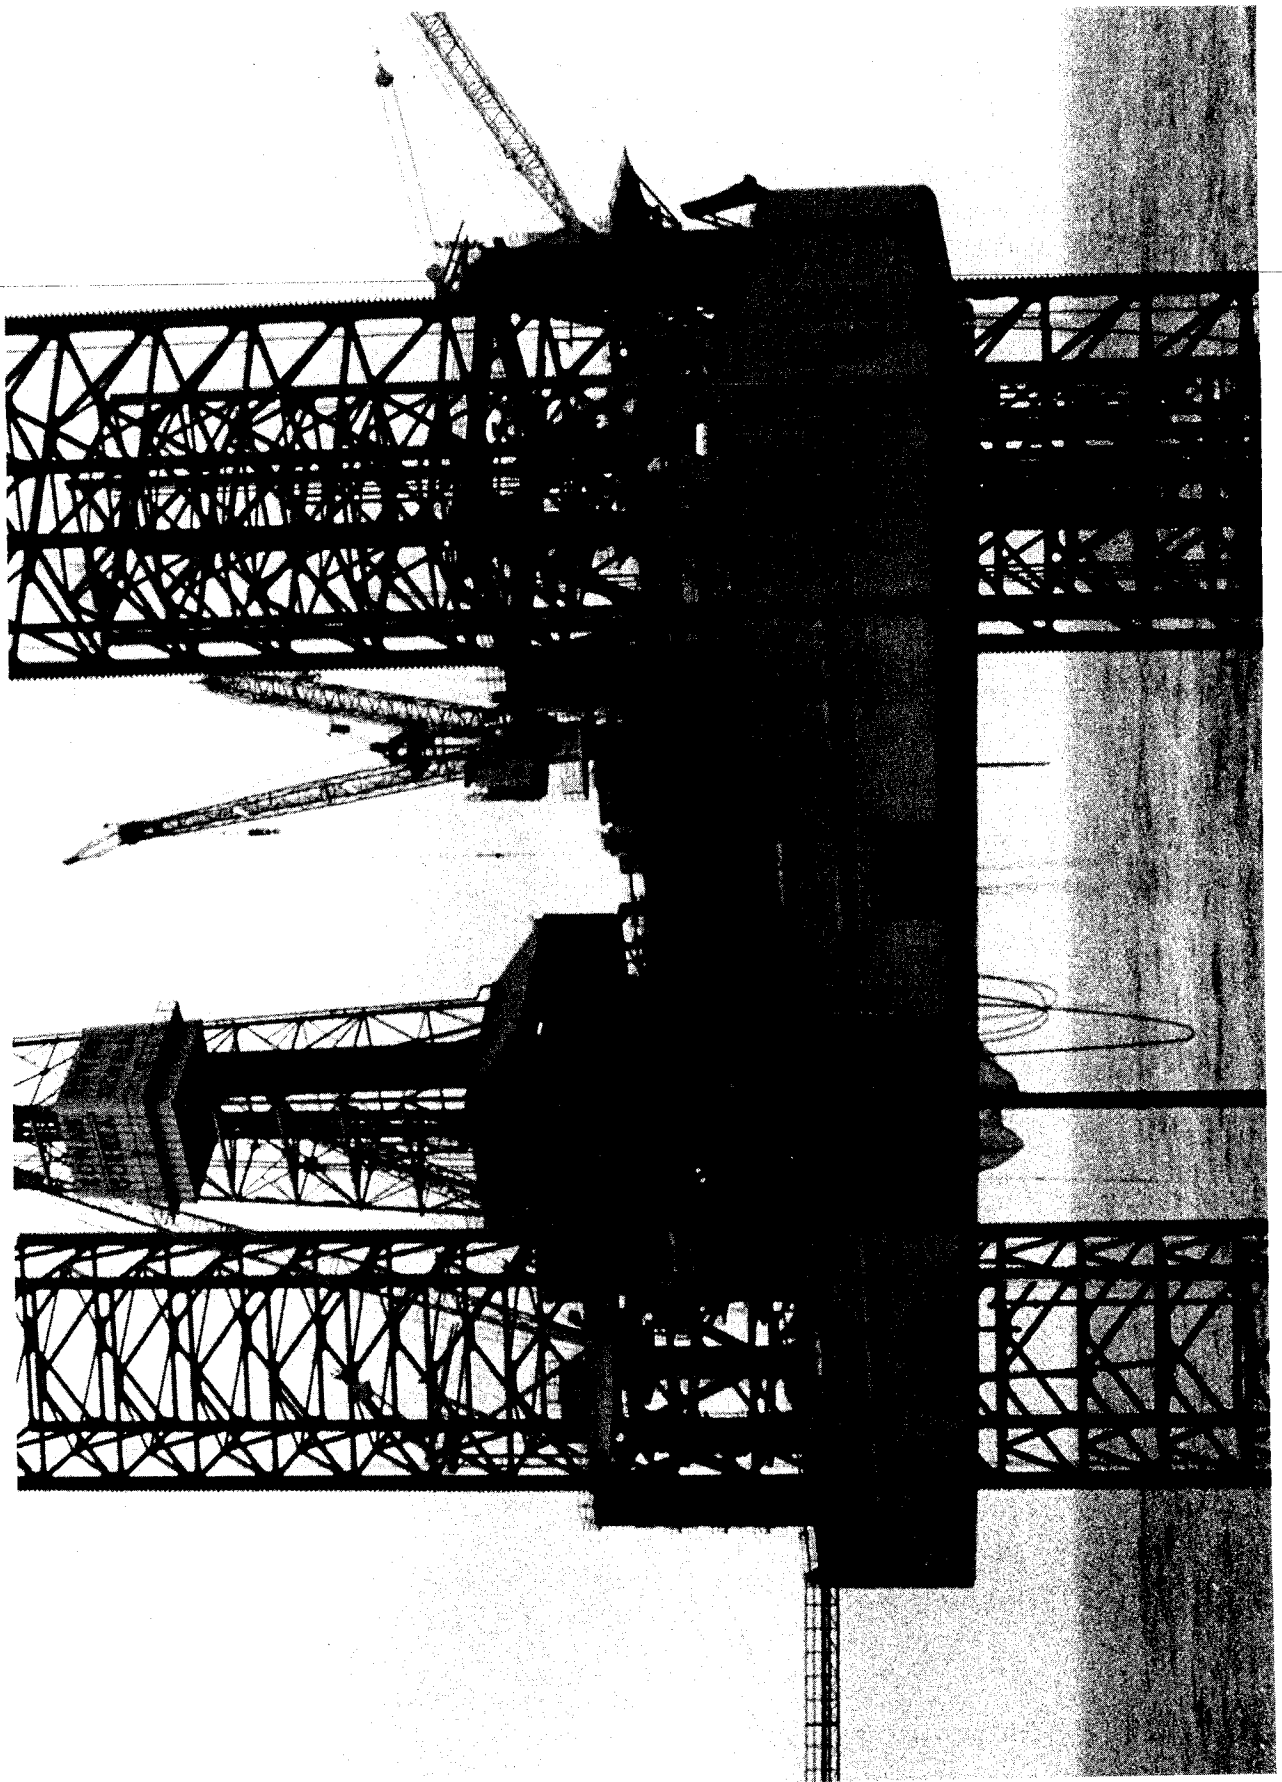
46. The Marine Board concludes that towing of self elevating units in severe storm conditions can be inherently dangerous. Some may choose to dismiss this, citing the vast numbers of successful trans-oceanic tows of jack-ups that have occurred over the years. However, the Marine Board doubts that many of these tows have been conducted in waters or at times of the year where they were subject to extreme winds and waves. The photograph on the next page clearly illustrates the potential damaging effects of boarding seas on a jack-up unit (not the ROWAN GORILLA I) under tow. Note that this unit's helideck is completely submerged.
