MARINE ACCIDENT REPORT

**EXPLOSION AND FIRE ONBOARD
THE U.S. MOBILE OFFSHORE DRILLING UNIT
GLOMAR ARCTIC II IN THE NORTH SEA,
130 NAUTICAL MILES EAST-SOUTHEAST
OF ABERDEEN, SCOTLAND
JANUARY 15, 1985**

NTSB/MAR-86/03

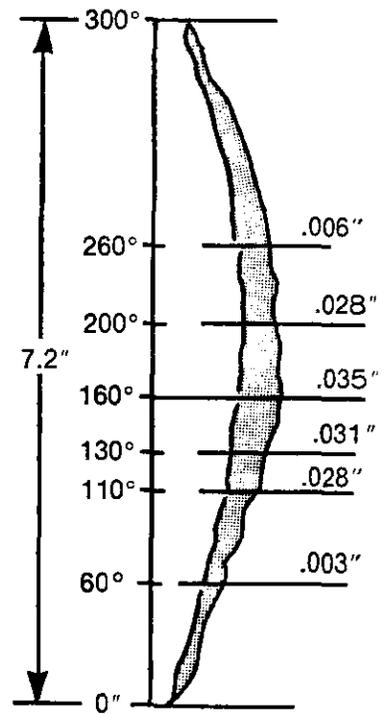
Figure 5-B.--Nozzle assembly dimensions.

Sketch of the No. 3 nozzle assembly (with the burner nozzle and gasket removed) showing the fracture which runs for 300 degrees around the circumference of the burner tip.

- (e) The dimensions of the open crack on the fractured burner tip No. 3 were measured using a micrometer microscope. (See figure 5-B.) The approximate area of the crack opening was 0.15 square inch.

Fracture Examination.--The fracture surfaces were found to have a light deposit of a viscous residue but were otherwise clean and free of corrosion deposits. However, a number of corrosion pits were observed on the surfaces of the inner shoulder radius of the No. 3 burner tip. The fracture was a "fast," or "brittle," fracture which propagated from the inner corner or radius of the No. 3 burner tip shoulder (see section 'YY' figure 5-A). There was no evidence of fatigue or stress corrosion. The burner tip was found to have suffered a complete through-wall fracture, mainly in the chamfered shoulder region with the fracture extremities extending downward into the skirt of the burner tip (see figure 5-B). The fracture ran for approximately 300° of the circumference of the burner tip with the greatest crack opening at the shoulder of about 0.035 inch.
