# **NATIONAL TRANSPORTATION SAFETY BOARD**

## **MARINE ACCIDENT REPORT**

**CAPSIZING AND SINKING OF THE  
UNITED STATES DRILLSHIP  
GLOMAR JAVA SEA  
IN THE SOUTH CHINE SEA  
65 NAUTICAL MILES SOUTH-SOUTHWEST  
OF HAINAN ISLAND,  
PEOPLE'S REPUBLIC OF CHINA  
OCTOBER 25, 1983**

**NTSB/MAR-87/02**

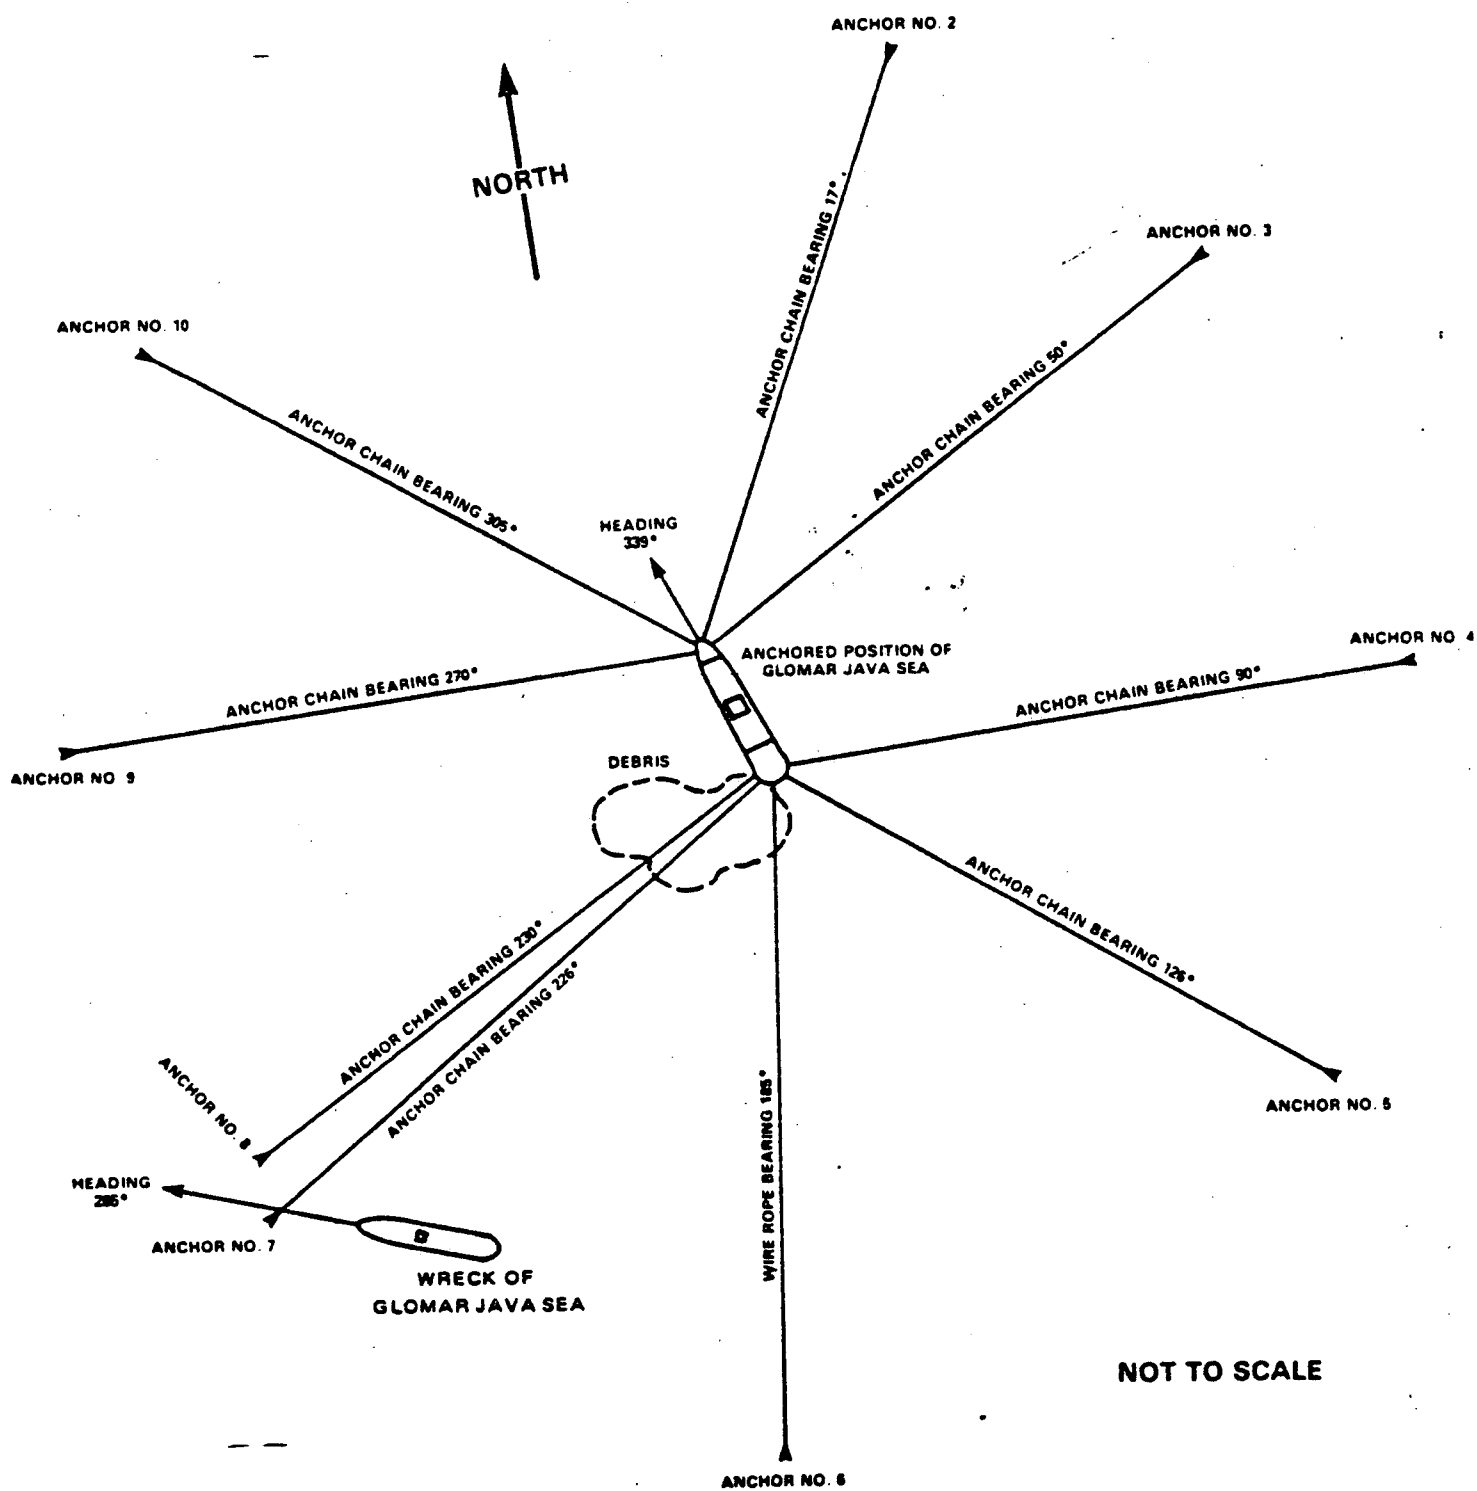
Figure 4.—Actual anchor pattern and position of wreck of GLOMAR JAVA SEA.

The GLOMAR JAVA SEA sank upside down in about 315 feet of water about 1,650 feet southwest of its anchored position over the well and is resting on the sea floor in an inverted position. Underwater videotapes of the sunken drillship were taken during November 1983 and March 1984. The videotapes showed a major structural failure amidships on the starboard side. The fracture ran from the main deck plating, down the starboard side shell plating, and into the bottom plating. The videotapes also showed a major deformation of the lower side shell plating for about 15 feet forward and 25 feet aft of the fracture and some damage to the shell plating near the bow. The drill tower was missing and the deckhouse was damaged. The value of the drillship was estimated at \$35 million.

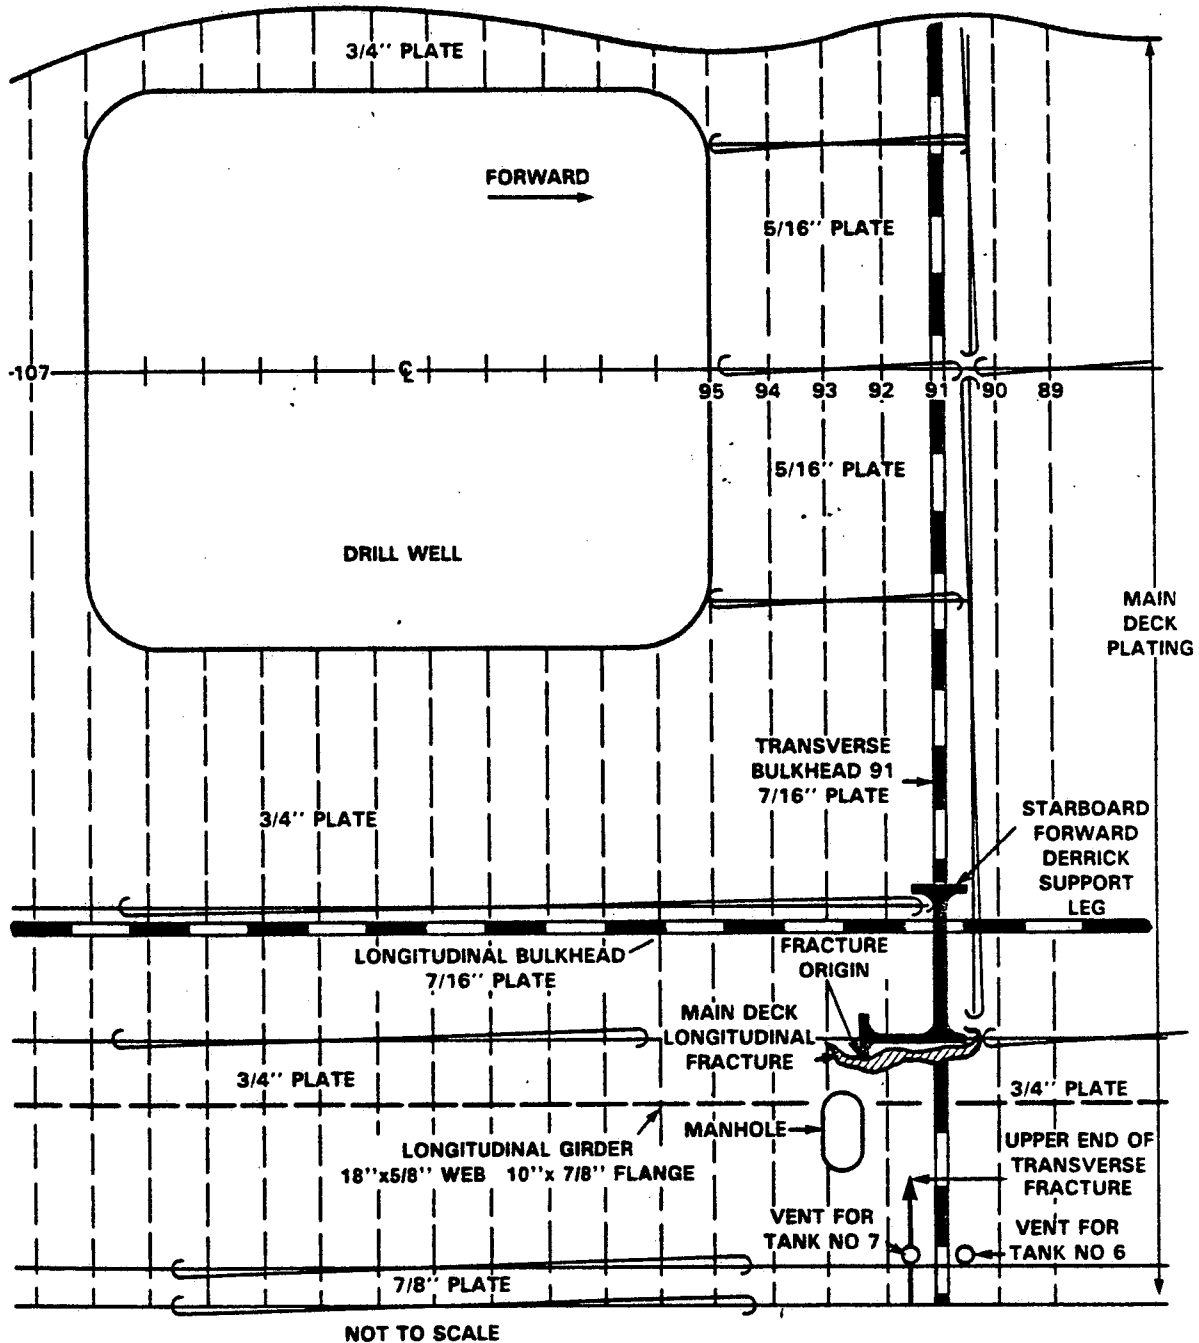
Underwater surveys of the wreck of the GLOMAR JAVA SEA were conducted during November 1973 and March 1984. The surveys examined the entire shell plating and some of the main deck plating of the drillship. Except for a large transverse fracture on the starboard side amidships and an 18-inch L-shaped fracture about 40 feet aft in the side shell plating, the hull was intact with some buckling of the bottom plating near the bow and at frame 146. There was a 5-foot longitudinal fracture in the main deck plating where the forward starboard derrick leg intersected the main deck. The surveys showed the drillship resting on the bottom in an inverted position about 1,650 feet southwest of the well. The wreck was on a heading of 285° (see figure 4) with its starboard side about 20 feet lower than the port side. There was an 8-foot mound of mud just forward of the bow. Both the port and starboard lifeboat davits were buried in the mud. The deckhouse was buried in the mud up to the superstructure deck. The side scan sonar survey conducted during March showed an area of debris between the drillship and the well about 230 feet wide and ranging from 120 to 300 feet from the well consisting mainly of drill pipe. The side scan sonar survey also showed a large object about 150 feet northeast of the drillship.

Figure 9.—GLOMAR JAVA SEA main deck plating showing longitudinal fracture and end of transverse fracture.

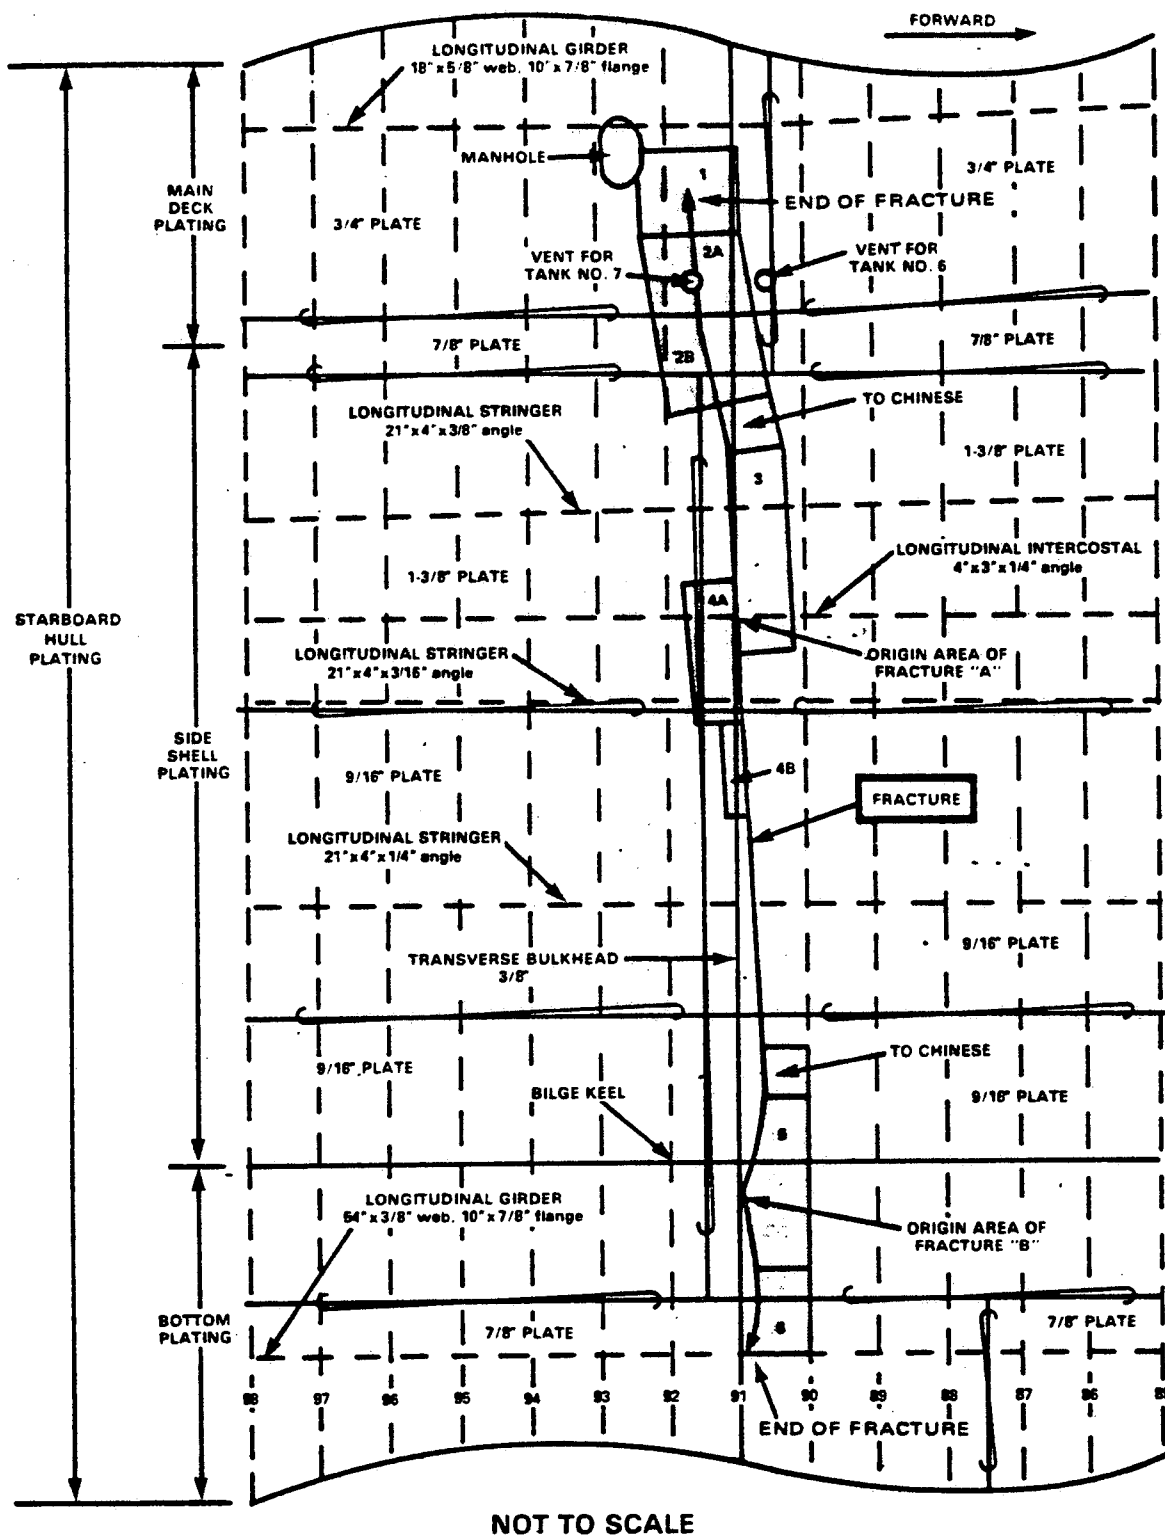
Figure 10.--GLOMAR JAVA SEA starboard plating showing fractured area and recovered coupons during March 1984.

within the No. 6 wing tank. The side shell at frame 110 was holed about 6 feet above the bilge keel by a transverse strut in the No. 7 wing tank. The fracture had two origins. The origin of fracture "A" was about 8 feet below the main deck in the 1 3/8-inch-thick side shell plating where it met the transverse bulkhead at frame 91 and where a longitudinal intercostal was welded to the shell plating and the bulkhead. Fracture "A" extended toward the main deck on the aft side of bulkhead 91, through the 7/8-inch thick sheer strake, into the 3/4-inch thick deck plating, around the fuel oil vent opening, and ended about 4 feet inboard in the deck plating. The bulwark near frame 91 did not show extensive damage. Fracture "A" extended toward the bilge keel on the forward side of bulkhead 91 into the 9/16-inch thick plating and ended near the bilge keel. The origin of fracture "B" was just below the bilge keel at bulkhead 91, and it extended toward the main deck until it intercepted the first fracture just above the bilge keel and ran about 2 feet into the 7/8-inch thick bottom plating and stopped. The fracture surfaces showed no evidence of battering or of striking each other. The divers cut coupons of the fracture about 2 feet wide and 6 feet long along the fracture surface for metallurgical analyses. Ten coupons were taken to the surface, cleaned, and preserved for shipment. Eight coupons were shipped to Failure Analysis Associates (FAA) in Houston, Texas, and two were given to the Nanhai West Oil Company.

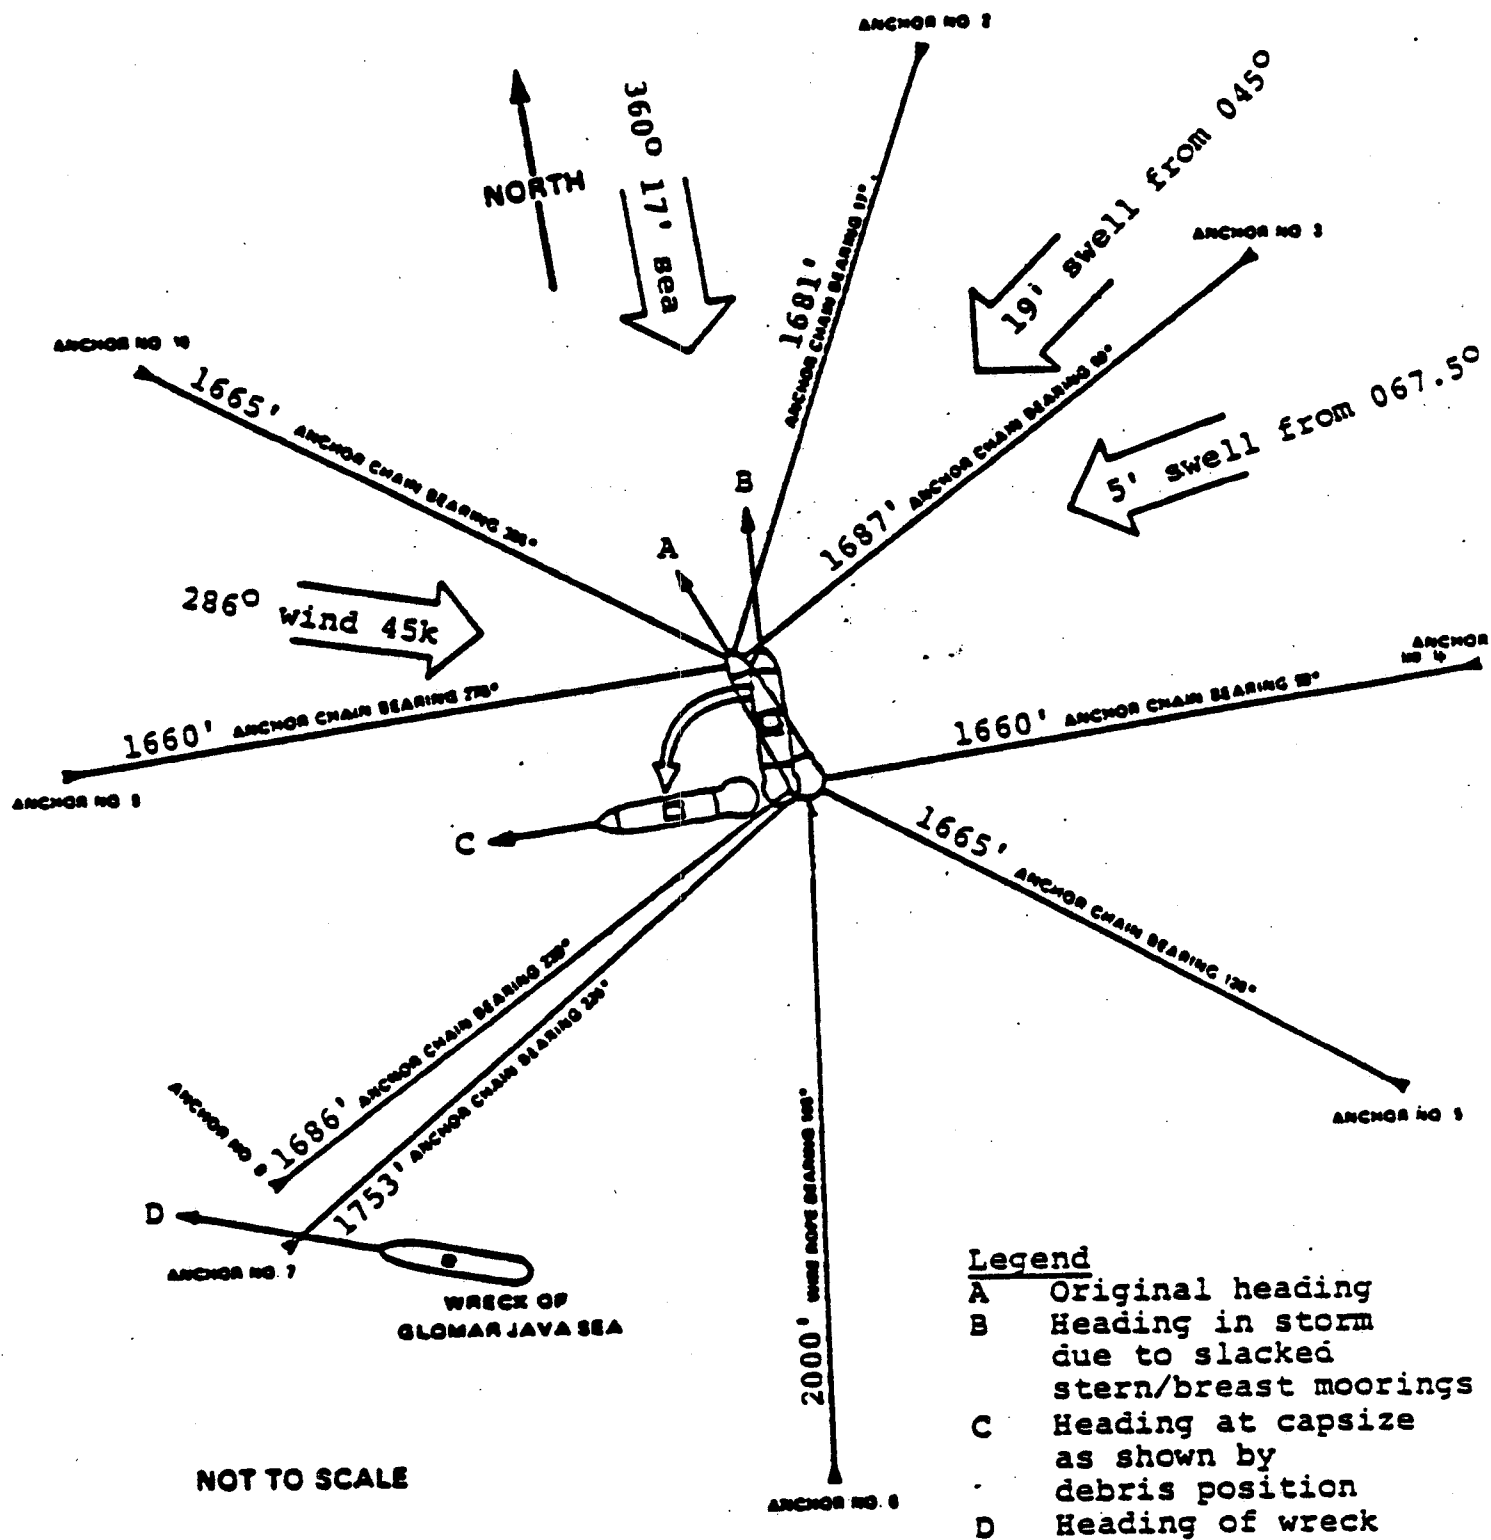
Although evidence gathering and studies are not complete, premature breaking of the starboard bow moorings, triggering a series of events culminating in capsizing and sinking, now appears to be a far more likely explanation for the casualty than the conclusion reached by the Board in its Report.

**Figure 1.** Headings before and during storm and at capsizing
