NATIONAL TRANSPORTATION SAFETY BOARD

MARINE ACCIDENT REPORT

**CAPSIZING AND SINKING OF THE
MOBILE OFFSHORE DRILLING UNIT
ROWAN GORILLA I
IN THE NORTH ATLANTIC OCEAN
DECEMBER 15, 1988**

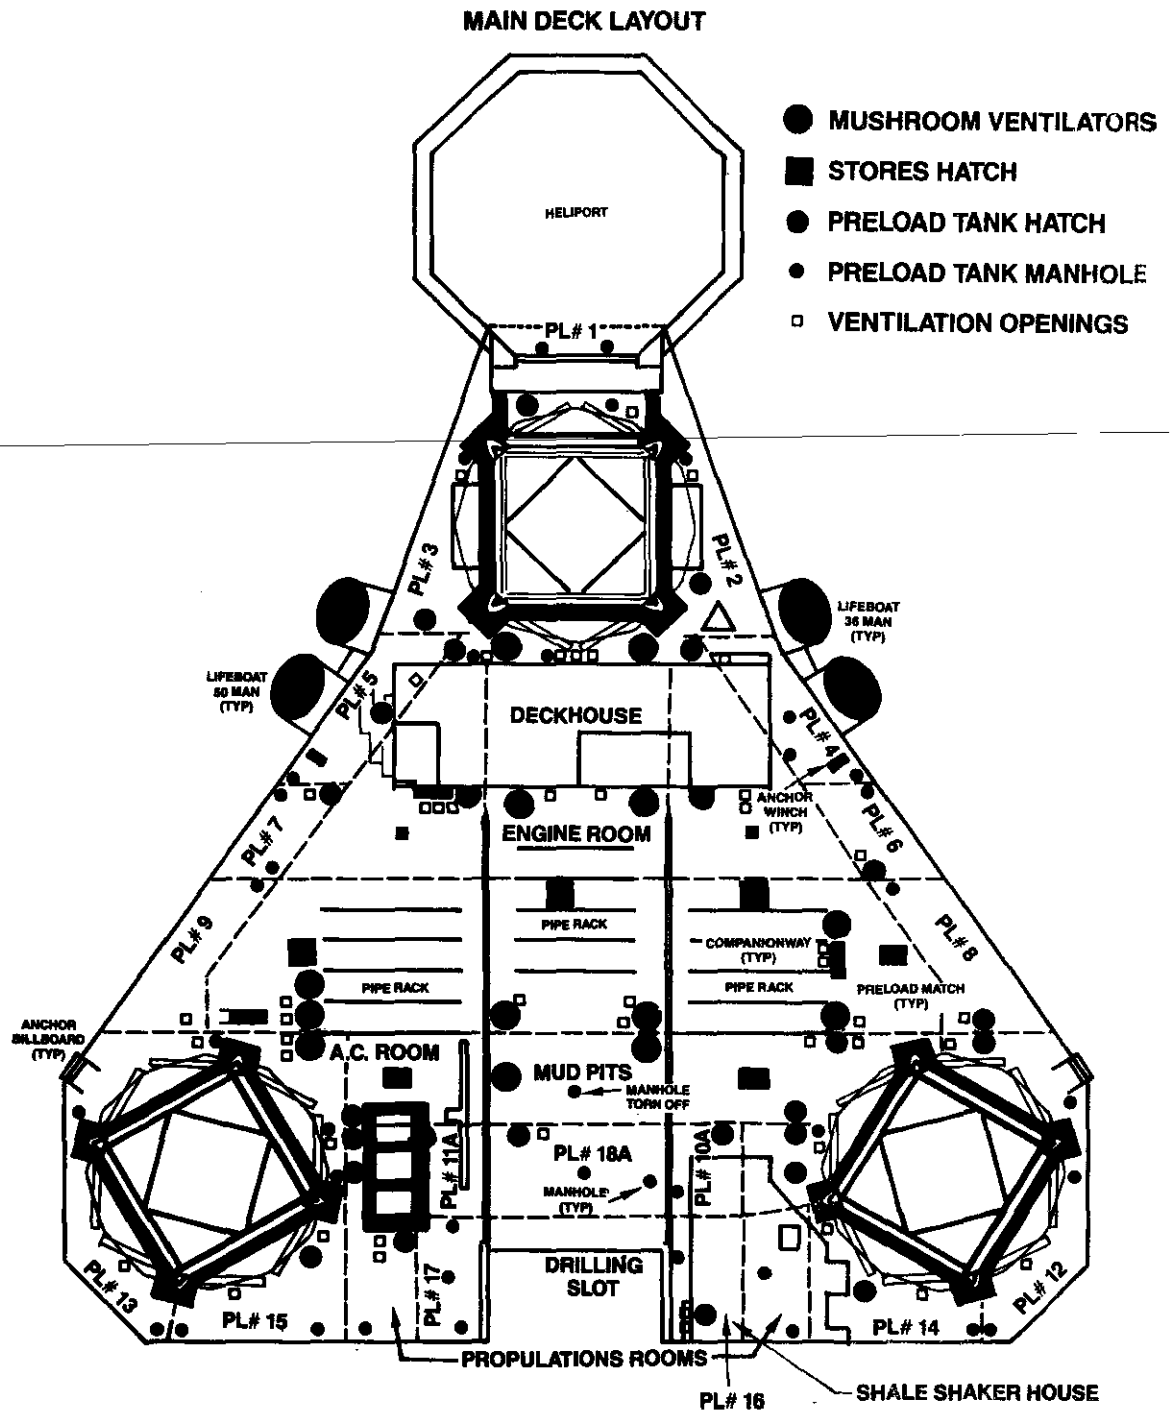
Figure 6.--Plan view of ROWAN GORILLA I main deck showing machinery deck and preload tanks.

1. Preload Tank No.15 - Two 7-inch-long horizontal cracks. These cracks were located approximately 23.5 feet below the main deck, near the connection of a 7/16-inch-thick longitudinal bulkhead and a 36-inch-wide by 7/16-inch-thick web frame.

2. Preload Tank No.14 - One 12-inch-long vertical crack. This crack was located along the port aft corner of the tank where the transom bulkhead connects to a longitudinal bulkhead about 22 feet below the main deck. The transom bulkhead plating was 5/8-inch thick while the longitudinal bulkhead plating was 7/16-inch thick. The two bulkheads were connected with 5/16-inch double continuous fillet welds.

3. Preload Tank No.13 - One small crack which yielded a negligible amount of water. This crack was located near the inboard aft corner of the tank along the connection of the transom bulkhead and a 45-inch-wide by 1/2-inch-thick web frame. The plating in this area was 5/8-inch thick.

6. Preload Tank No.16 - One small crack. This crack was found along the overhead (main deck) of the tank near the crack on the inboard gear unit boundary plate of the aft starboard leg. The main deck plating in this area was also 1/2-inch thick.

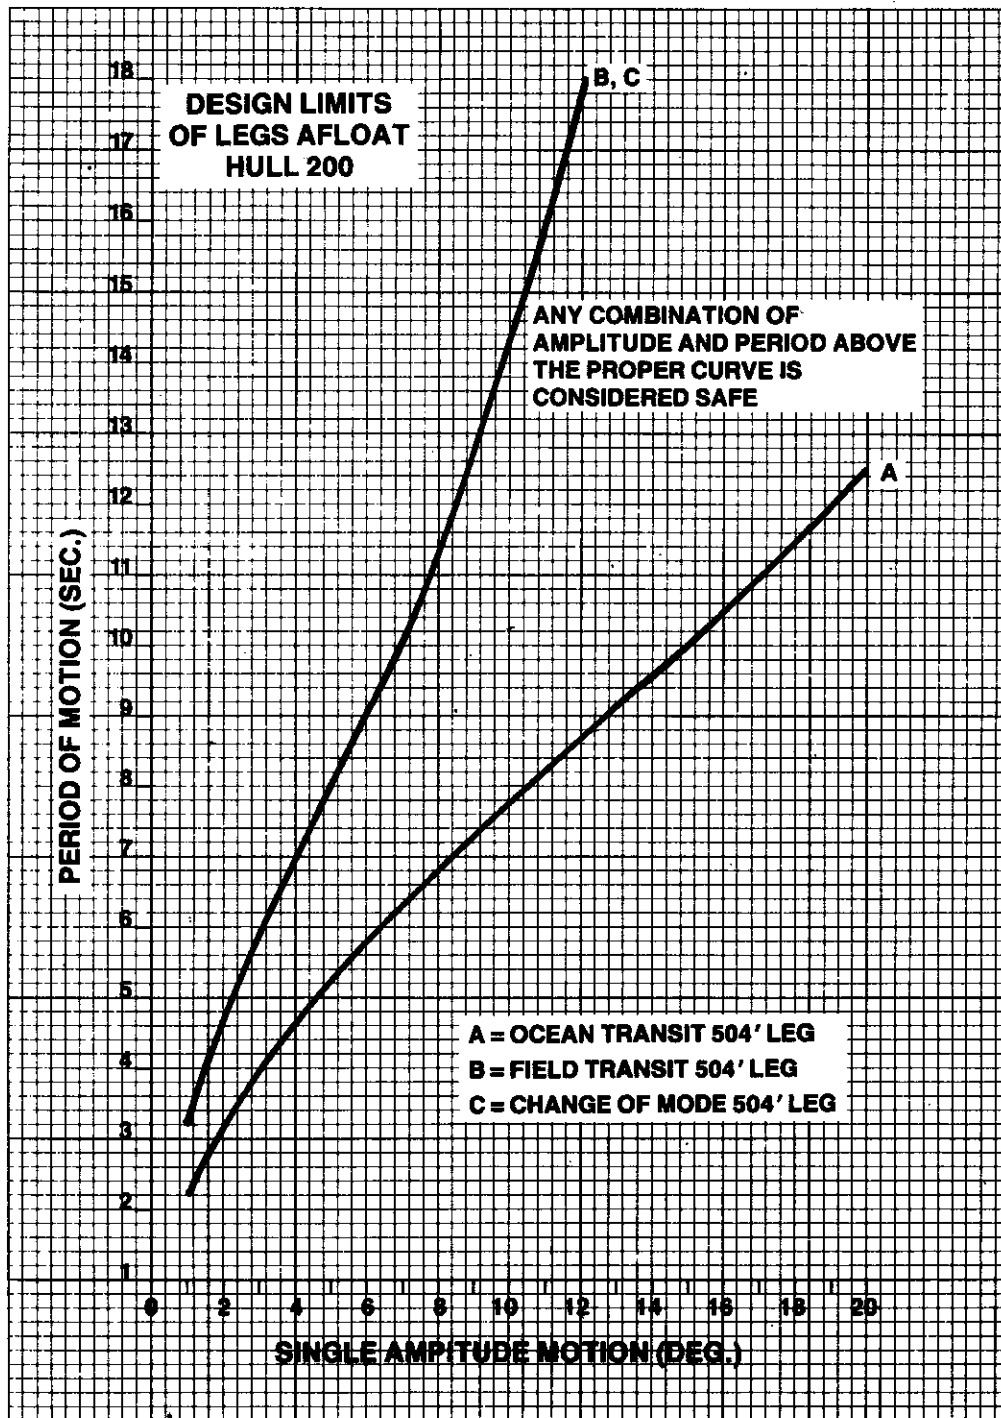
Figure 7.--Design limits of legs afloat graph.

The Marathon vice president further stated that the ROWAN GORILLA I legs were not designed to be lowered beyond the 25-foot level while in transit. The legs are specifically reinforced at the 12.9- and 25-foot levels. Lowering the legs beyond the 25-foot level would be "jeopardizing the

integrity of the leg...if you continue to lower the leg and dampen the motion, then you're going to take more green water over the deck." The Rowan vice president stated that the rig superintendent was responsible for ensuring that the rig did not exceed the design limits of the legs afloat graph. He further stated that if the rig motions were exceeding the design limits with the legs at the 25-foot level, the only option for the rig superintendent would be to attempt to change heading to reduce the motions and that the rig superintendent should never lower the legs below the 25-foot level.

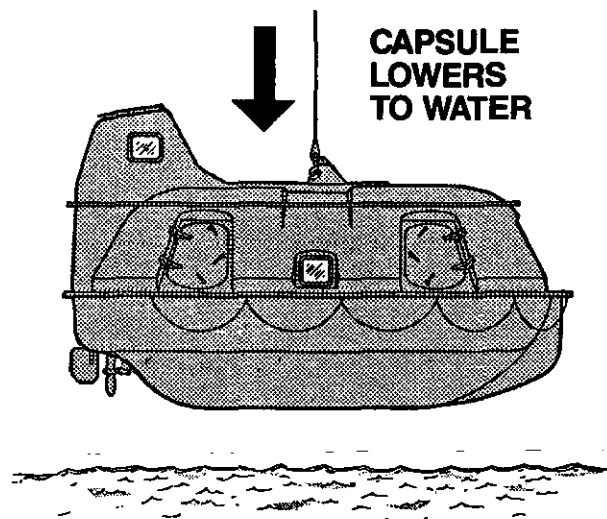
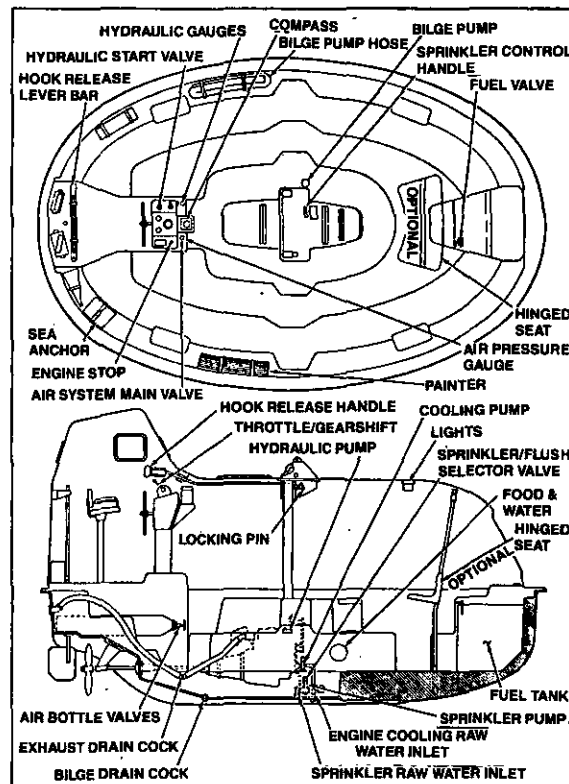
Figure 8.--Drawings of the type of survival capsule used aboard the ROWAN GORILLA I.
(Courtesy of Survival Systems International)

- o the adequacy of the design of the survival capsules aboard the ROWAN GORILLA I regarding external lighting, radar reflectors, and capacity when survivors are wearing immersion suits.
