## **MARINE ACCIDENT REPORT**

**EXPLOSION AND FIRE ABOARD THE  
U.S. MOBILE OFFSHORE DRILLING UNIT  
ZAPATA LEXINGTON  
GULF OF MEXICO  
SEPTEMBER 14, 1984**

**NTSB/MAR-85/11**

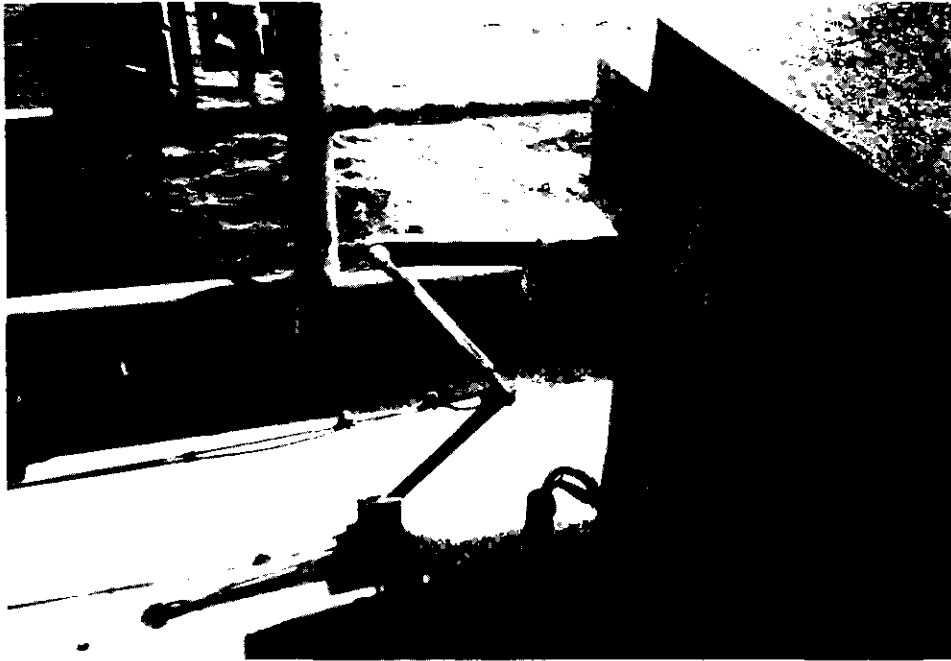
Figure 5.--Brake release handle on lifeboat winch.

When the eight persons entered the ZAPATA LEXINGTON's single lifeboat and attempted to launch it by pulling the releasing ring attached to the brake release handle (see figure 5), the lifeboat would not lower. No one tried to turn the brake drum (see figure 6) on the lifeboat winch by hand to release the brake. After several unsuccessful attempts the group moved to the other end of the rig and launched two inflatable liferafts. A postaccident examination of the brake mechanism on the lifeboat winch revealed that several sharp raps on the brake band dislodged an accumulation of rust and allowed the brake to release.

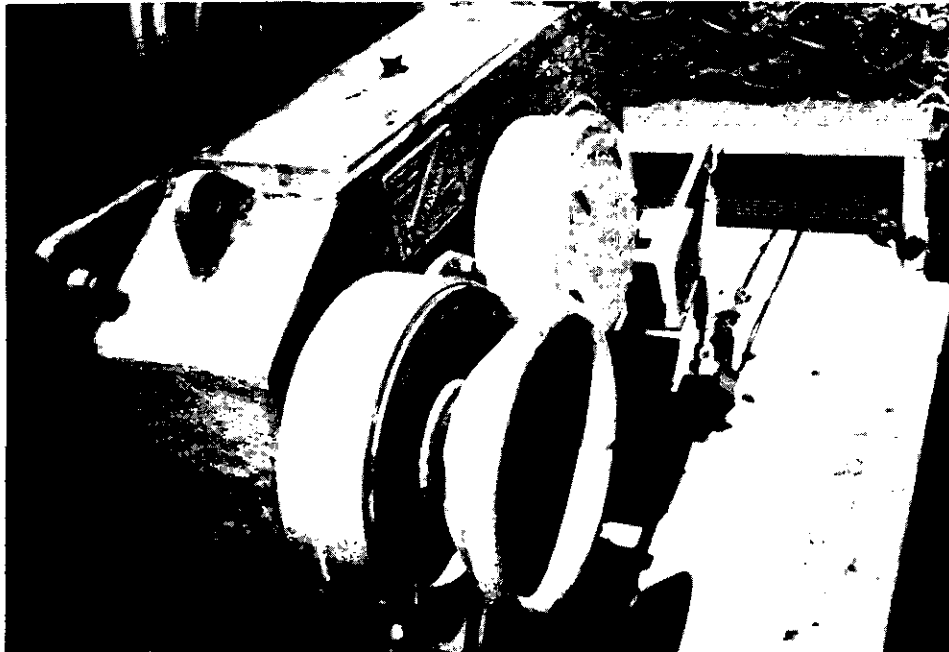
Figure 6.--Brake drum on lifeboat winch.
