NAVIGATION AND VESSEL INSPECTION CIRCULAR NO. 4-85 CHANGE 2

Subj: Change 2 to NVIC 4-85 of 29 May 1985, Recalls and Other Corrective Measures for Lifesaving and Fire Protection Equipment

NAVIGATION AND VESSEL INSPECTION CIRCULAR NO. **4-85**

Subj: Recalls and Other Corrective Measures for Lifesaving Equipment

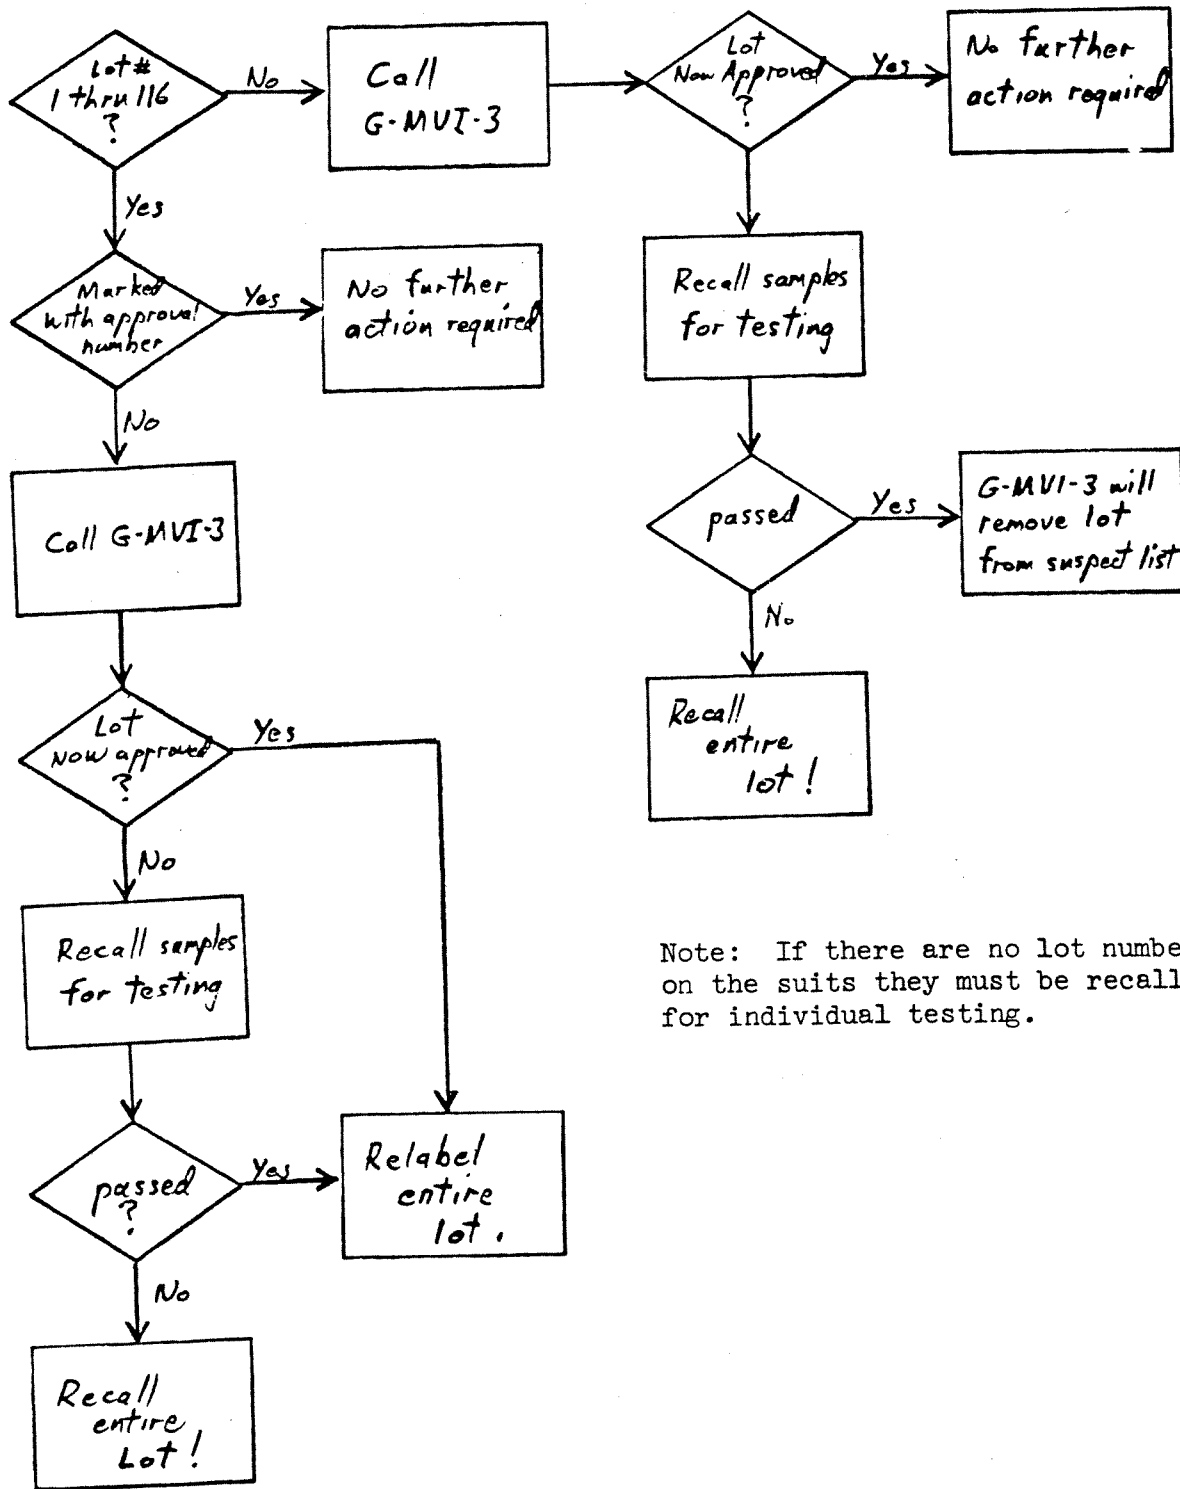
FITZ-WRIGHT SUITS RECALL PROCESS

- a. Fitz-Wright exposure suits up to and including Lot 116 were inspected and tested for Coast Guard approval by Warnock Hersey Professional Services but were not marked with an approval number on the suit.
- b. Production inspection has since been taken over by Underwriters Laboratories (UL), but suits from lot numbers 117-132, 134, and 136-137 may have been labeled as Coast Guard approved even though they were not inspected and tested at the factory by Warnock Hersey or UL.
- c. Some Fitz-Wright suits have been found to have no lot numbers, and their factory inspection status can not be determined.

Note: If there are no lot numbers on the suits they must be recalled for individual testing.

- a. Where records in the custody of Underwriters Laboratories indicate that a lot numbered 116 or lower was inspected by Warnock Hersey Professional Services, the suits may be relabeled in the presence of a UL inspector.
- b. Where the records indicate that any lot was not inspected by an independent laboratory, representative samples of the lot must be returned to Fitz-Wright for testing by a UL inspector. Fitz-Wright will provide replacements for the samples recalled for testing. After samples of a lot have been tested and inspected, the lot will be approved and all suits of that lot may be relabeled in the presence of a UL inspector.
- c. Any suit which does not bear a lot number can not be considered Coast Guard approved.

- b. Operators may contact Underwriters Laboratories to determine the status of suspect suits and arrange for relabeling. If samples from the lot are needed, the operator will be referred to Fitz-Wright to arrange for replacements and shipping of samples. Point of Contact at UL is:

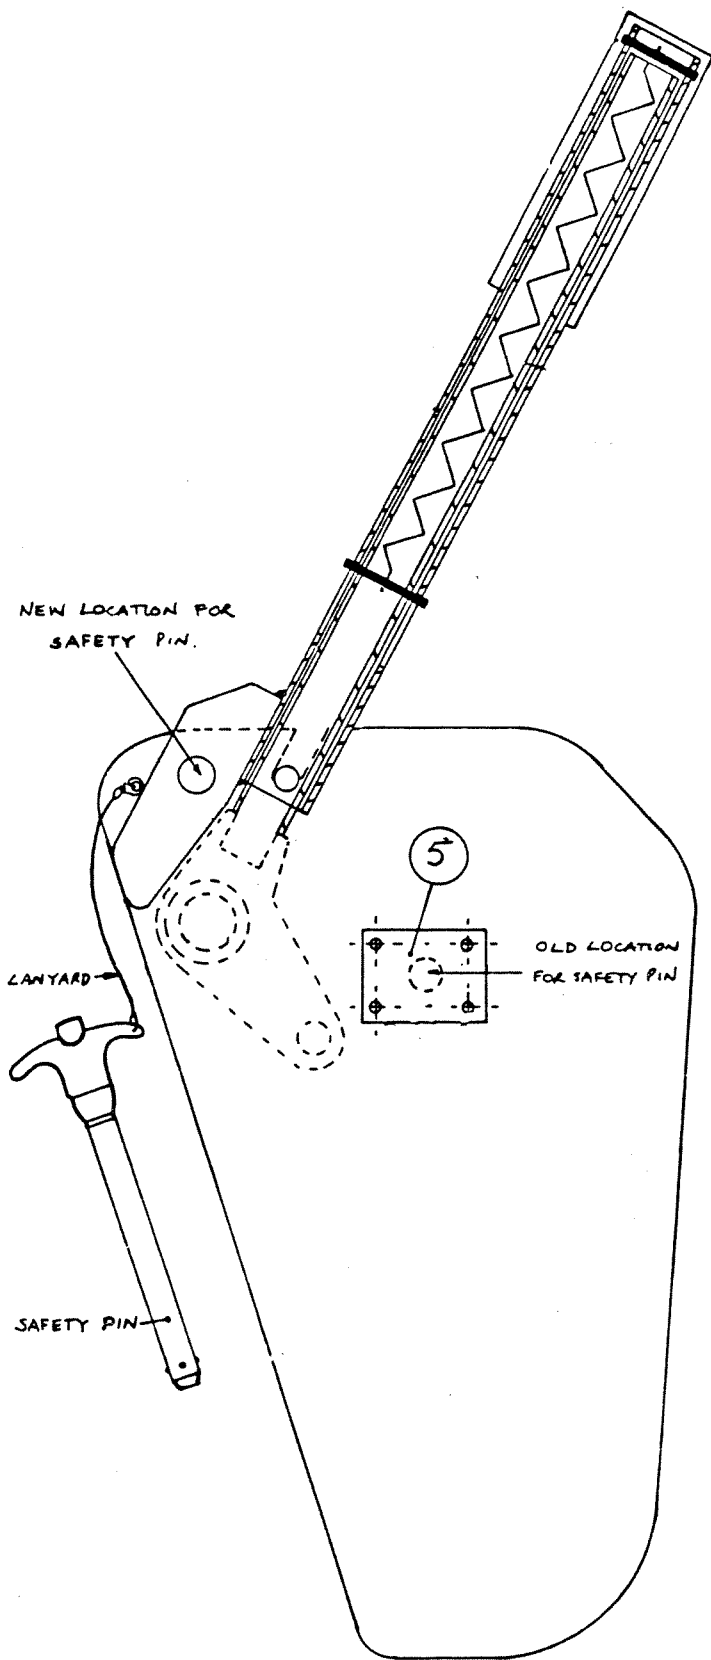
1. PROBLEM. The safety pin on the Titan release gear operating handle used in certain Watercraft America lifeboats, can be inserted before the handle is in the safe, fully closed position. In this condition, the release hooks may appear to be fully closed, but may unexpectedly open when a load is applied.

3. ACTION.
 - a. Vessel and MODU operators having Watercraft America lifeboats equipped with Titan gear having approval number 160.033/69/0 shall make sure the release gear is modified in accordance with Watercraft America drawing SP-201 and Engineering Instruction P-131, both dated 28 October 1985. The Coast Guard Officer in Charge of Marine Inspection shall be notified before the modification work begins. The drawing and instruction may be obtained from:

Watercraft America, Inc.
P.O. Box 1130
Edgewater, FL 32032
(904) 428-5781
Telex: 567415
 - b. Coast Guard inspectors will require modification of Watercraft America Titan release gear with approval number 160.033/69/0 in accordance with the Watercraft America drawing and instruction.

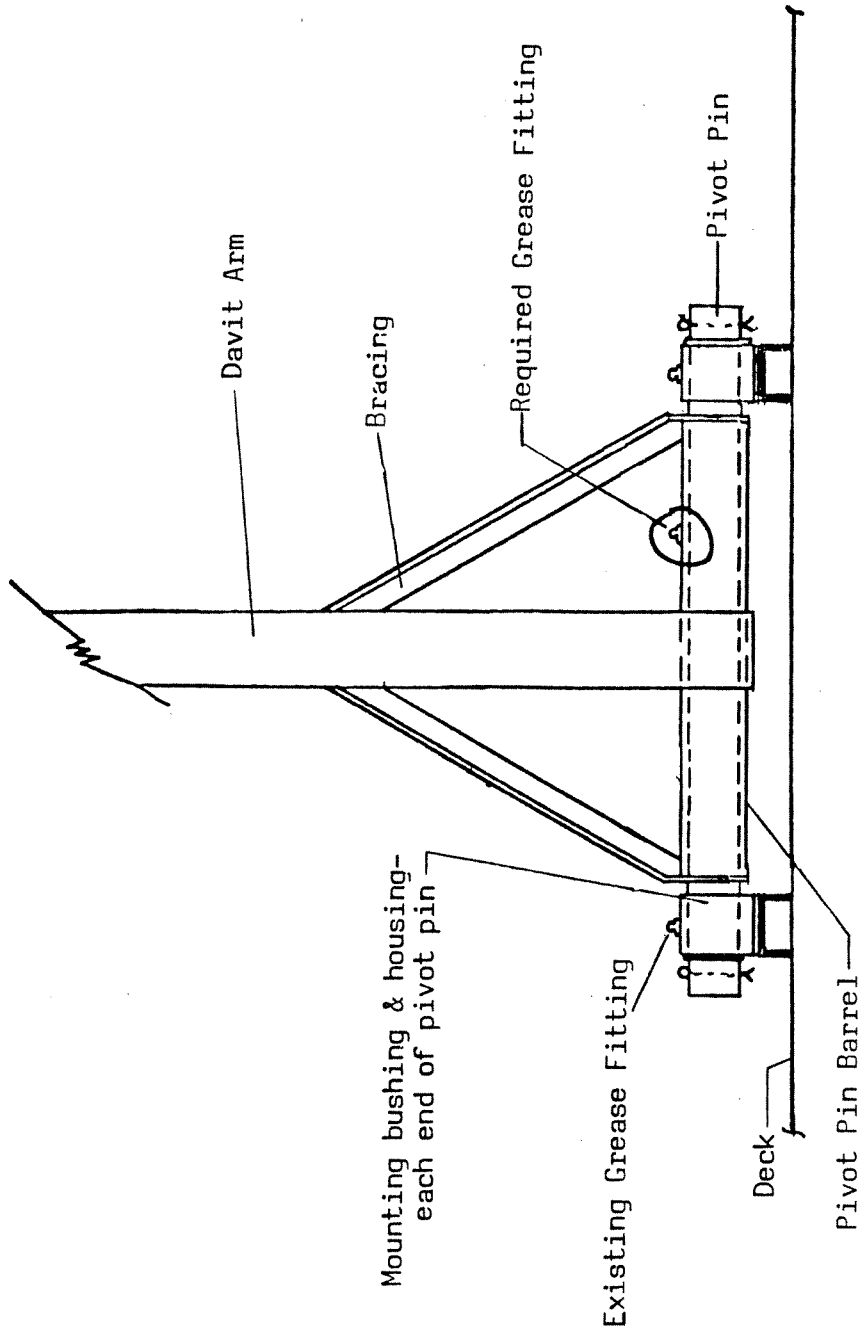
Looking Inboard at Davit Arm Base

1. PROBLEM: The pivot pins of certain mechanical davits arranged as shown in the figure on the following page, are subject to corrosion and seizure, due to water accumulation inside the pivot pin barrel.
2. ACTION: To prevent corrosion and seizure of the pivot pin, the pivot pin barrel should be equipped with a lubrication fitting as shown in the figure. Grease should be applied to this fitting regularly to exclude accumulated water in the barrel in order to permit easy operation of the davit.
 - a. Modification of mechanical davits to add this lubrication fitting is authorized. The Coast Guard Officer in Charge of Marine Inspection shall be notified before the modification work begins.
 - b. Coast Guard inspectors will require the addition of lubrication fittings to the pivot pins of mechanical davits where it is evident that water accumulation and corrosion is a problem.

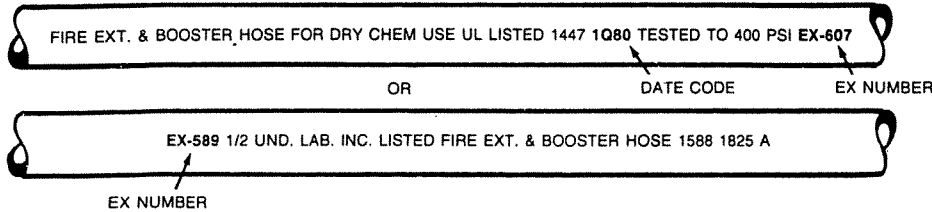
ILLUSTRATION 1

1. If extinguisher has a yellow "Inspected" sticker on the front, go to step 9.
2. Find U.L. Listing information printed on hose (either white print or molded on hose cover). (See illustration 1 below.)

3. If there is no printing, or printing is unreadable, replace hose assembly and destroy old hose.
4. Refer to **EX** number on hose, if it is **NOT** EX-607 or EX-589, hose is good, do **NOT** replace.
5. If EX-607

6. If EX-607, refer to date code (Example 1Q80 means 1st Quarter 1980)
7. If Date Code is between 1Q77 and 4Q83, replace hose assembly, destroy old hose. If dated **BEFORE** 1Q77, hose is good, go to step 9.

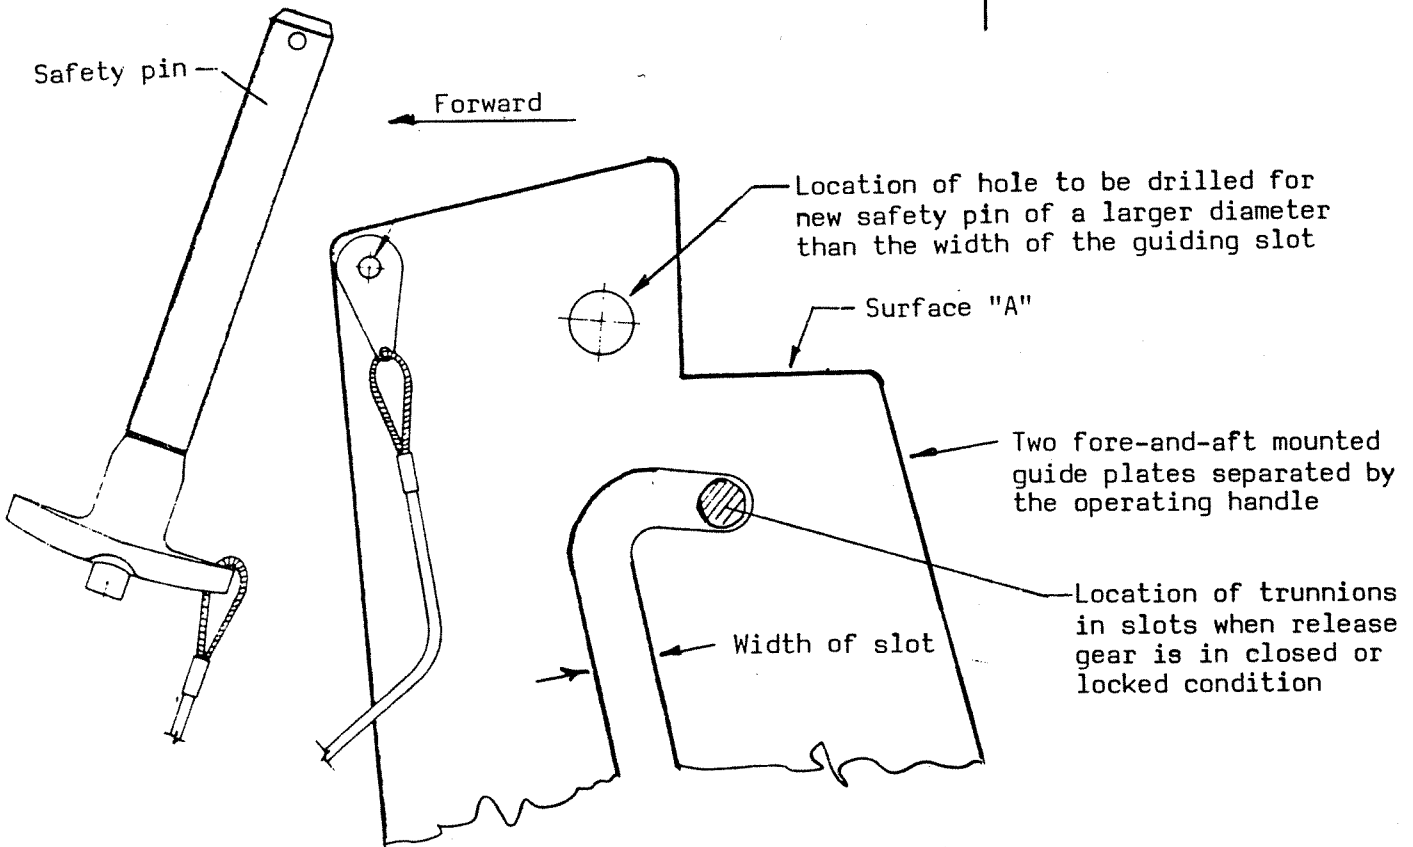
Inboard profile view of slotted plates for guiding the trunnions of the operating handle

1. PROBLEM. The safety pin for the Viking release gear operating handle used in certain Watercraft America lifeboats, can be accidentally inserted into the slot for the release handle trunnion, rather than the hole intended for the safety pin. If this is done, the release gear is not in a safe condition.

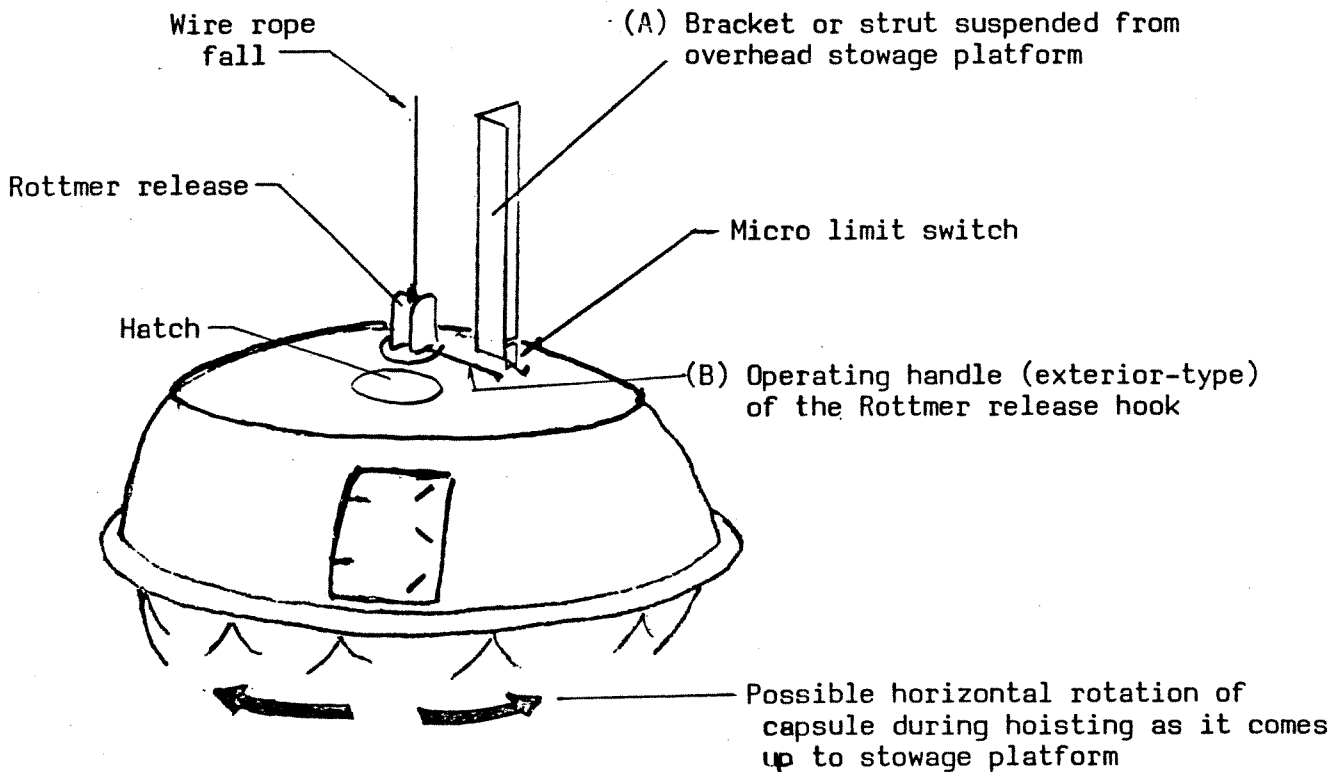
Figure 1 of Enclosure(23) to NVIC 4-85 CH-2

NOTE: The above arrangement has the danger of letting the operating handle(B) of the Rottmer release to push against the bracket(A) suspended from under the stowage platform. This could result from the horizontal rotation of the capsule as it comes up into the stowed position. This unintended interference is a potential hazard because of the chance that the operating handle(B) could be moved from its locked position, thus permitting the capsule to drop free of the wire rope fall.
