# UNITED STATES COAST GUARD

## MARINE SAFETY ALERT

Alert 04-10

### Watertight Doors – Close Them and Dog Them!

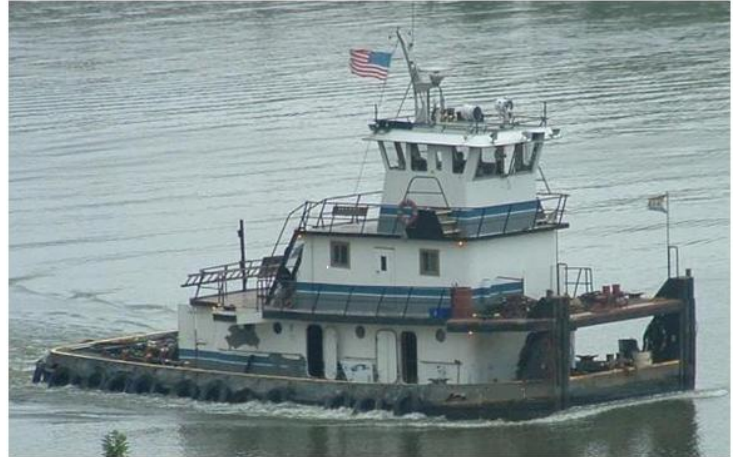
Recently a push boat operating “unfaced” (no barges attached) in the Houston Ship Channel flooded and sank while in the wake of tractor tug resulting in the death of the push boat crew and the narrow escape of two others. Although the investigation is not yet complete, it appears that the following occurred: The vessel’s watertight doors leading to its engine room had each been pinned open. The push boat had very little freeboard and was fully loaded with fuel and water. As it took the wake of the tractor tug, the vessel listed to one side and down flooded the engine room through a watertight door. As it rolled to the other side, it took on more water, eventually sinking stern first

Not Actual Vessel

and coming to rest on the bottom of the channel in an upright position. A person working in the engine room was trapped by the incoming water and drowned. Two others narrowly escaped death after being trapped in a berthing area for over 10 minutes, breathing only a pocket of air before taking dramatic efforts to reach the surface via a broken window.

Watertight doors function to establish the watertight integrity of the vessel and must always be treated as such. Although an open or poorly maintained door may seem like an insignificant issue, when the right causal factors align, the door can become a death trap and result in terrible circumstances to a vessel and its crew. The Coast Guard **strongly recommends** to all operators of any vessel, underway, having watertight doors to:

### CLOSE THEM and DOG THEM!
