Proceedings of the MERCHANT MARINE COUNCIL

Damage to and Loss of Lifeboats and Life Rafts

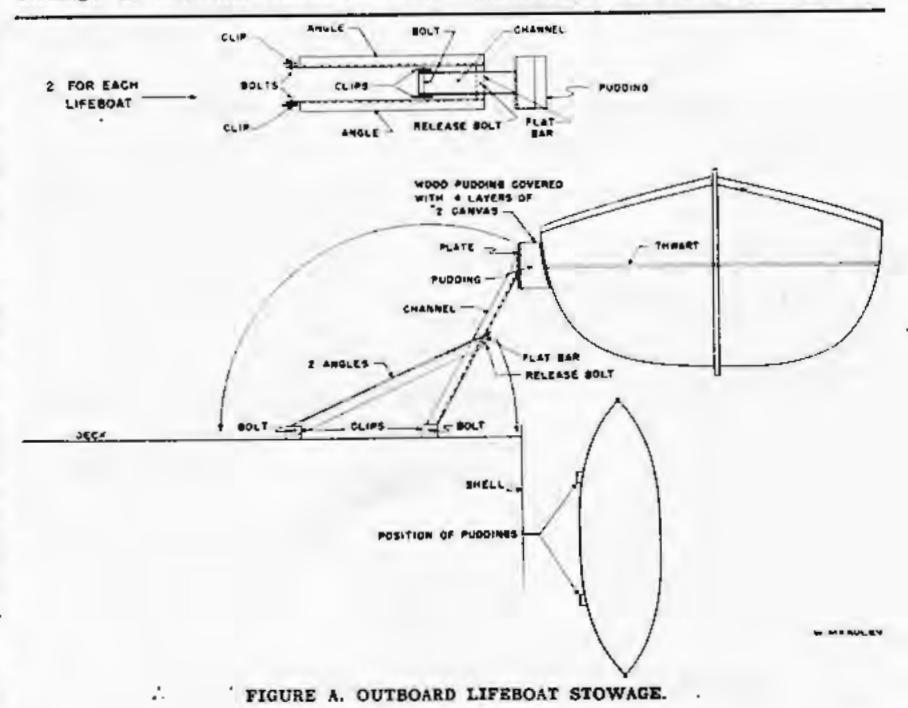
U-bolts welded directly to the deck. rails, or davits have not proved of sufficient strength for attaching any of the lifeboat securing assembly or davit guys. This may be attributed to poor welding practice, combined with the small diameter of the stock. Stay pads or pad eyes should be installed for this purpose.

Boats should be carried as high up as possible and it is recommended that means for outboard lifeboat stowage should be provided constructed of steel angles and channels with face plates and puddings attached. (See sketch A.) The puddings should be of sufficient area not less than 20 by 20 inches, well padded and properly located to meet the sheer strake of the boat in way of the thwarts. There are still a large number of vessels fitted with a pudding spar between the davits for securing boats in the outboard position, and reports indicate that many of these spars have broken during heavy weather, causing the boat to get adrift in many instances with serious consequences, and frequently the boat has been lost. It is recommended that a suitable shore or prop be fitted to the center of the spar and lodged against a clip on deck to further strengthen the spar. This shore should be attached so that it will be readily removable. (See sketch B.)

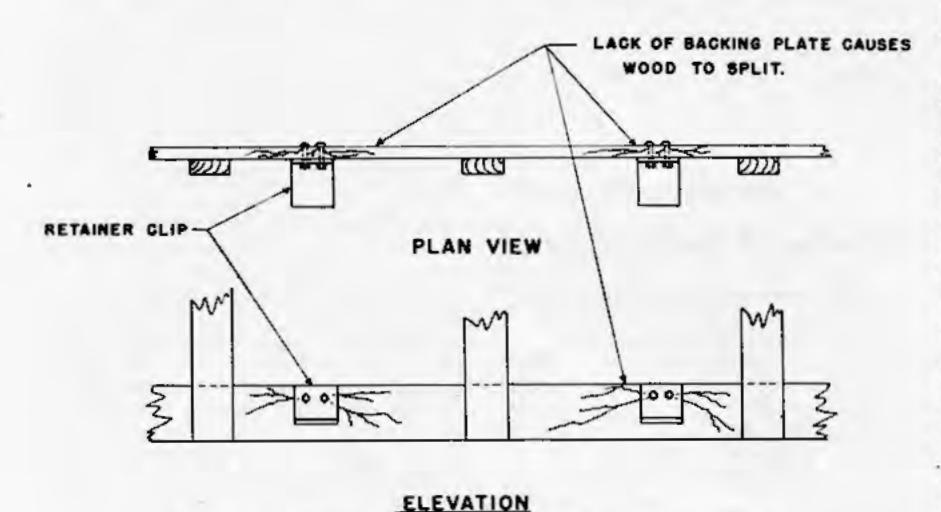
FIGURE D. RETAINER CLIPS AT UPPER END OF WOODEN RAFT.

Most life rafts have been lost overboard on account of the vessels rolling heavily during gales, with rough seas. In most cases the retaining clips at the upper end of the raft have not been sufficiently engaged and the raft has toppled over into the sea. On a number of vessels the retainer clips are fastened to the raft with lag screws or light bolts with washers. Some of the wood members to which the plates are attached were found to be split, as illustrated by sketch D. Heavier bolts with backer plates should be used.

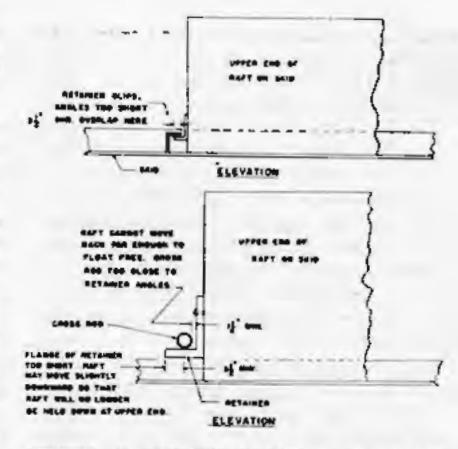
Many of the arrangements noted for securing the rafts at the upper ends were unsatisfactory. Holdingdown angles were erected from the upper cross members of the raft structure bearing tightly on the raft. In some instances the rafts had been chamfered to make them fit, and there was insufficient holding-down bearing surface. Numerous other arrangements of retaining clips at upper ends of rafts without sufficient bearing surface were noted (illustrated by sketch E).

FIGURE E. FAULTY RETAINER CLIPS ON RAFTS.

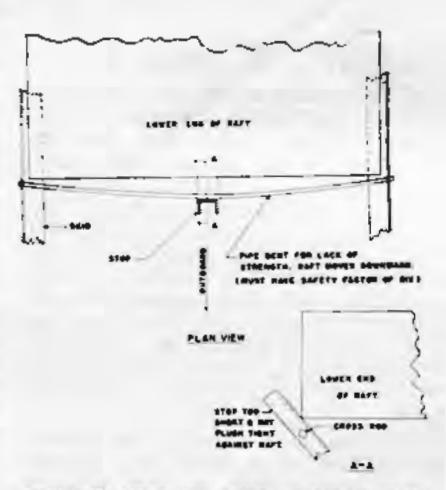
FIGURE F. STOP ATTACHED TO WEAK CROSS PIPE.

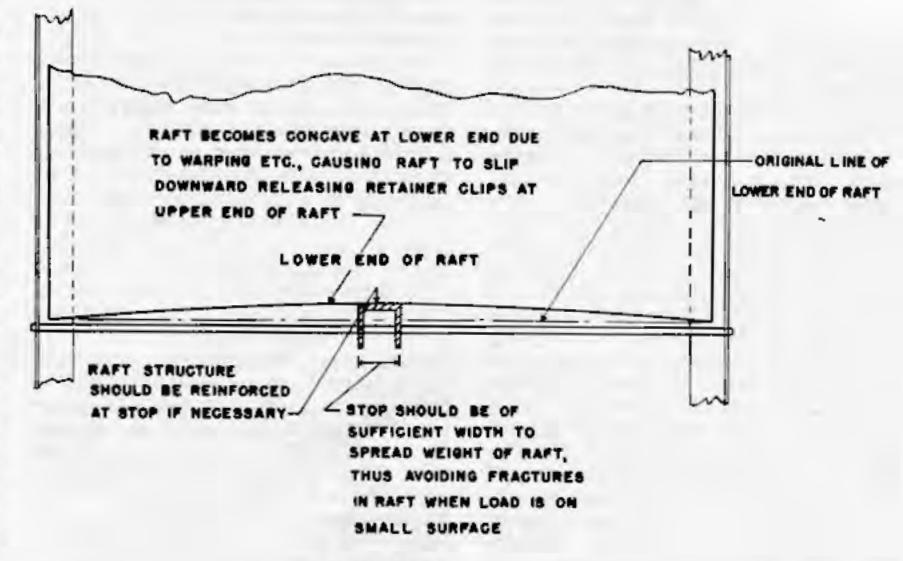
The main reason for the loss of life rafts overboard is that, combined with the limited overlap of the clips at the upper ends, the rafts have worked down on the skids, due to the following failures in the original installation: Base stop plates holding the raft on the skid not being properly seated on raft strength members; base stop plates made of iron bars, the edges of which penetrated the base of the raft; base stop plates made of angles seated on the end of the raft decking; base stop plates connected to weak revolving pins or bars which bent under the weight of the raft (see sketch F); single base stop plate resting on one light cross member of raft structure at the center, causing curvature (see sketch G); lack of strength of part or of the entire release and support assembly, consisting of chain or wire, shackles, pelican hooks, turnbuckles, and eye pads.

FIGURE G. DOWNWARD MOVEMENT WHEN RAFT BECOMES CONCAVE AT LOWER END.
