# PROCEEDINGS OF THE MERCHANT MARINE COUNCIL

Vol. 14

January 1957

No. 1

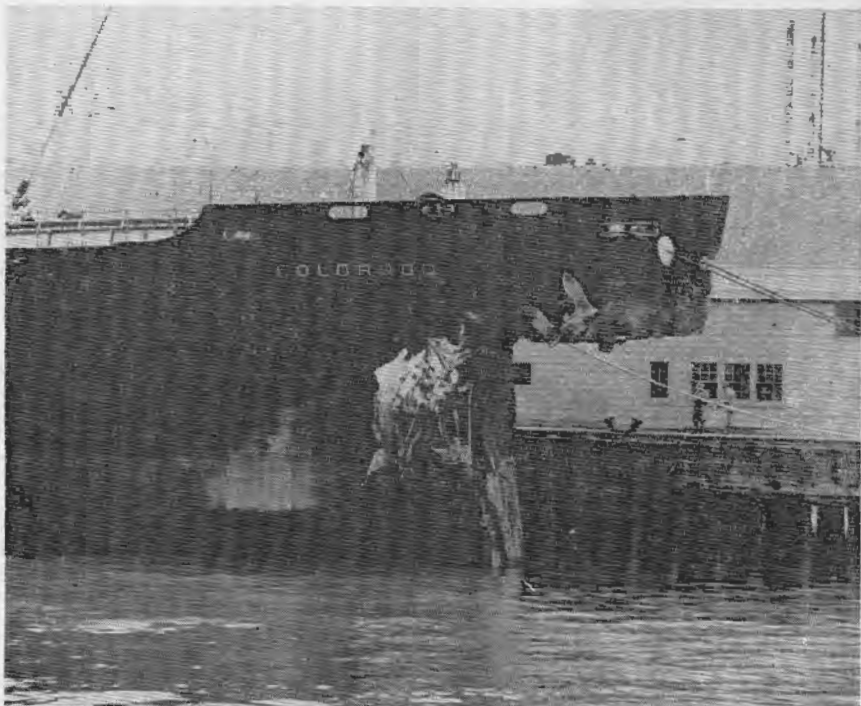
**BATTERED BOW:** An interesting picture of the radar equipped SS Colorado prior to start of repair work following collision with the SS *Permanente Silverbow* off the coast of California.

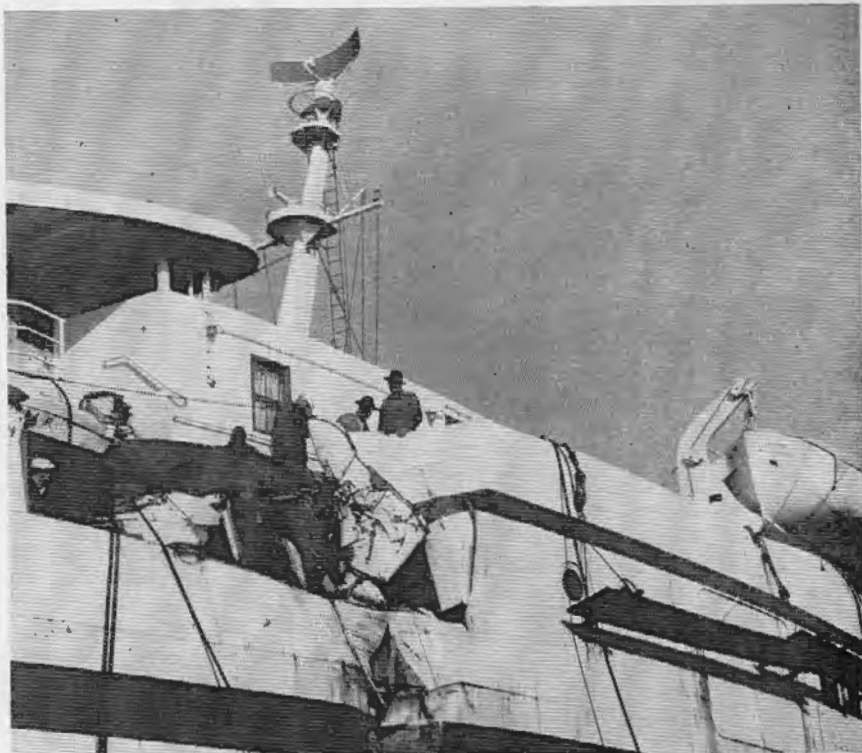
**RADAR EQUIPPED:** Port side view of the MV *Chinook* after collision in the Puget Sound. Note radar mast and antenna with unobstructed sweep of the horizon.

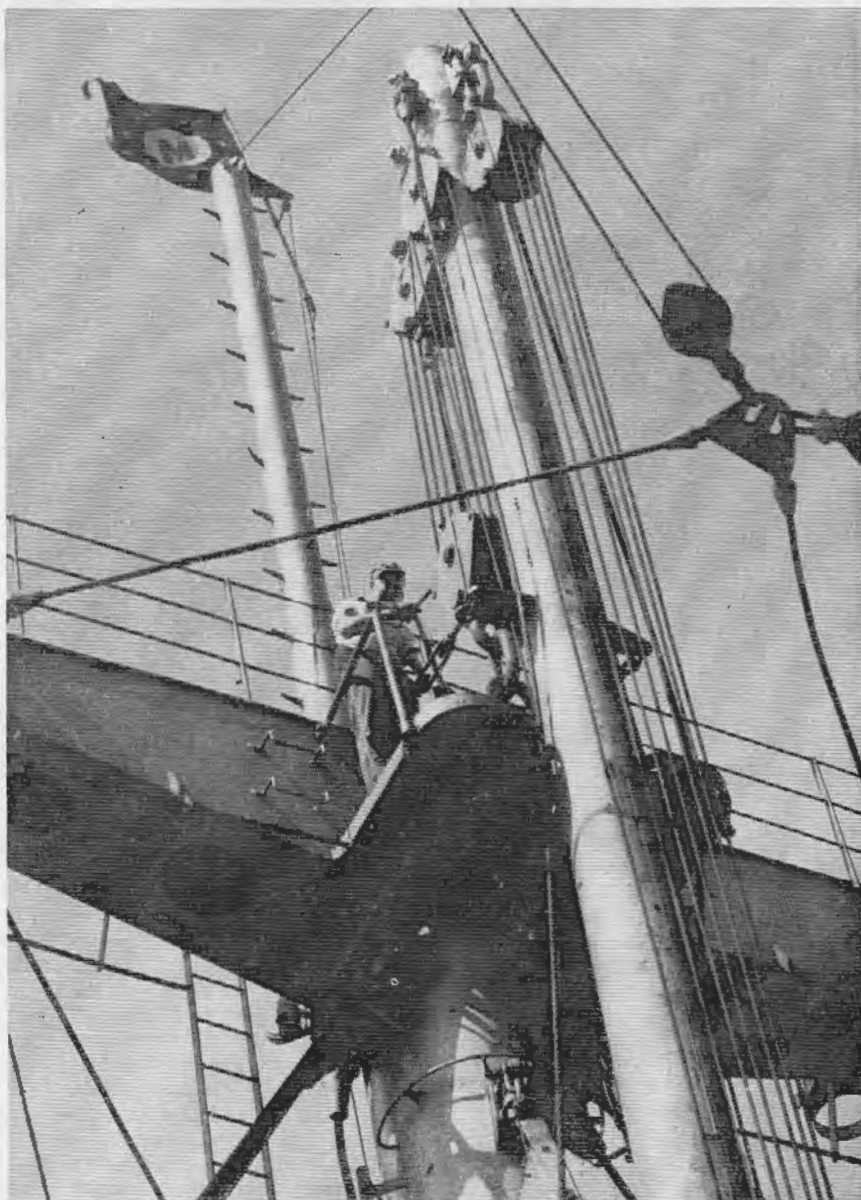
In this case the deck department was securing a 30-ton heavy lift boom at #4 hatch. The bosun was directing the operation and handling the winch controls for the topping lift winch. As the boom neared the vertical, the two men stationed aloft shouted for him to stop. Apparently he did not hear the warnings and continued to heave in. The three-quarter inch wire parted under the terrific strain and the boom crashed to the deck below. Fortunately, all hands scrambled to safety and no one was injured. Repairs to the boom were necessary and a new topping lift wire had to be rove.

No doubt the bosun was an experienced man, but his attempts to supervise and manipulate the winch controls at the same time were ill advised. His station should have been where he could have observed all phases of the operation.

Figure 1. Seaman shown aloft preparing to let go turnbuckles securing 30-ton boom on Victory type vessel. Note number of parts at moving block.

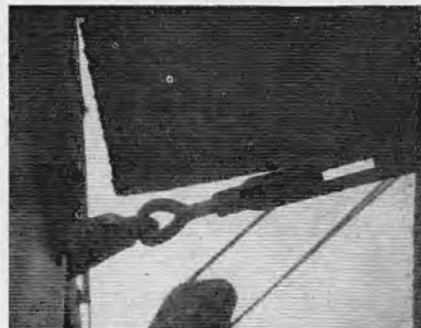
Figure 2. Closeup shows topping lift swivel bracket pulled off its foundation.

involving two Mariner vessels. These ships literally pulled the topping lift swivel brackets off their foundations. (See figure 2.)

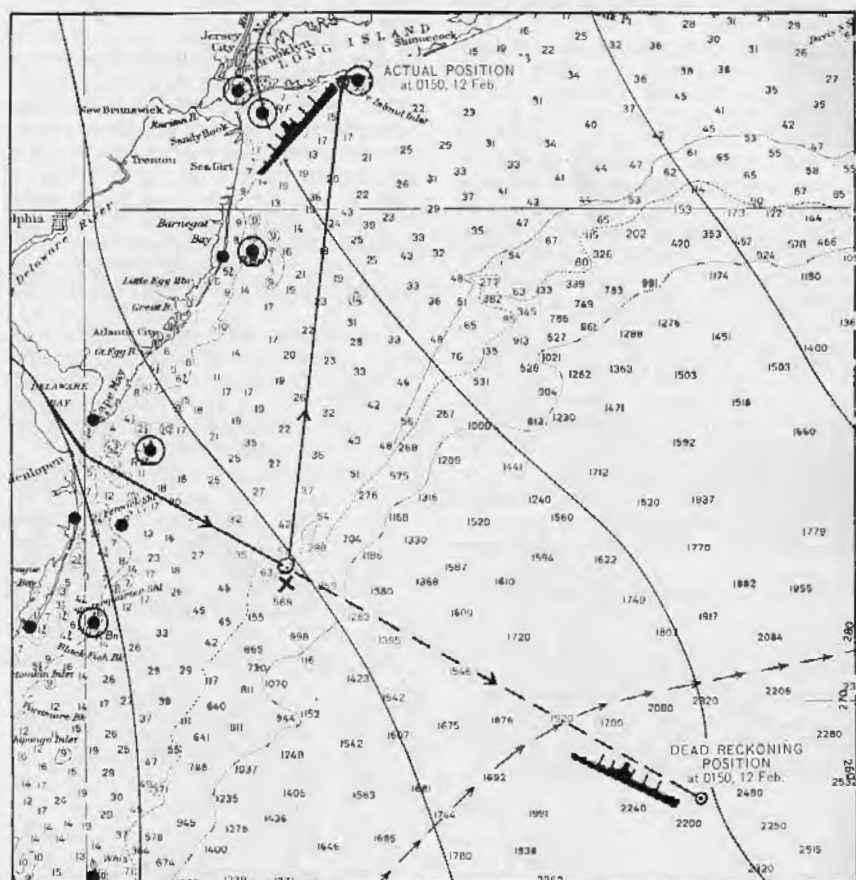
Shortly after taking departure the vessel steadied upon 118° by gyro compass, which, based on comparisons made under pilotage, was considered a true heading. Ten minutes after this course was set the gyro repeater system failed. The repeaters froze on 118°. In approximately fifteen minutes the temporary derangement had corrected itself so the repeaters were again functioning, but were out of synchronism with the master gyro compass.

A seaman steering by the gyro repeater had thought it was unusual that the heading did not change for almost 15 minutes but he failed to report it to the mate on watch. The wind now was logged from the starboard bow about two points forward of the beam. Previously the wind had been noticed on the port bow, but this vital clue to a large change of course

Figure 1. This reproduced section of an East Coast chart illustrates courses followed by tanker to its stranding on Fire Island. Solid line shows courses vessel actually followed. Dotted line is course ship's officers thought vessel was on.

The value of the lesson to be learned from this casualty is obvious. This vessel plunged through the dark February seas without the Master or deck officers exercising a fundamental principle of good seamanship. **DON'T LET IT HAPPEN TO YOU!**
