Proceedings

of the Marine Safety Council

Vol. 44, No. 6

June 1987

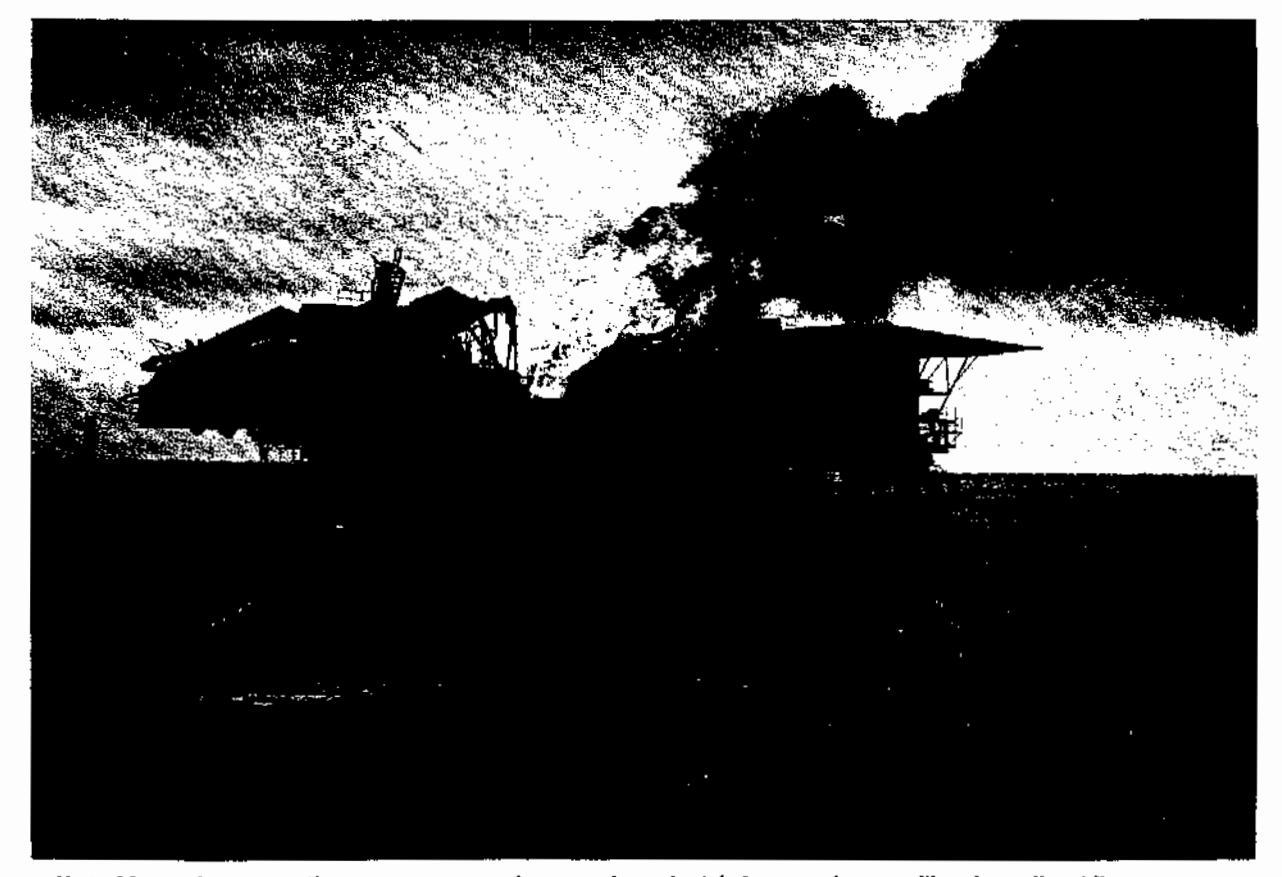
Up to 14 vessels were on the scene at any one time to assist Red Adair Company in controlling the well and fire. (Official U.S. Coast Guard photo)

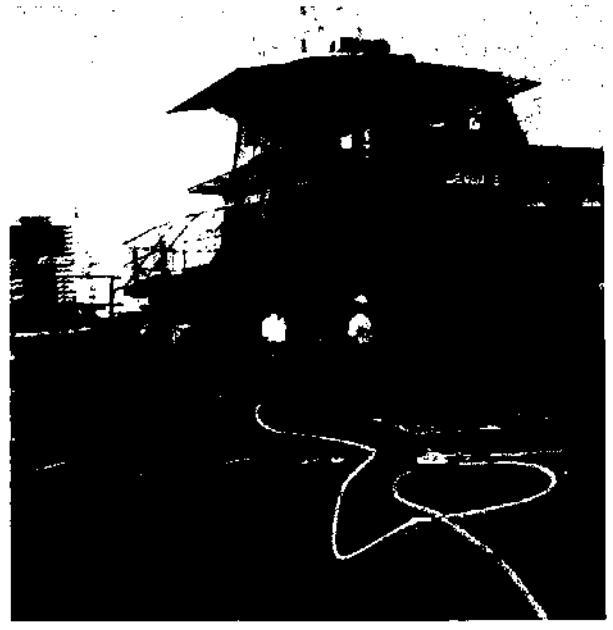
The tug Jenna B, port side. (Photo courtesy of the author)

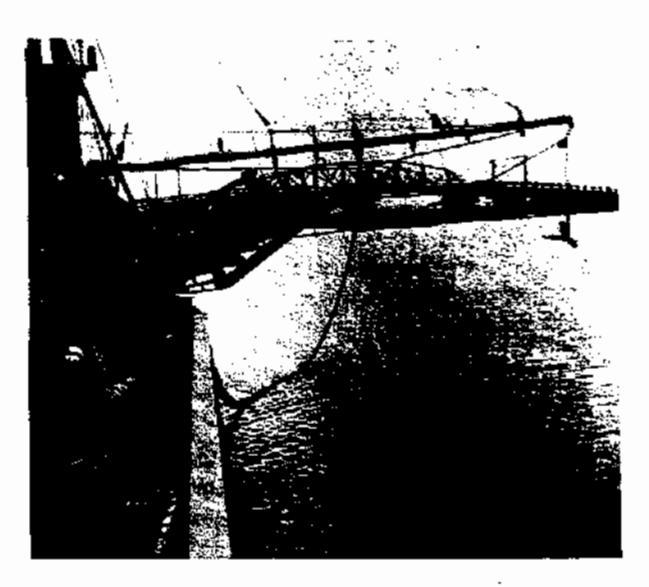
As the deckhand fell, he struck his head sharply against the dredge's steel frame. His body slipped through the dredge's latticework and landed in the water. The seamen yelled in the direction of the pilothouse and then sprinted for the vessel's stern, grabbing a lifering. He tossed the ring into the water, but the deckhand was unconscious.

Starboard clam dredge on the fishing vessel from Case 1, looking forward. (U.S. Coast Guard photo by LTJG R. L. Terry)

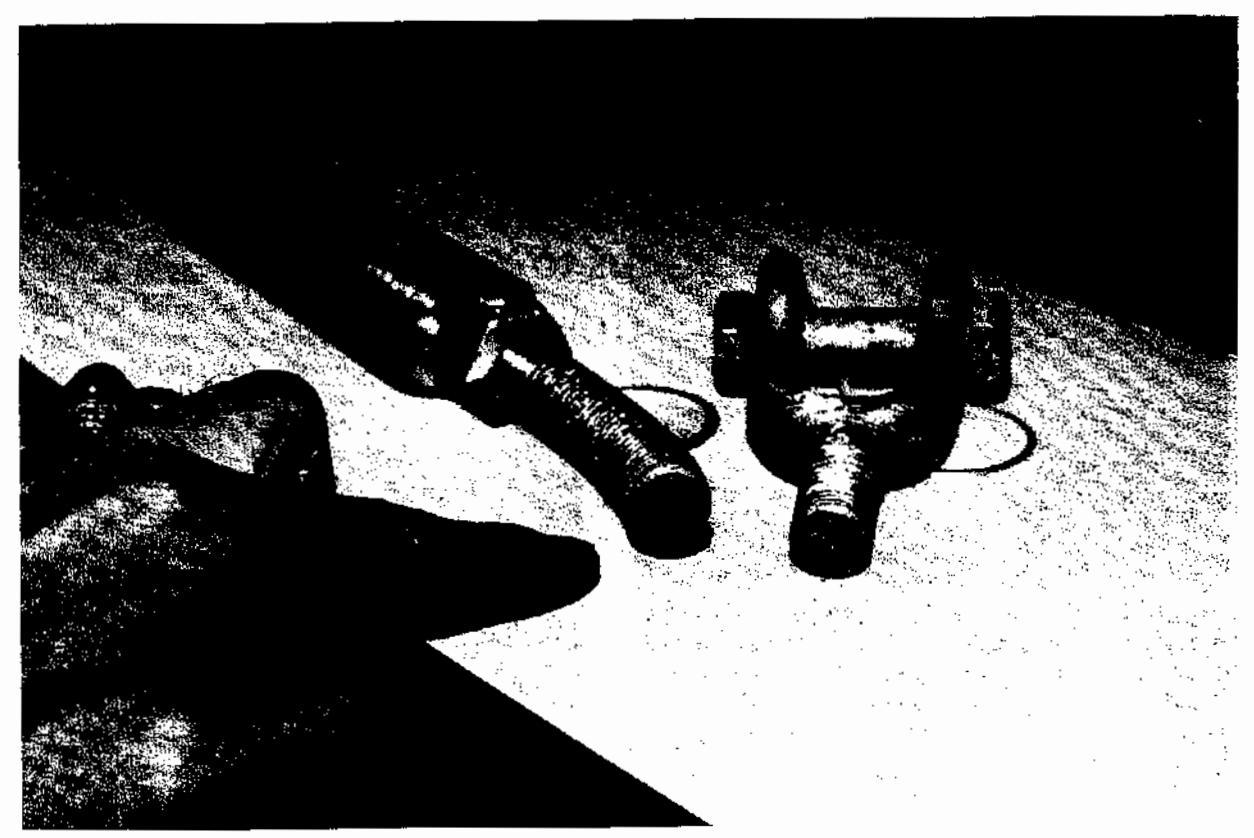
Fractured turnbuckle from the lifeboat in Case 2. (U.S. Coast Guard photo by the author)

There was a loud bang. The turnbuckle on the forward gripe, progressively weakened by the earlier releases of the falls, finally suffered material failure and parted when the boat's entire weight fell into the gripes. The lifeboat tipped outboard, and the bow keel fell off the davit block. The bow slid down the davit, allowing the stern to slip out of the after gripe. The lifeboat fell 30 or 40 feet toward the water, throwing the seaman clear of the vessel on the way down. He was pulled out of the water and taken to a hospital, where he was treated for broken ribs, severe bruising, and a wrenched back. Damage to the boat was estimated at \$10,000.

The statistics show us that working over the side too often results in death and injury. What can we learn from the two cases illustrated in this article? First, workers should check to see if equipment can be brought up on deck or put down in the water before work is begun. If this is not possible, then all persons working over the side should wear lifejackets. Finally, never trip a lifeboat's releasing gear lever unless the boat is in the water.

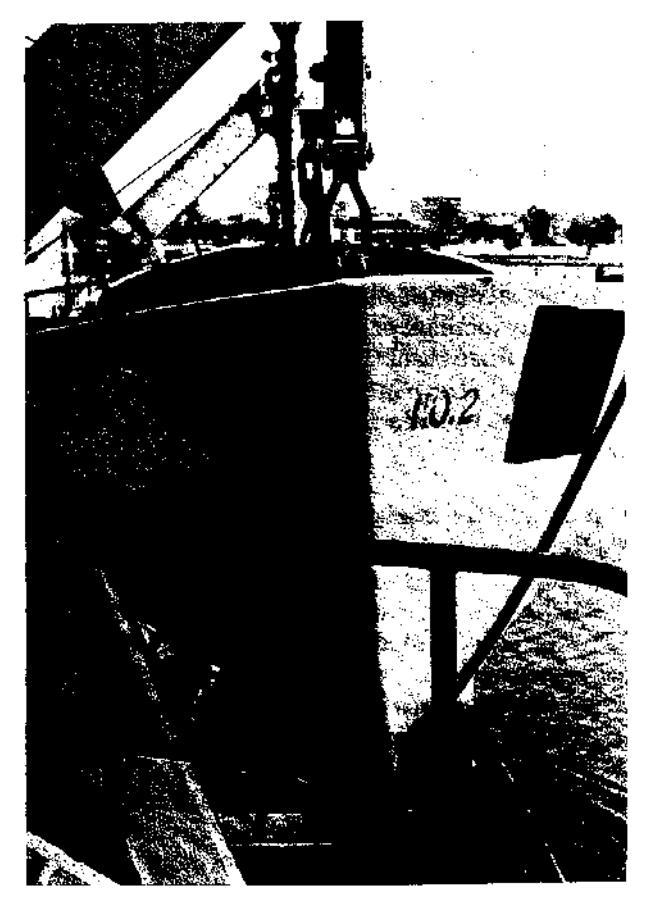
Port lifeboat stowed in its davits on the vessel in Case 2. The gripes wrap around the boat to assist the falls in holding the boat against the davits. (U.S. Coast Guard photo courtesy of the author)
