# Proceedings

July/August 1987

# The Fall and Rise of the Barge 45

# Bridge Collision Accidents in St. Louis Harbor

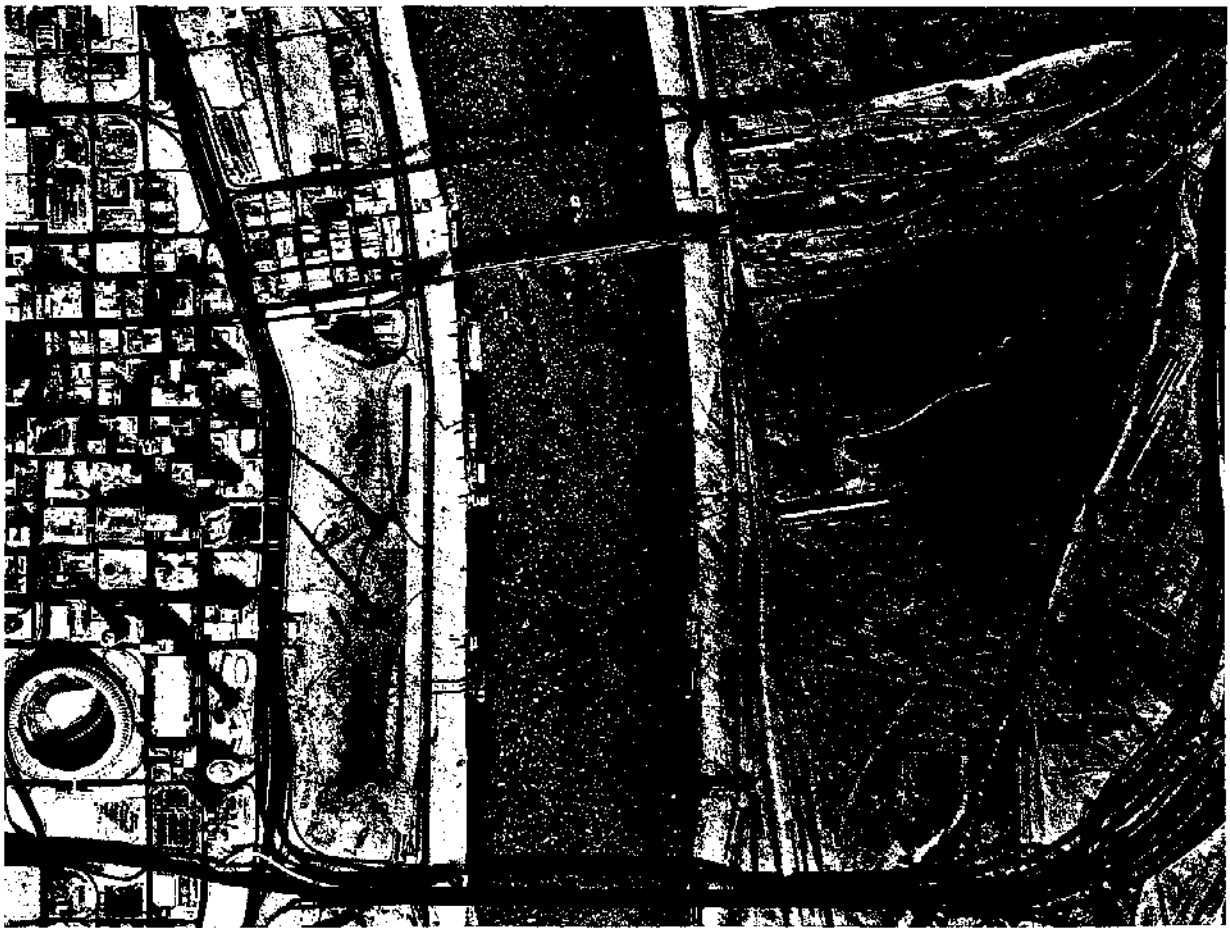
Adding to the navigation difficulties of the downbound operator is a set in the current, encountered immediately above the Martin Luther King Bridge, which runs from the Missouri shore toward the Illinois shore. This set is much more pronounced when the St. Louis gage reading exceeds 20 feet. The photo shown on the next page, taken when ice was present in the river, illustrates this set.

This aerial view of ice in the Mississippi River illustrates the set in the current immediately above the Martin Luther King Bridge. (Photo courtesy of U.S. Army Corps of Engineers, St. Louis)

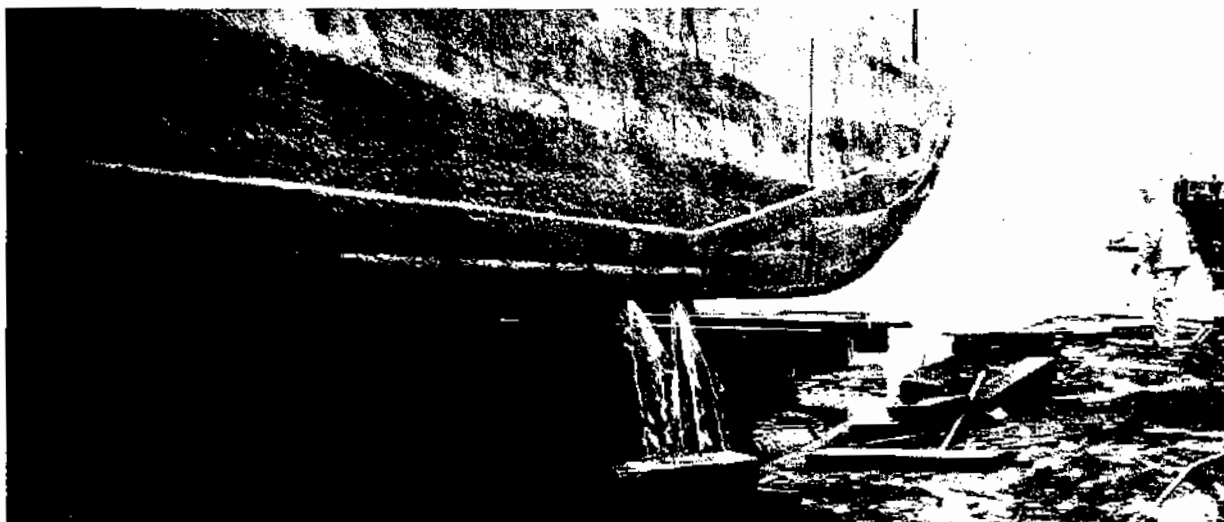
Water drains from the wing tank after the barge was salvaged and hauled out. (Photo courtesy of the author)
