Marine Accident Report

Report on the investigation of

the fire onboard

Star Princess

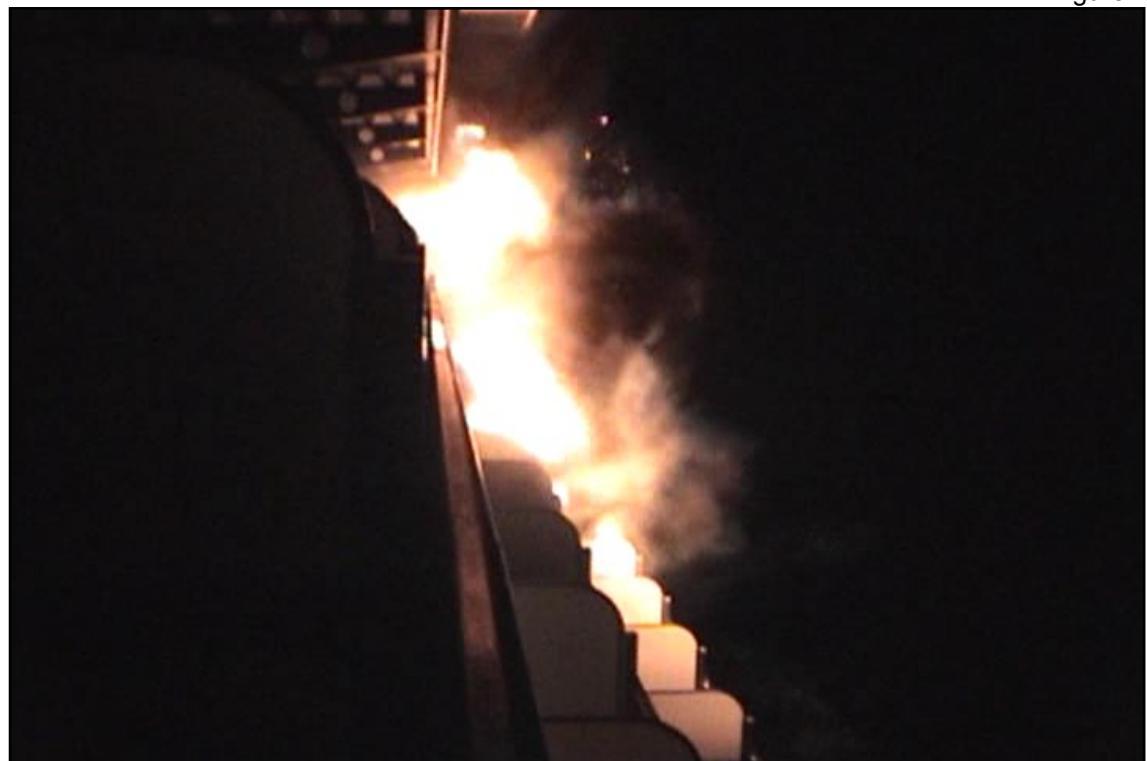
Figure 2

Still from video taken at 0311

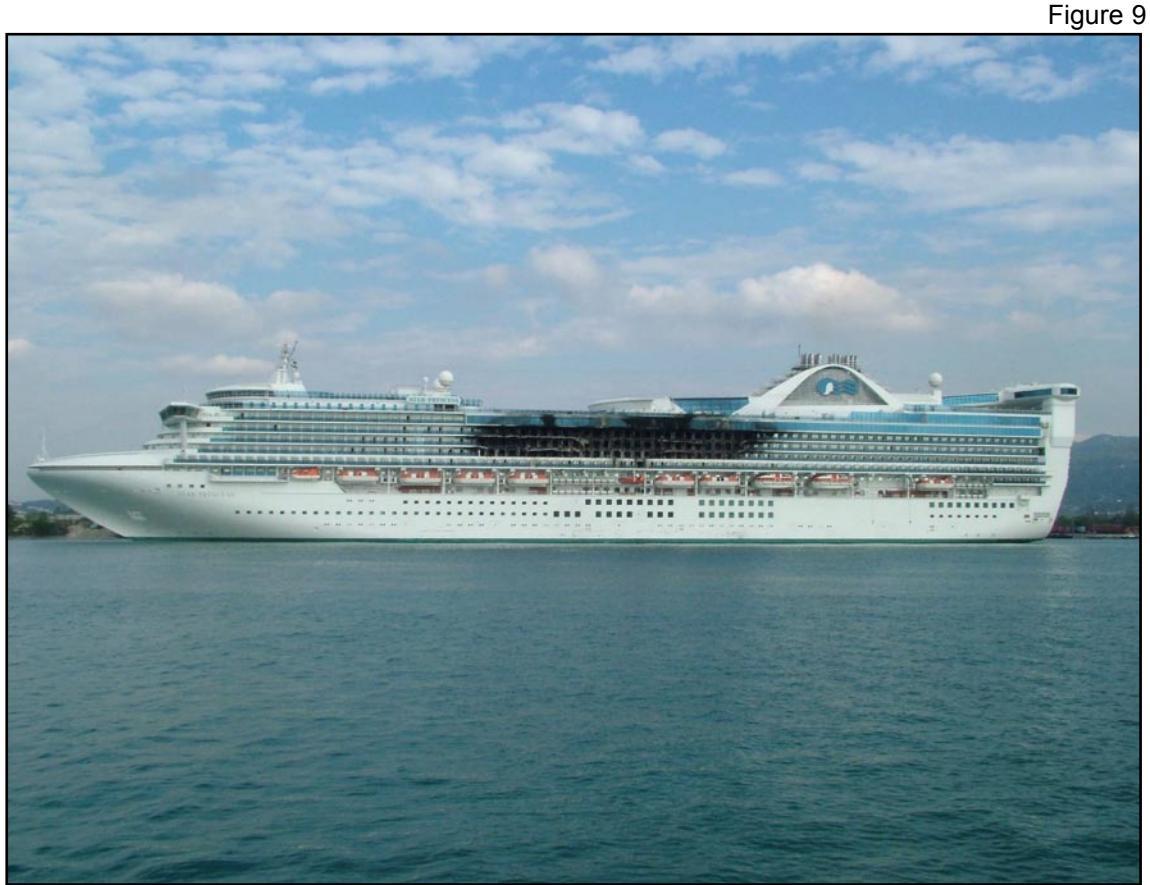
Extent of damage on ship's port side

Fire damage extended over the balconies and outboard staterooms in the central third of the ship's length, in Fire Zones 3, 4 and 5 on the port side (**Figure 9**). The most severe damage was on decks 10, 11 and 12 (**Figure 10**) in which 79 outside staterooms were seriously damaged by fire. A further 218 were damaged by fire, smoke, or water. One balcony on deck 9 was seriously damaged by fire, and numerous others sustained minor damage caused by falling debris. Semi enclosed public areas on the port side of deck 14 were damaged by heat and smoke (**Figure 11**). Minor smoke damage and debris of the products of combustion was evident on deck 15.

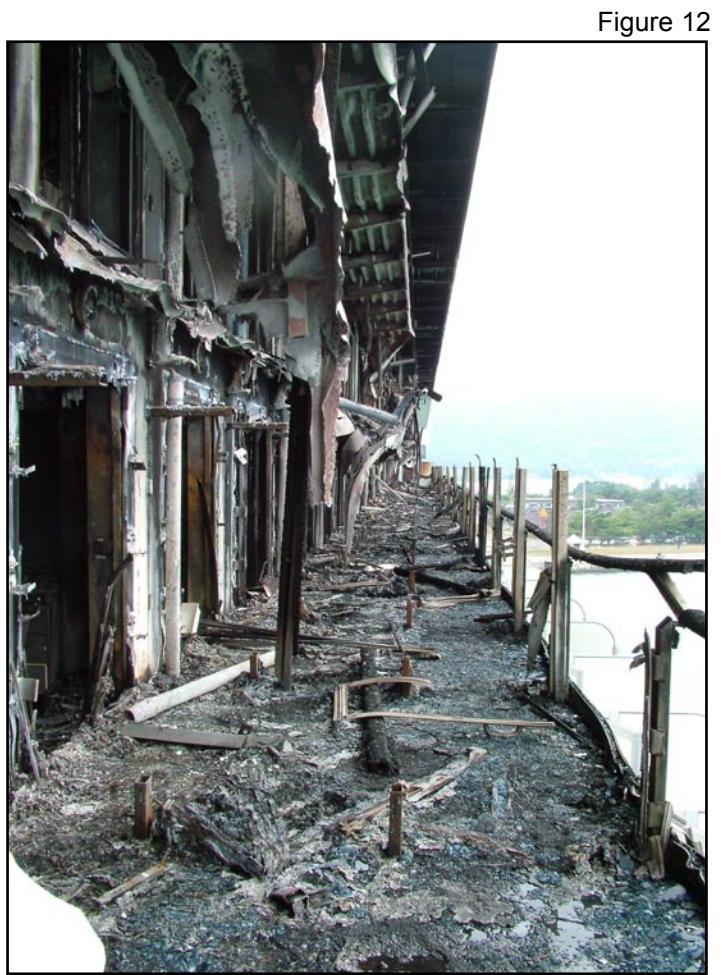
Melted aluminium structure

The fire generated sufficient heat to melt the aluminium structure of decks 11 and 12 (Figure 12). The heat also caused glass in the balcony balustrades and doors to shatter, which allowed the fire to penetrate into the outside staterooms (Figure 13).

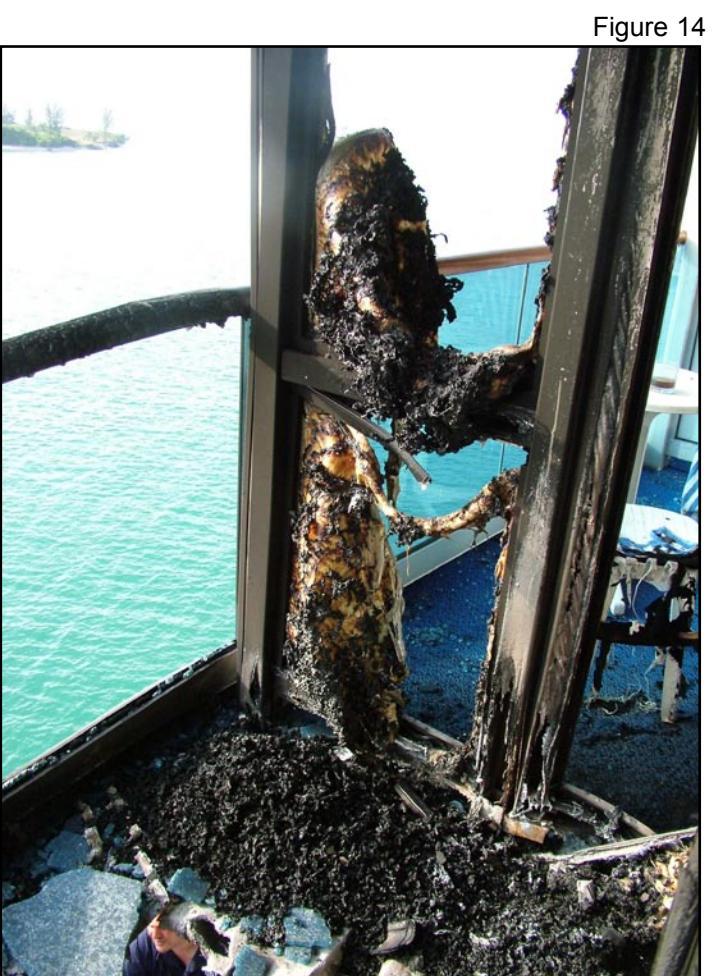
Melted polycarbonate partition

At the outer boundaries of the damaged areas, the balcony partitions were charred and melted, and sagged under their own weight (Figure 14). Where this occurred, it was possible to see that the partitions had burned before their aluminium frames distorted. In all other places, the partitions were reduced to ash and their frames partially or totally melted. The plastic furniture and deck tiles were mostly reduced to ash within the fire affected area, and were melted and scorched at its outer boundaries (Figure 15). The only electrical fitting provided on each of the balconies was an exterior light sited over the balcony doors. There was no evidence of any electrical failure or arcing on these fittings.

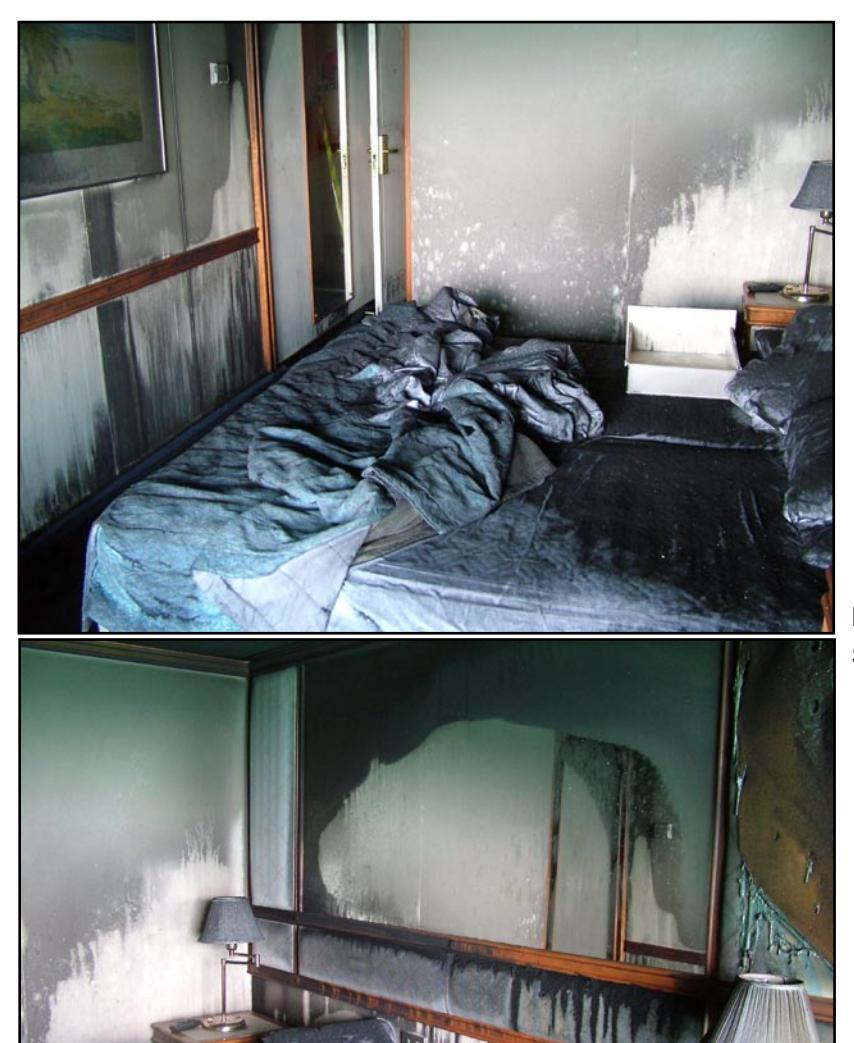
Figure 16 and 17 Soot in stateroom interior

Fire damage in the staterooms was worst immediately inside their balcony doors, and reduced towards their interior. A rapid reduction in temperature was shown by undamaged chocolates found on many bedside tables, and bedding and furnishings, which looked charred (Figures 16 and 17), but were in many cases only stained with heavy soot washed from the smoke by the water mist.

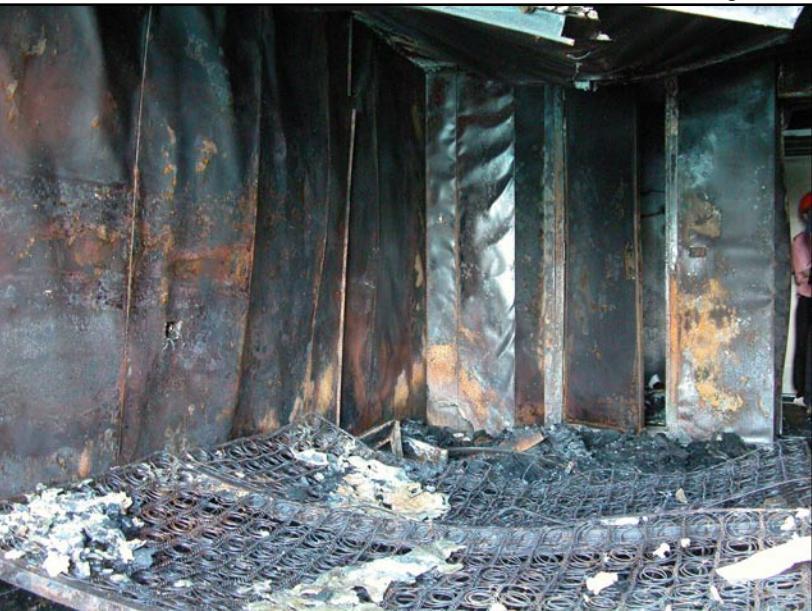
Stateroom C510

The most severe damage to a stateroom was in C510 (**Figure 18**), where the water mist head was found on the deck, having failed to activate. The heat generated had buckled the stateroom's deckhead panels, and its door to the alleyway was also badly buckled and very nearly breached.

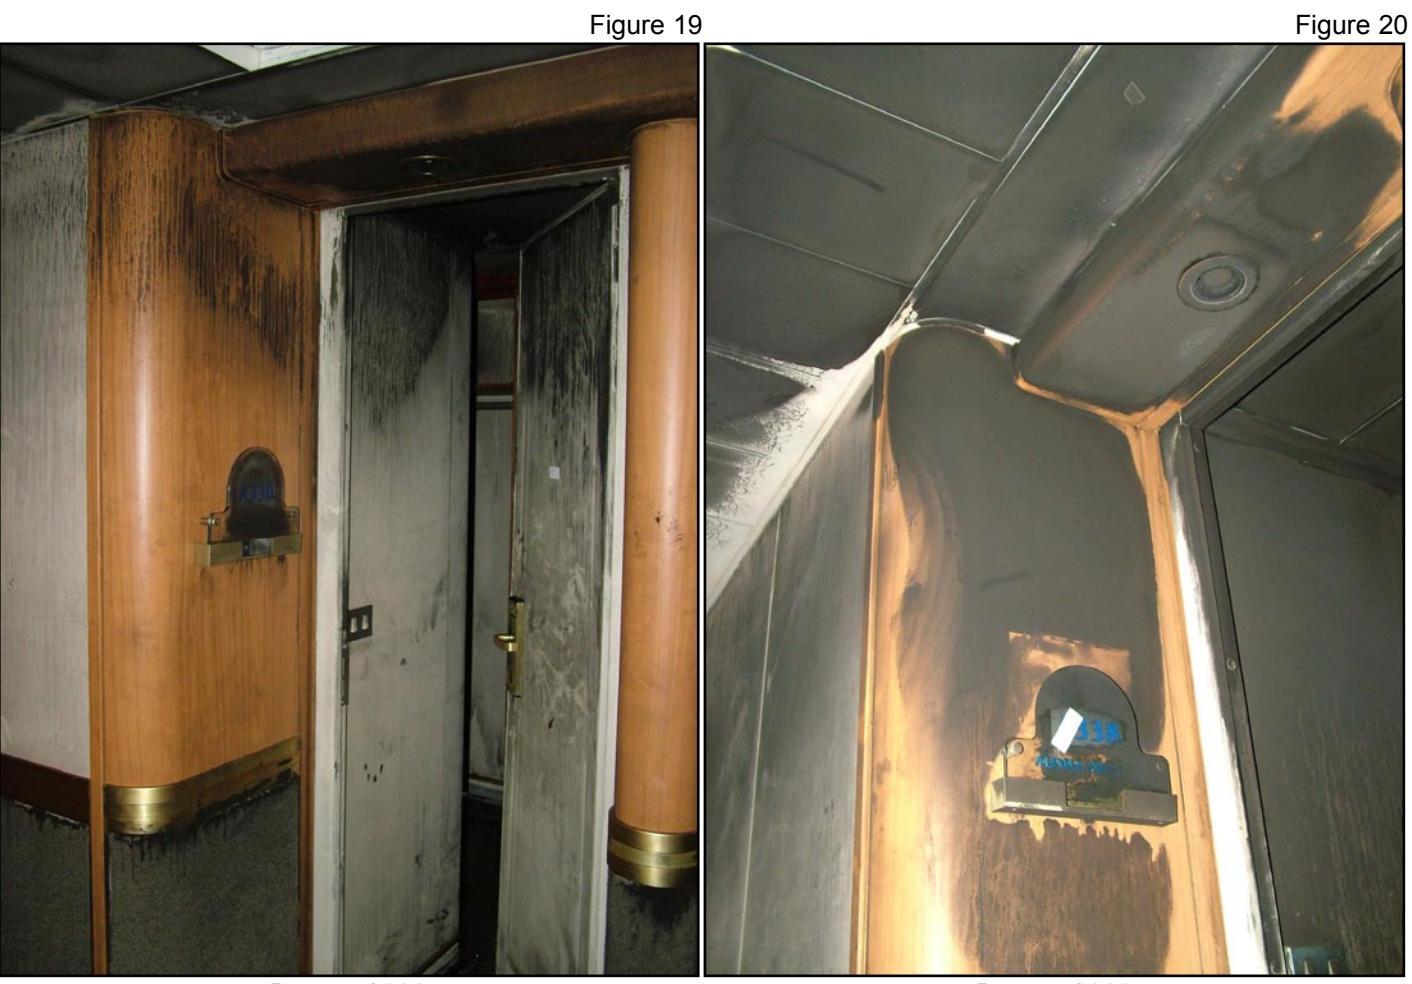
Soot deposits indicated that smoke entered the ship and reached internal alleyways in accommodation spaces through staterooms via open balcony doors. **Figures 19 and 20** show the soot deposits outside the entrance to staterooms of A330 and A338. The stateroom door of the latter was held open due to the insertion of a wedge in its self-closing mechanism. Although soot stains were evident in zone 3 on deck 12, they were less evident in zone 4 (**Figure 21**).
