United States Coast Guard

INVESTIGATION INTO THE CIRCUMSTANCES SURROUNDING THE PARASAILING ACCIDENT ON THE TIED HIGH 0.5 MILES OFF THE COAST OF OCEAN ISLE BEACH, NORTH CAROLINA ON AUGUST 28, 2009 WITH MULTIPLE LOSS OF LIFE

ACTION BY THE COMMANDANT

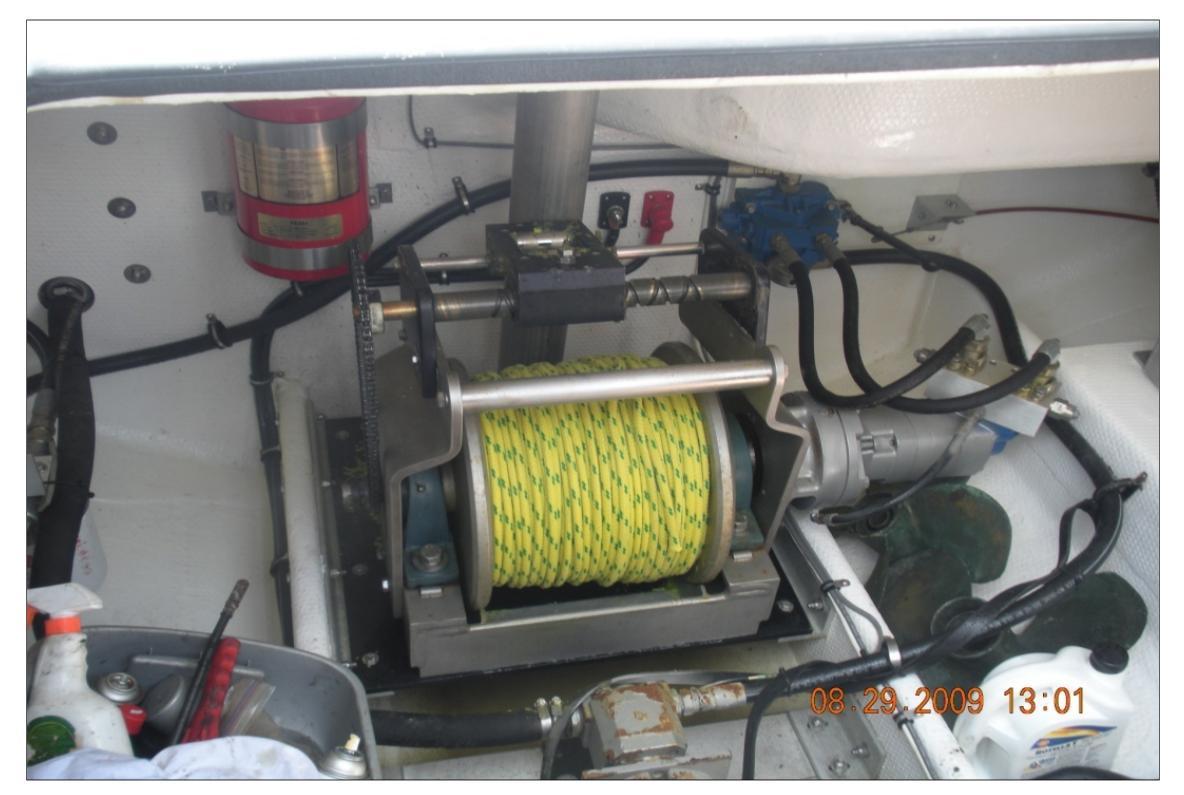
17. While waiting for assistance, the master stated he opened the engine room hatch door to see if the winch was malfunctioning and to check the hydraulic lines for any leaks, but detected nothing out of the ordinary. He also paid out additional towline to see if the hydraulic fluid was circulating, and the system responded properly. During testimony, the master stated that after running these basic system checks, he was confident the winch was still in good working order but that its recovery capacity had been exceeded.

Figure 4. Picture of the winch, hydraulic system, hoses and towline onboard the TIED HIGH

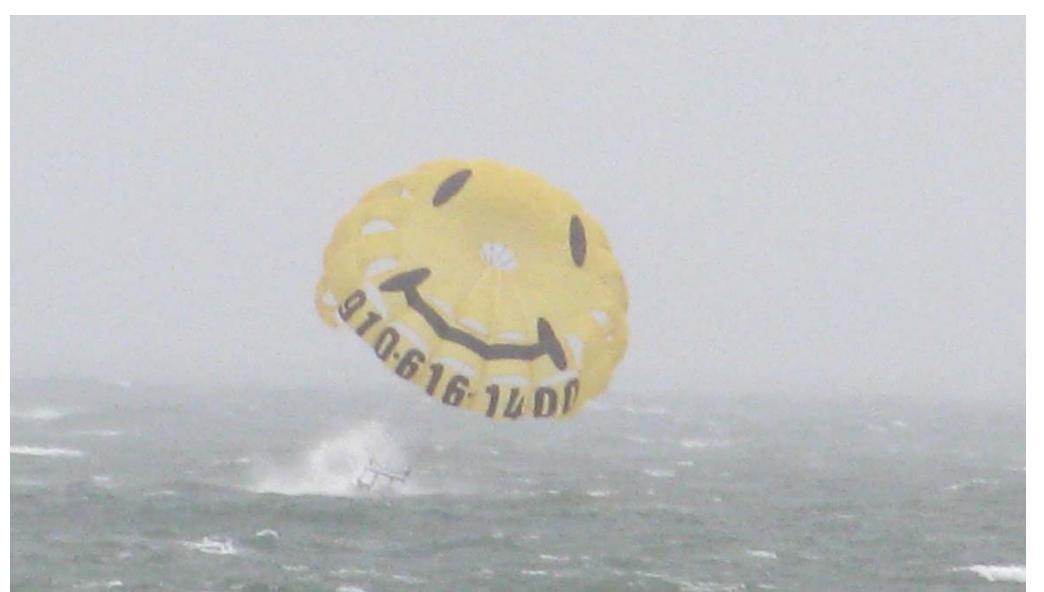
18. After completing basic hydraulic winch system checks, the master called the owner again to get an estimate as to when the owner and assist boats would be arriving on scene to render assistance, and to emphasize that the situation was dire. During the conversation at about 1351, the vessel's towline parted at the bowline knot and Mrs. Shoup and Mrs. Woodcock were carried away from the vessel as they descended upon the surface of the ocean. Upon entering the water, the still inflated parasail rapidly dragged the two passengers backward along the surface of the ocean. Winds at this time ranged from 23 to 34 mph with gusts upward to 40 mph. Seas were choppy with waves four to six feet high with an occasional eight-foot crest.

Figure 6. Witness photo of passengers being dragged across the water in heavy seas.

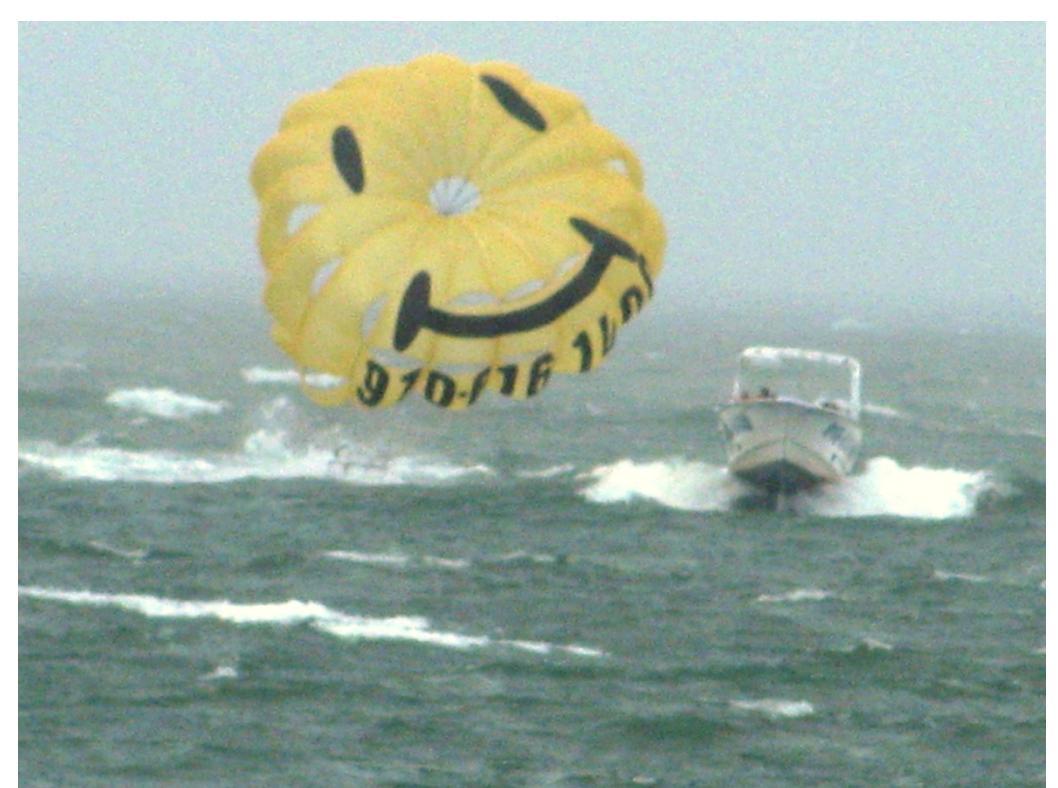
20. On the second rescue attempt, the master passed the two passengers, went downwind and positioned the TIED HIGH perpendicular to and in way of the passengers' expected path. However, the two passengers collided with the side of the vessel and the parasail bridle and gear became entangled in the aluminum superstructure. The master grabbed hold of the passengers, but was forced to let them go moments later as the TIED HIGH rolled to port and again almost capsized due to the wind and inflated parasail.⁶ The passengers cleared the vessel and continued their advance through the waves toward the Ocean Isle Beach Fishing Pier. The master went back to recover the deckhand and then gave chase after the two passengers again.

Figure 7. Witness photo of second rescue attempt just before the two passengers collided with the TIED HIGH

⁶ During the hearing, the vessel master described the two passengers' impact with the TIED HIGH as a glancing blow. The passengers aboard the vessel said the two women struck the TIED HIGH with extreme force. However, the witnesses who testified at the hearing stated the women appeared to be dead or unconscious prior to the collision.

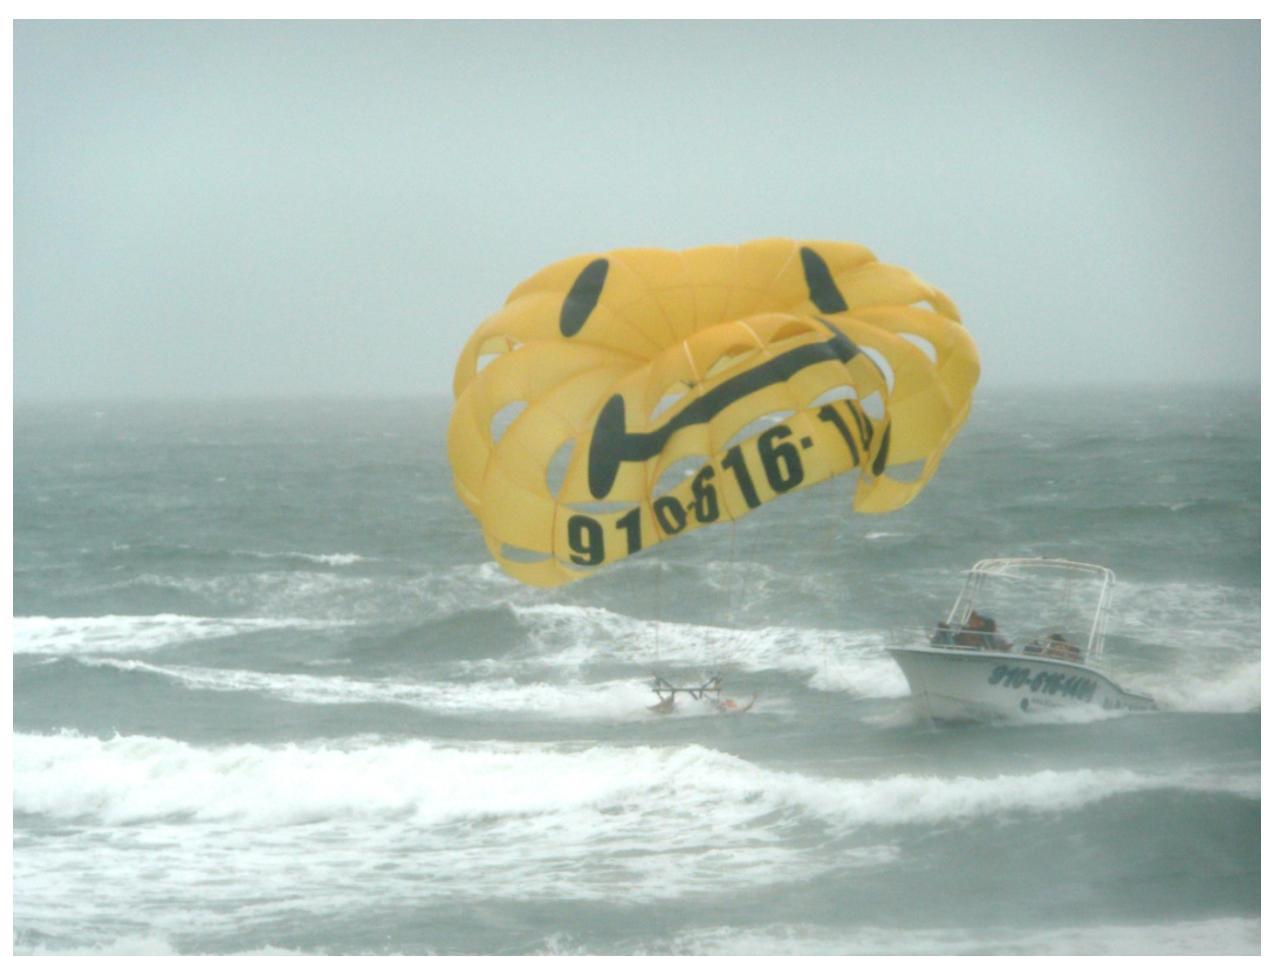
Figure 9. Witness photo 2 of the third rescue attempt. Picture shows deckhand clinging to harness bar with several shroud cords having been cut.

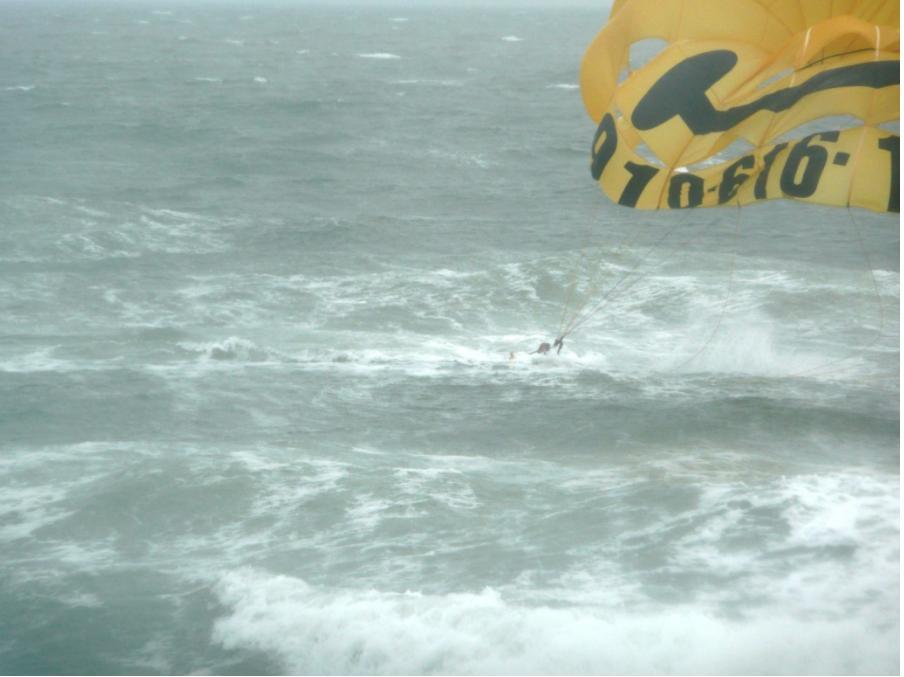
Figure 10. Witness photo 3 of the third rescue attempt. Most of the shroud cords have been cut by the deckhand and the canopy is starting to deflate.

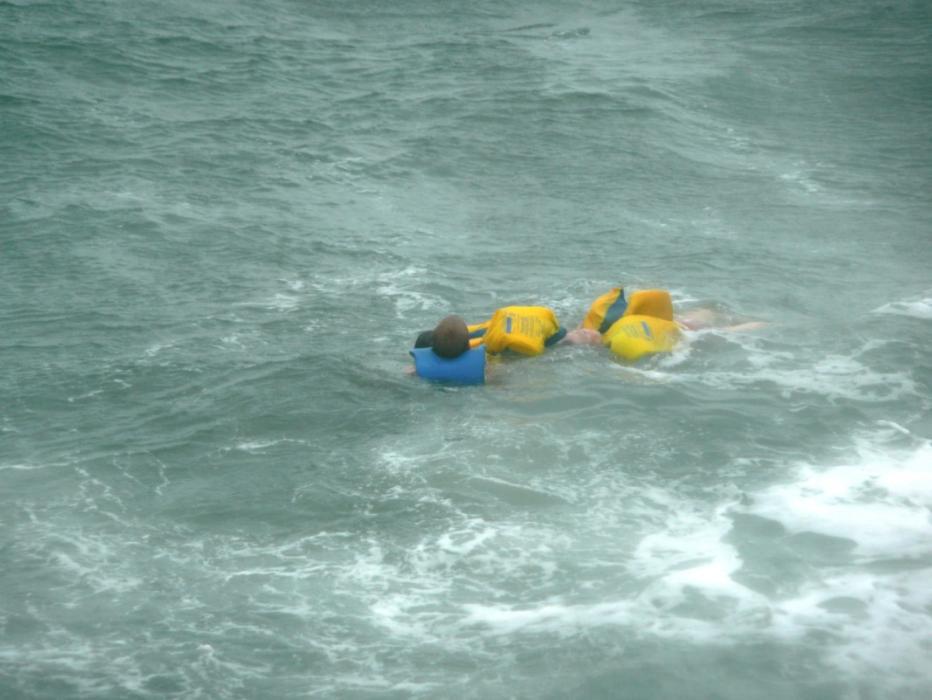
Figure 11. Witness photo 4 of the third rescue attempt. Deckhand recovers passengers and is adrift near the Ocean Isle Beach Fishing Pier.

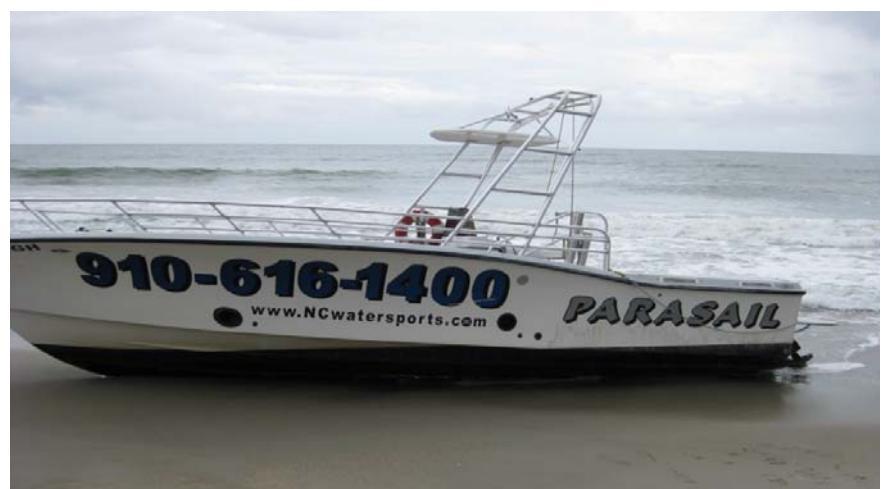
master intentionally grounded the vessel approximately 50 yards east of the Ocean Isle Beach Fishing Pier.

Figure 12. Picture of the TIED HIGH aground post incident

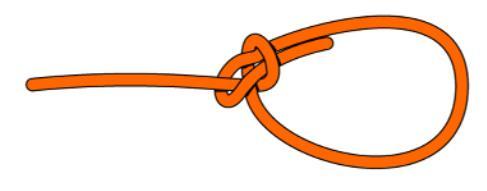
73. The towline onboard the TIED HIGH was fastened to a towing yoke on the riser using a basic "bowline knot" and the other end was secured to the winch located below the deck of the parasail vessel.

Standard Bowline Knot Figure 18. Graphic of a standard bowline knot
