PROCEEDINGS OF THE MERCHANT MARINE COUNCIL MINING of this MUNITED STATES COAST GUARD MINING WITH MARINE

March 1953

MERCHANT MARINE COUNCIL

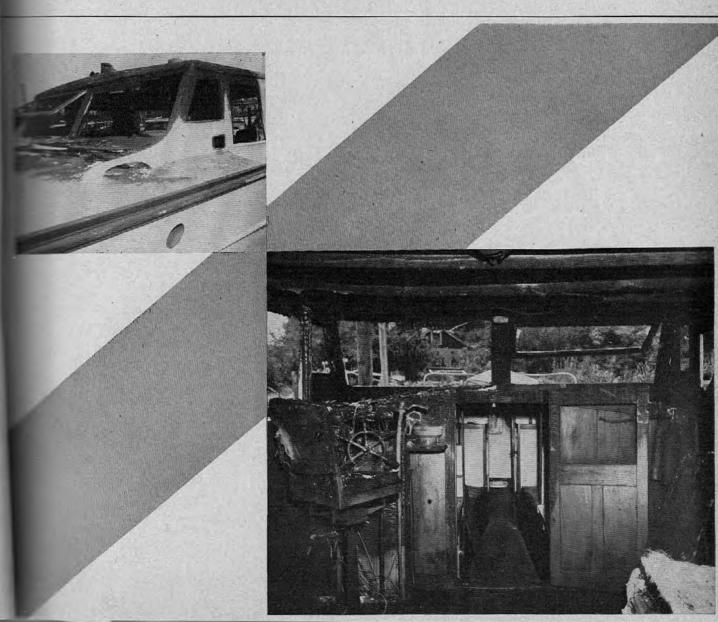
One morning a fire broke out in the cabin. A cruising police car was the first to notice the fire and summoned the city fire department, who put out the fire very quickly. But, by that time approximately \$4,100 worth of fire damage had been incurred. (See front cover.)

- Damage to the vessel consisted of: Interior and cabin burned and charred.
 - All glass windows broken.
- Foredeck partially burned. Overhead in cabin burned through

The fire apparently started behind the engine controls. It may have been caused by faulty wiring in that area. It also may have been caused by numerous other factors. No one can be certain, but, whatever the cause, one thing is very clear. Casualties can occur from the slightest cause. Instances such as this serve warning that motorboat operators must be eternally vigilant.

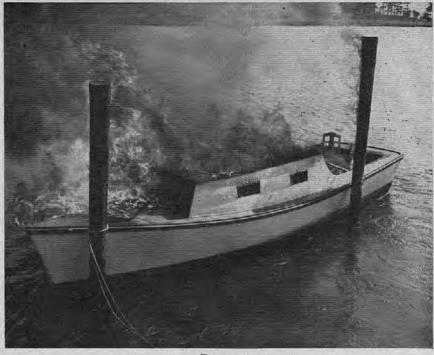
Figure 2

There is always danger of fire and explosion on gasoline propelled motorboats. (See figure 2.) The best guarantee to minimize the danger of fire and explosion occurring on your boat is to religiously adopt the recommended practices for motorboats put out by the Coast Guard or Coast Guard Auxiliary and organizations such as the National Fire Protection Association.

The owner, who was attired in bathing trunks, suffered severe burns on his legs from the fiare up of the explosion. He jumped overboard and wam to shore, where he was taken to the hospital for emergency treatment.

As for the boat, it drifted up against some pilings near the shore and was almost completely consumed, before the local volunteer fire department extinguished the fire.

Investigation of this casualty indiated that there was no gasoline in the bilges prior to the explosion. There were indications, however, that the explosion was due to the gas tank, which was in the back of the boat, opturing, or that the fuel line from the electrical fuel pump broke, causgasoline to be sprayed over the tot manifold of the engine. Most what happened was that a moken fuel line liberated a quantity gasoline over the hot engine, which was then ignited by a spark.

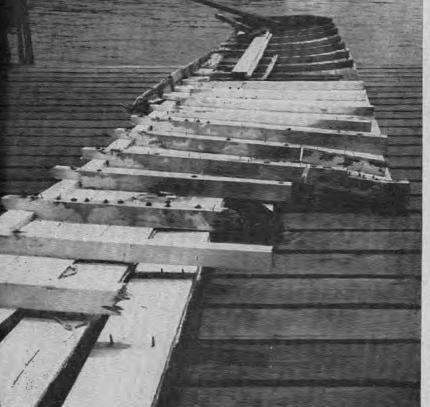
Figure 3.

A 21-foot, cabin cruiser exploded, causing injuries to the owner and the single passenger on board. Both sustained second degree burns on the arms and face. Only the strip (See figure 3) shown in the photograph was left after the explosion. Aside from the physical injuries incurred, damage was estimated to be \$2,500 to \$4,000.

When this happened, the owner decided the best way to use up the excess fuel was to get the boat underway and let the converted automobile engine, which propelled the boat, use it up. He started the engine without any incident and pulled away from the dock slowly.

When about a hundred yards off the dock, he opened up the throttle to increase the speed. The engine backfired. The cabin, which was locked at this time, blew out in a loud explosion.
