IN THIS ISSUE . . . Yarmouth Castle Report Grain Shift Hazards Public Hearing Summary Safety Legislation Examined

| FEATURES | Page |
|---|---|
| Yarmouth Castle Casualty Report | 98 |

PROCEEDING

MERCHANT MARINE COUNCE

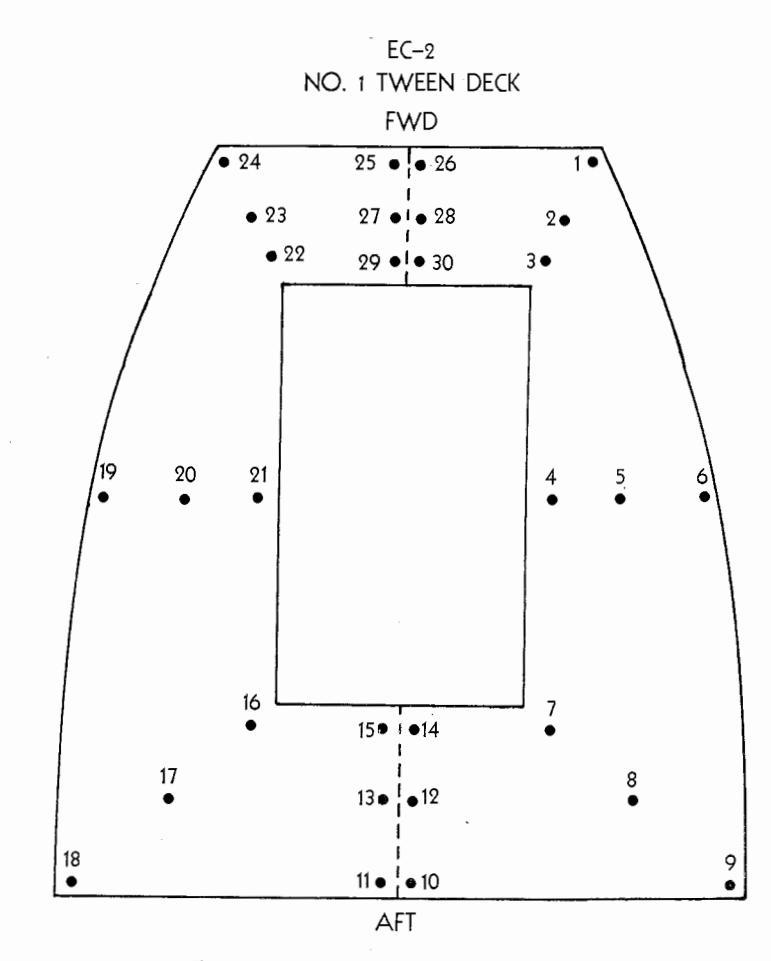
Figure 3. Pattern of measuring holes

B became apparent that the only re way to determine the presence voids under the tween decks was direct measurement. By experi**nt** conducted by the Coast Guard's -chant Marine Technical Division, **was** found that the grain surface **Id** be located accurately using an dinary carpenter's rule, inserted rough a small hole in the deck above grain surface. The States Marine thes graciously offered their "Blue **Bruss** State" for a first full-scale test, with the support of the U.S. DLAS Subcommittee, the National Bureau, the American Bureau **f Shi**pping, and the owners of three 🖛 grain vessels, a program was seloped. Small holes were drilled the tween decks of one hold in each the vessels. Measurements of the **tance** from the tween deck to the in surface were taken by the ships' cers at the completion of loading, nice during the voyage, and again at **com**pletion of the voyage. A typi**pattern** for the holes in the tween **ck** appears in figure 3.

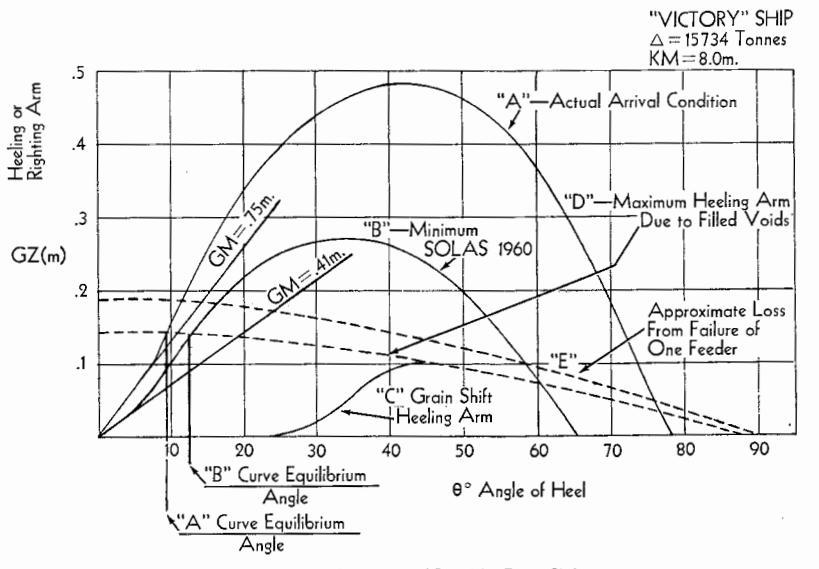
Figure 4. Righting arm loss due to grain shift

Curve "C" is the curve of *heeling* arms due to grain shifting into the voids.

As curve "C" shows, there is relatively little heeling arm developed until the vessel lists to angles near 30⁻.

Curve "D" indicates the maximum heeling arm due to complete filling of the voids. Its intersection with curve "A" and with curve "B" defines the angle of equilibrium attained under each of those conditions of initial stality. Equilibrium is at $9\frac{1}{2}$ ° with curve "A" and at $12\frac{1}{2}$ ° with curve "B"

shift of grain, the vessel may capsize when a feeder or shifting board carries away. Curve "E" in figure 4 shows the effect of additional loss of righting arm due to failure of one feeder besides filling the voids. If the vessel in the study had only the minimum GM needed to satisfy the requirements of the 1960 Convention, it might then capsize.

Stability Effect of Possible Grain Shift
