# Review of Marine Casualties . . Marine Casualty Statistics . . .

November 1968

# A REVIEW OF MARINE CASUALTIES 1968

Captain Winford W. Barrow USCG Chief, Merchant Vessel Inspection Division, Headquarters

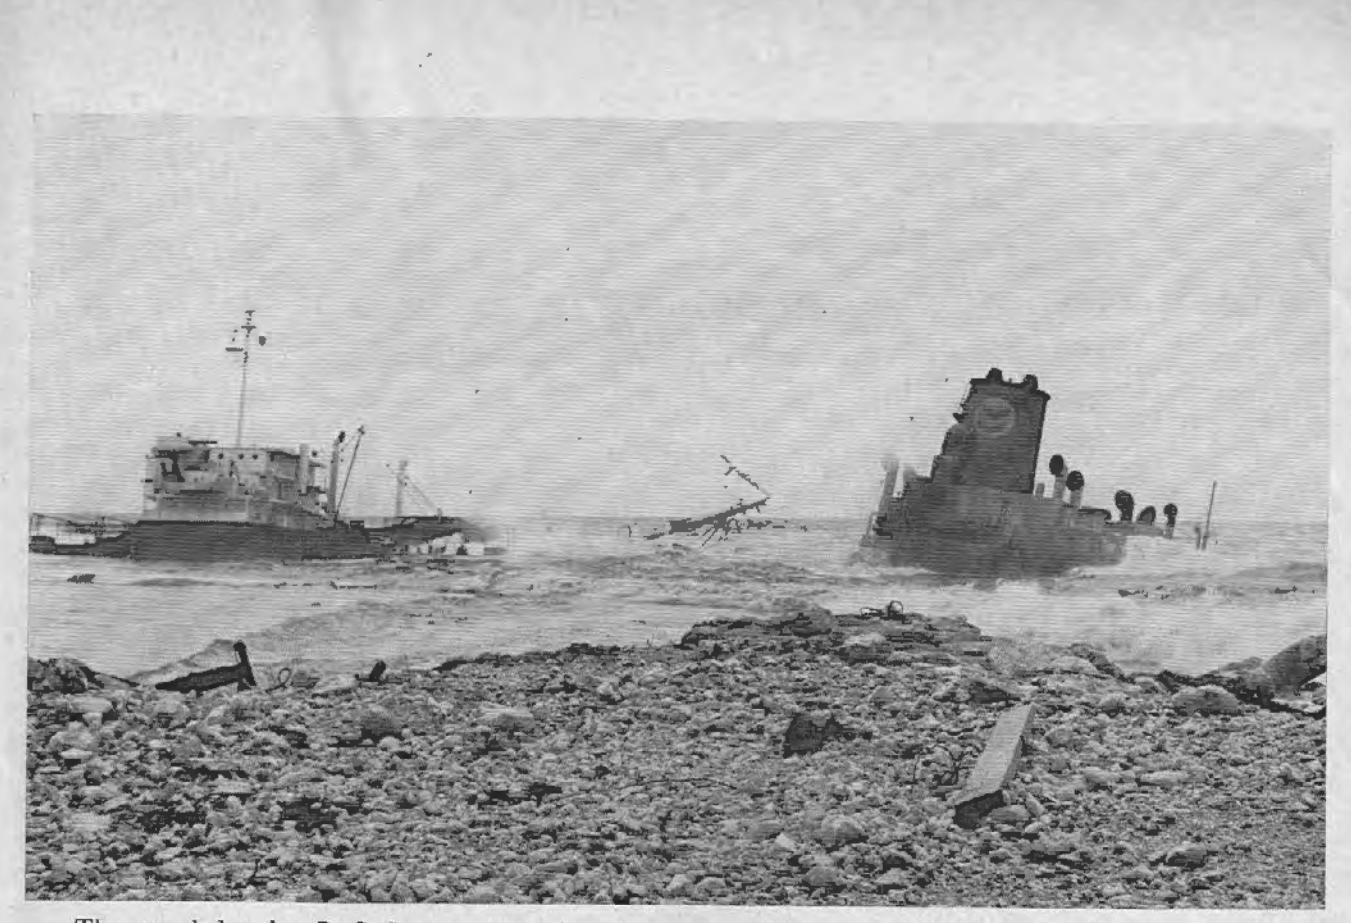
The Pacific Ocean took its toll of casualties, with the flooding and sinking of the SS *Panoceanic Faith* on October 9, 1967, with the loss of 36 lives and the grounding and subsequent stranding of the tankship  $R. \ C. \ Stoner$ , while attempting to moor to offshore buoys at the entrance to the Wake Island small-craft harbor.

Before attempting to moor, the Stoner-an 11,600-ton tanker-hove to off Wake Island for 3 days, waiting for favorable weather. On the morning of September 5, with a 10- to 12knot onshore wind, seas of 1 to 2 feet and swells of about 3 feet in height, the master felt that he could make the moor safely. The starboard anchor was dropped, a how wire made fast to the mooring buoy forward, and an LCM proceeded to the after mooring buoy with a stern wire. Upon reaching the buoy the wire was lost. The stern wire was then retrieved aboard the ship, payed out to the LCM, and again run to the stern buoy. By the time it was secured the stern was drifting to shore and inshore of the line of mooring buoys. The stern winch was unable to take up on the wire in order to move the stern away from shore and closer to the stern buoy despite the small craft pushing on the port quarter. It was decided that a second stern wire to an additional stern winch was needed. The first stern line was slackened to bring the mooring buoy above the water, and the second wire was connected to a different winch. Both stern lines were taken up but the port quarter continued to drift to the reef. With the engine on full ahead and with full left rudder the starboard anchor chain parted and the bow of the vessel set toward shore riding over the bow buoy. The vessel could not be maneuvered clear, so she grounded and subsequently stranded.

The pollution resulting from the subsequent spillage of JP-4 diesel oil and aviation fuel taxed the facilities of the island personnel. The pollution cleanup was assisted considerably by the passage of typhoon Sarah directly over the island about 10 days after the stranding. The report indicates that the effect of the typhoon was literally a scouring of the shoreline, cleaning it of an estimated 95 percent of the pollution. Both of these casualties have spurred the intensive study of water pollution already underway following the Torrey Canyon disaster.

The stranded tanker R. C. Stoner, as seen from the closest point of land on Wake Island. Blackened stack is the result of wind-blown pollution, which is also noticeable in the water.

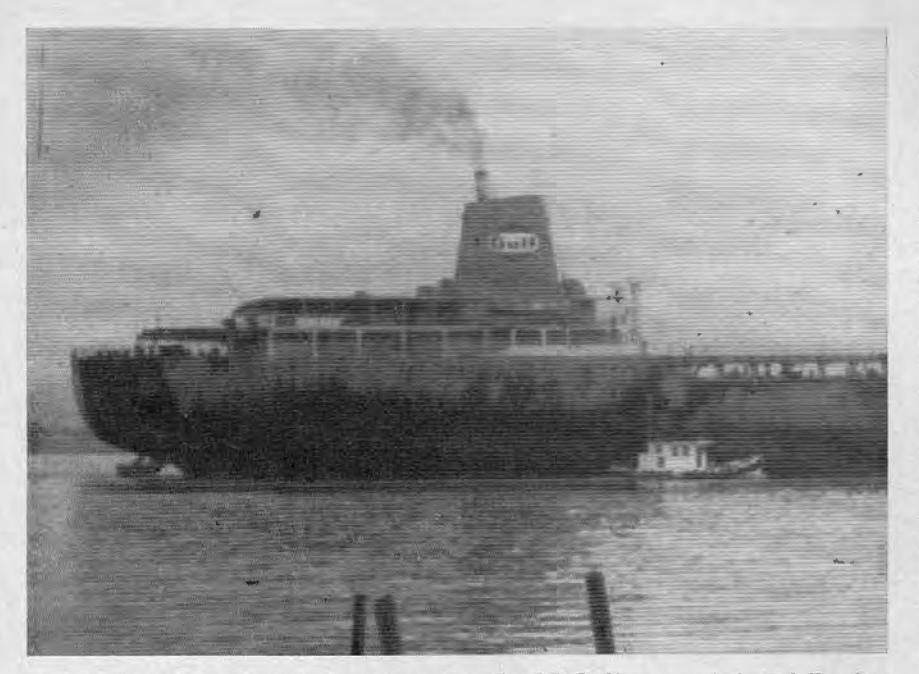
Evidence of fire damage is apparent on the SS Gulfsupreme's hull following a collision with barges in tow of the tug Kate Malloy.

On the early morning of Christmas Day last year, the tug Kate Malloy, while attempting to make up a tow of two loaded tank barges allowed the lead barge to collide with the anchored SS Gulfsupreme off Bursa, La., in the Mississippi River. There was no appreciable wind at the time of the casualty and estimates of the current in the river range from 31/2 to 6 m.p.h. After the barges had been loaded at a terminal at Ortrica, La., (about 11/2 miles north of the Gulfsupreme anchorage), the master of the Kate Malloy instructed his mate to back the doubled-up barges out into the river and string them out for the trip to Port Arthur, an operation which had been performed several times before. While backing down against the current, one barge was allowed to drift around to the stern of the other by pivoting on one securing line. As the tug backed against the swift current and while moving down and across the river, the mate on the Kate Malloy realized he was unable to control the downstream movement of the tow. The current caught the tow abeam and drove it downstream into the Gulfsupreme's extended port anchor chain and bow. The ensuing fire involving the crude oil cargo on the tank barges caused threequarters of a million dollars damage to the tanker and the two barges and serious burns to nine crewmembers aboard the Gulfsupreme. More than 3 hours were required to bring the fire under control. As the fire advanced to engulf the Gulfsupreme, the master of the tanker got his vessel underway and separated from the source of the fire on the barge within 4 minutes. This quick action probably saved the ship and averted a possible explosion. The Coast Guard investigation found evidence of negligent operation on the part of the unlicensed operator of the tug.
