# PROCEEDINGS

SS Panoceanic Faith . . .

## SS PANOCEANIC FAITH OF LIFE NORTH PACIFIC

## FOUNDERING WITH LOSS OCEAN, 9 OCTOBER 1967

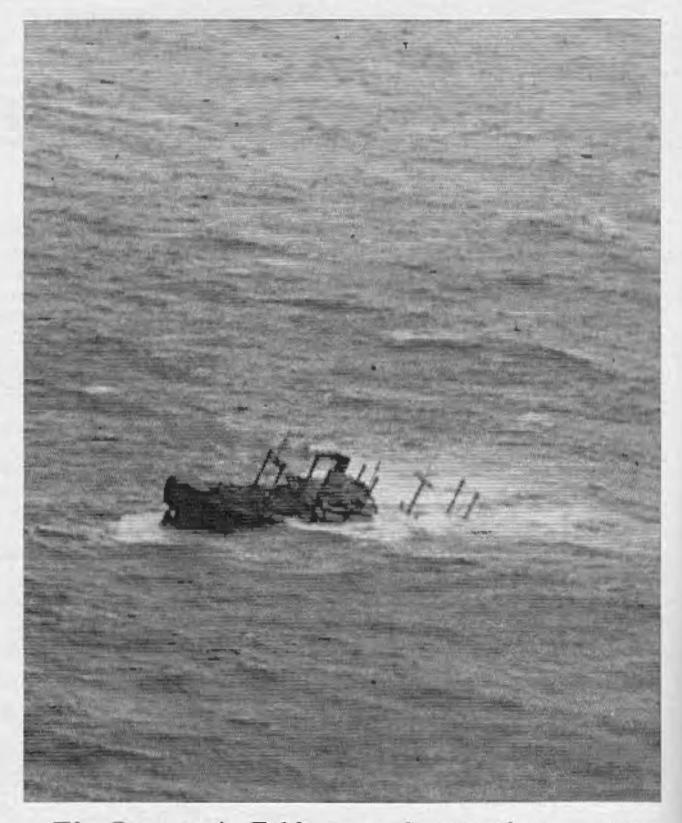
The Panoceanic Faith noses downward to a watery grave. Abortive efforts to launch a lifeboat contributed to the loss of 36 of the 41 persons on board.

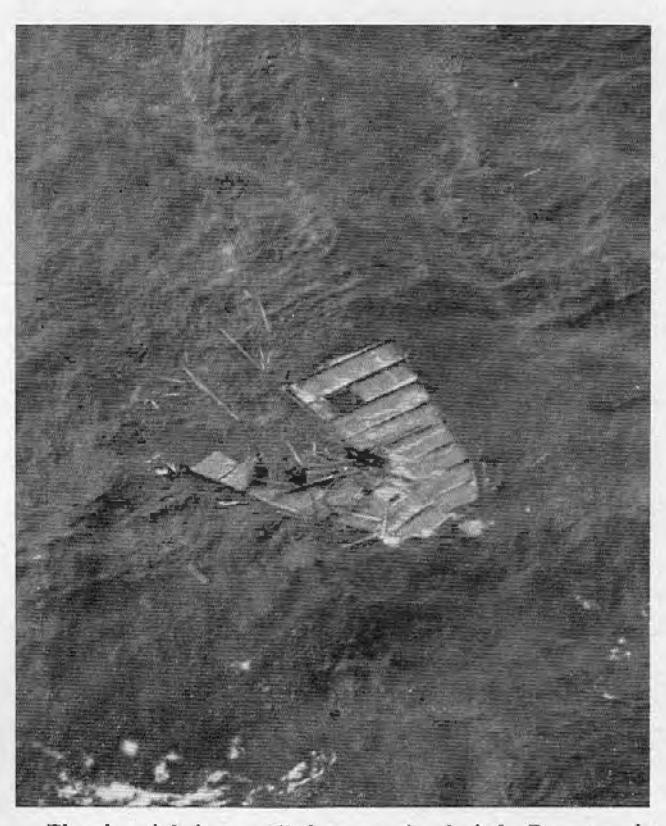
Floating debris was all that remained of the Panoceanic Faith. Two crewmen managed to cling to pieces of the debris and were rescued by vessels converging on the scene.

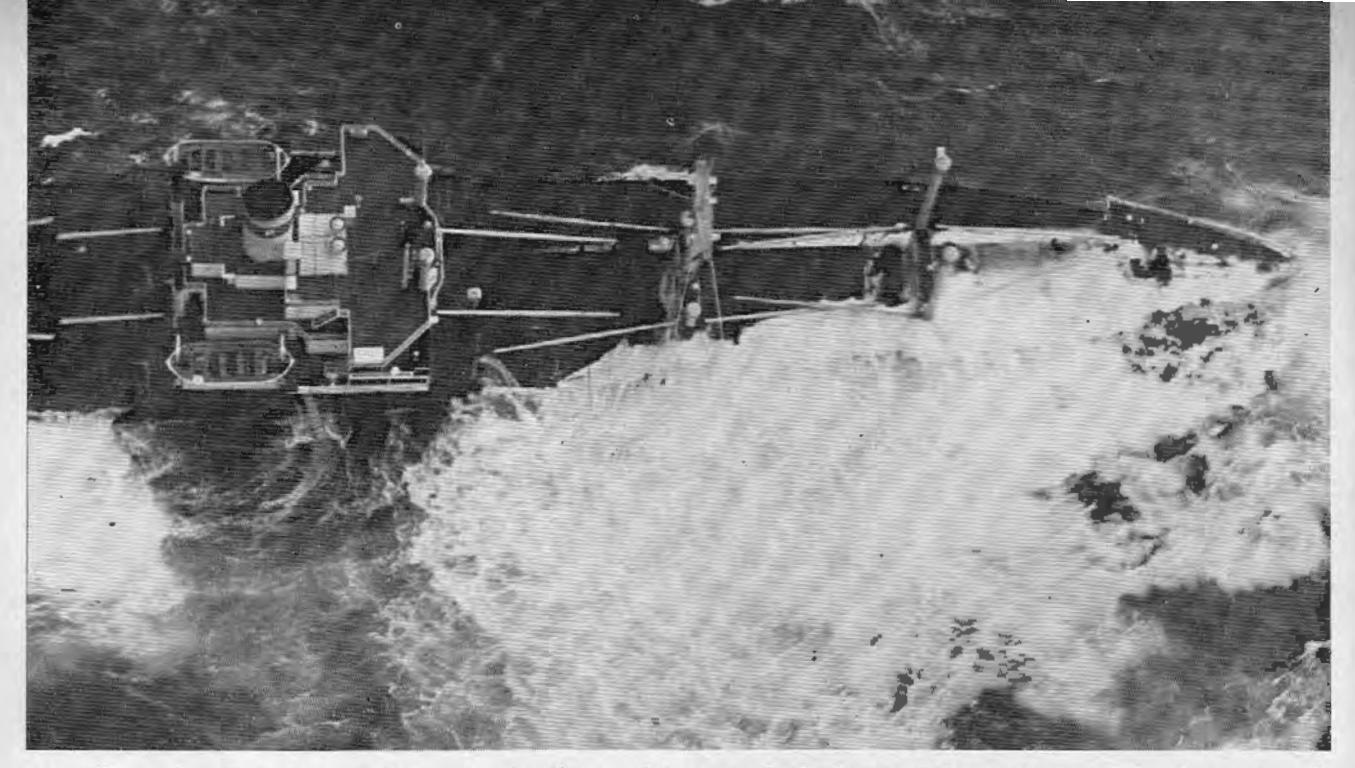
When aircraft arrived on the scene, the distressed Panoceanic Faith was listing to starboard, her forward decks awash. Inflatable liferafts were dropped near the sinking ship, but only three men managed to survive aboard one of the rafts.

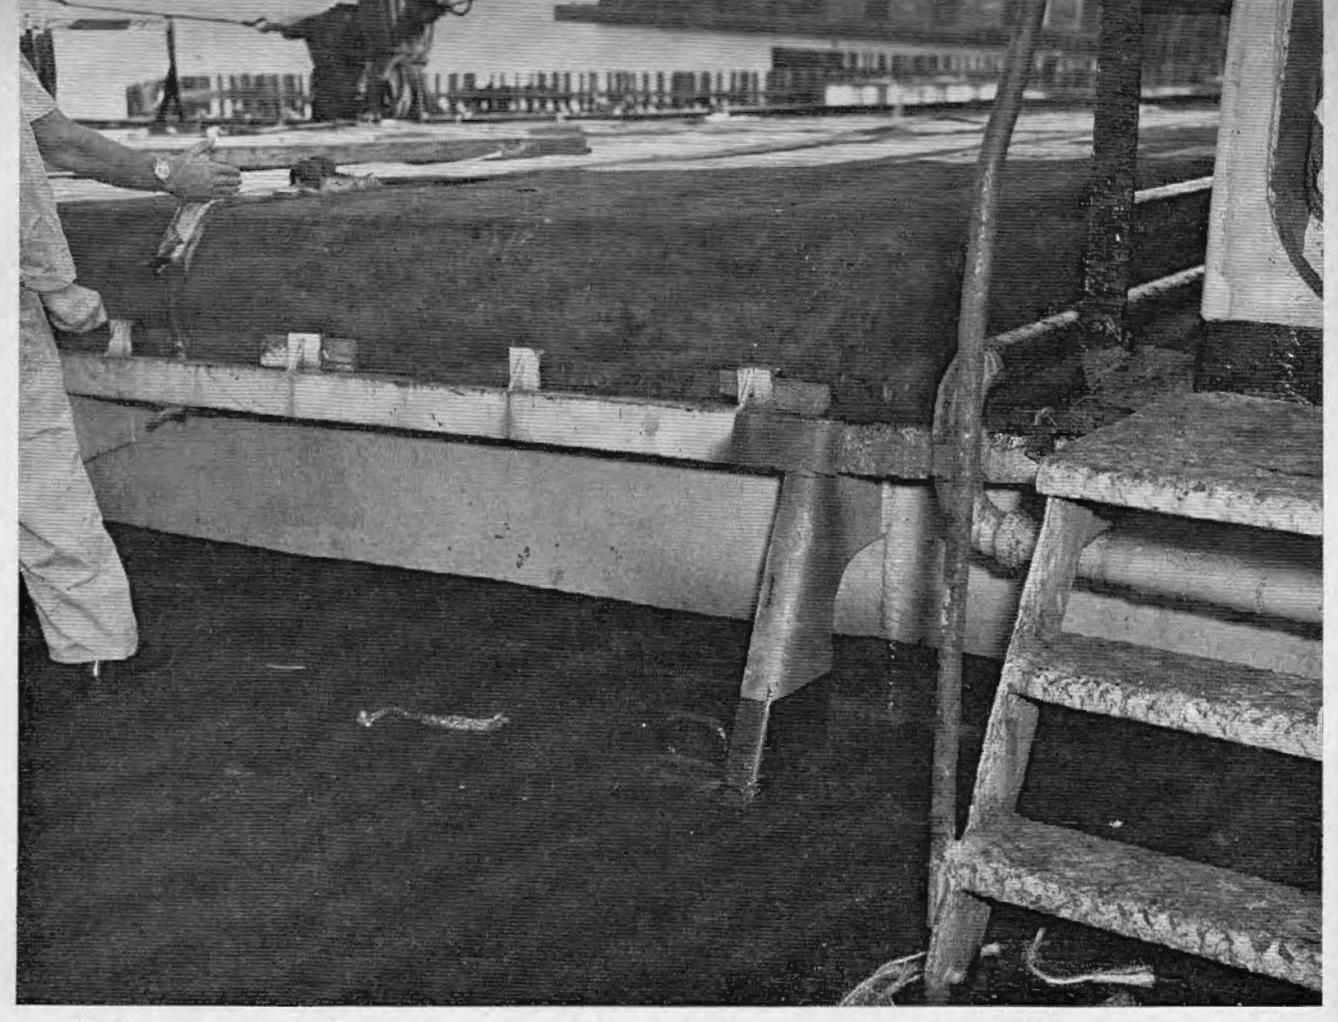
2. The flooding of No. 1 hold occurred as the result of the canvas hatch covers loosening and eventually being lost in heavy weather. During the night of 8 October the steel pontoon hatch covers were lost and the hold was completely filled and open to the sea. Since the hatch covers on No. 2 hold appear to have been reasonably secured until shortly before the ship sank it is probable that the principal flooding of No. 2 hold resulted from a failure of the bulkhead between holds Nos. 1 and 2.

Hatch covers such as pictured here were instrumental in the loss of the Panoceanic Faith. Two days before the foundering of the vessel, the hatch covers on No. 1 hold were loose. No remedial action was attempted until it was too late. Boarding seas flooded No. 1 hold, leading to further flooding and eventually a fatal loss of stability and buoyancy.

The probable cause of this vessel's foundering was failure of the master to have the tarpaulins secured on No. 1 hatch when they were observed to be loose. Neglecting to effect prompt repairs ultimately resulted in this hold being open to boarding seas and complete flooding. This flooding, combined with flooding in the forepeak spaces, and partial flooding of No. 2 hold, aggravated by loss of freeboard due to extreme starboard list, resulted in loss of longitudinal stability and sufficient buoyancy. The *Panoceanic Faith* sank bow first. It is possible that the master's concern about the fuel supply, and slow speed made good, may have influenced his actions. He obviously underestimated the seriousness of these conditions.
