# PROCEEDINGS

# F/V "FENWICK ISLAND" CAPSIZING IN ATLANTIC OCEAN

### MARINE BOARD OF INVESTIGATION

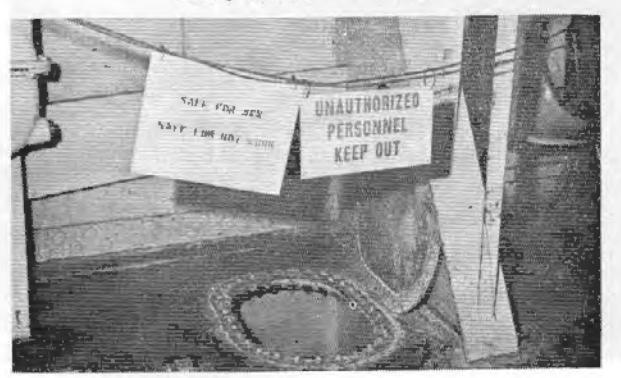
No coffin here! However, note hazardous manhole cover stowage.

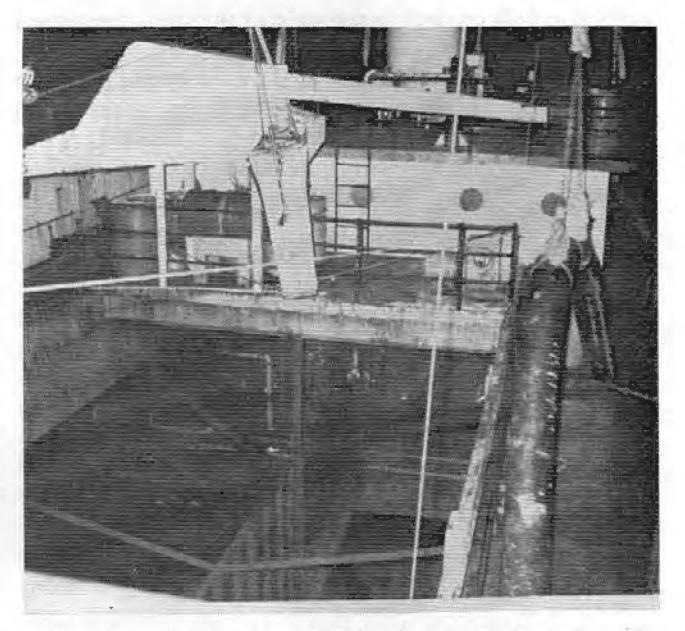
The loss of the Fenwick Island was attributed to the entrance of sea water into her main fish hold, similar to the one pictured above. Heavy seas and the failure of efforts to regain stability doomed the vessel and seven crew members.
