PROCEEDINGS

Marine Casualties— Prevention Through Legislation . . .

SS African Star and M/V Midwest Cities and Tow; Collision and Fire . . .

M/V *MIDWEST CITIES* AND-ON THE MISSISSIPPI RIVER ON MARCH 16, 1968

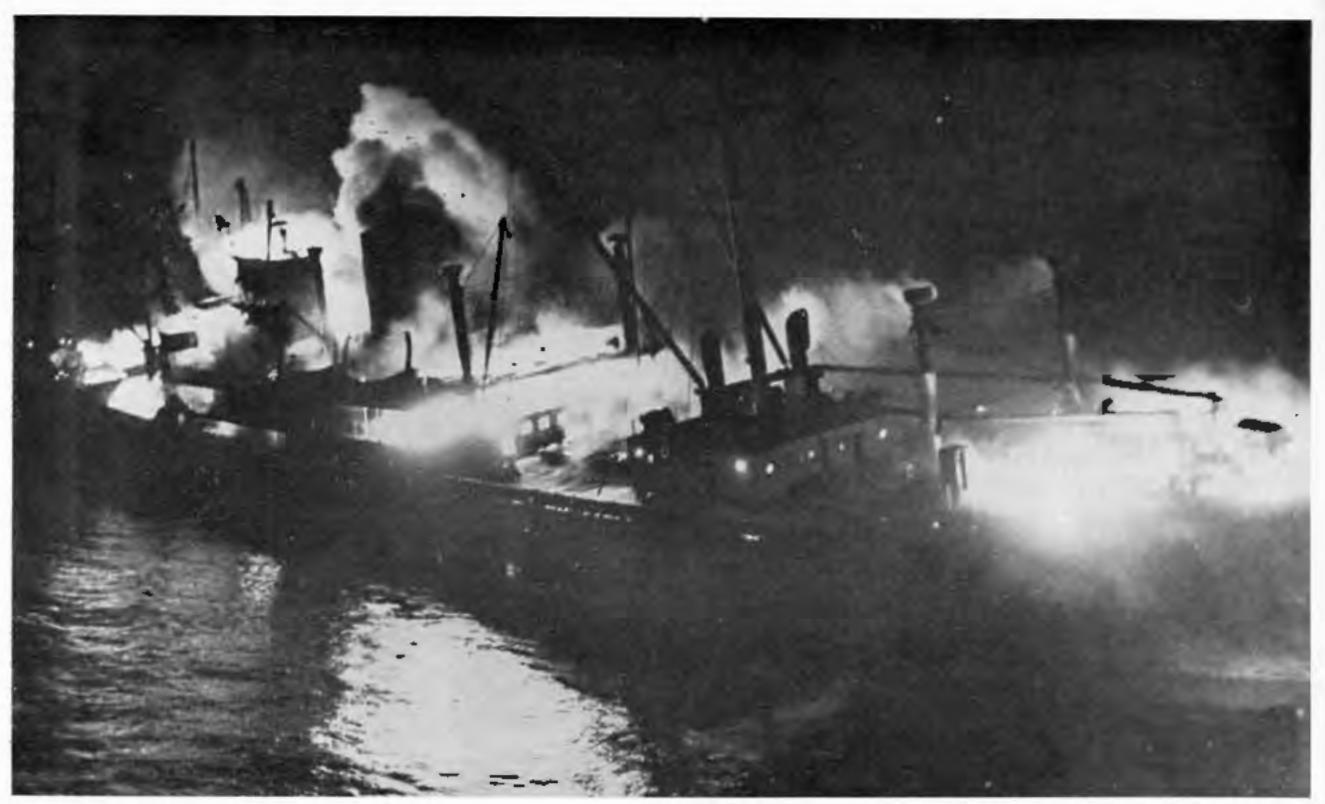
Shortly after colliding with the barge pushed ahead by the Warren J. Doucet, the flames from the Union Faith cast their deathly glow over the doomed vessel. (The outline of the Greater New Orleans Bridge is barely visible in the upper left corner).

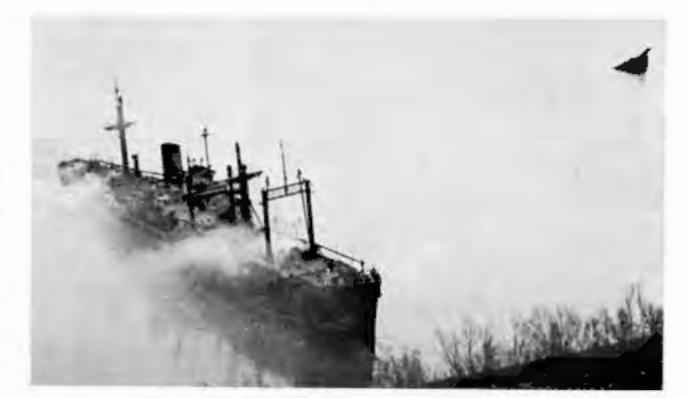
The small triangular object protruding from the surface of the water in the upper right corner is all that is visible of the Intercity barge. With smoke still billowing from the African Star, she rests safely aground on the bank of the river.

The Intercity No. 11 grounded and sank near the west bank at Mile 45.7 (AHP). After being released by the Coast Guard, the *Midwest Cities* recovered the loose Intercity No. 14 and secured it, undamaged. The towing vessel sustained minor damages. Total cost of this collision exceeded \$1 million, exclusive of cargo damage on board the African Star.

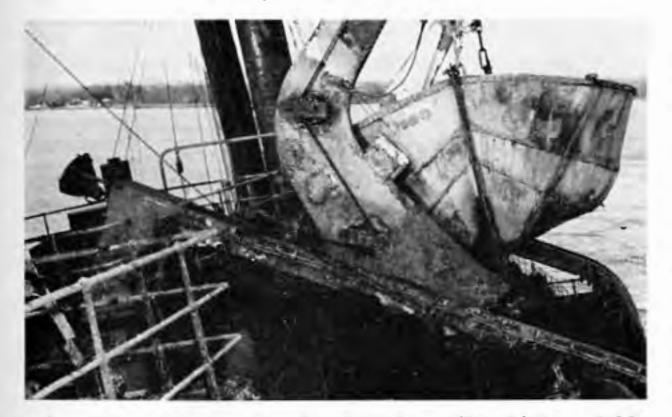
Severely scorched by the burning oil which quickly spread from the Intercity barge, the African Star lists to starboard after members of her crew valiantly maneuvered the vessel to shore.

7. The crude oil cargo on the barge ignited seconds after the collision. Several explosions on the barge caused oil to be sprayed on the African Star. The fiercely burning oil ignited many secondary fires in combustible material on board the vessel. When the fixed CO_2 system was discharged to fight the fire in No. 5 hold, a flexible line ruptured between a cylinder valve and the header. This did not prevent the effectiveness of the CO_2 or the containment of the fire in the hold. The African Star backed out of the barge shortly after the collision and was purposely beached on the right descending bank at Mile 45.9. The Intercity No. 11 sank in 43 feet of water about 700 feet from the right descending bank at Mile 45.8.

The fire and subsequent explosions were caused by sparks generated by the shearing of the *Intercity No. 11's* steel side and deck by the bow of the *African Star*. Rapid spread of the fire on the *African Star* is attributed to the wind's blowing the burning oil over the bow of the *African Star*, and the abundance of combustibles on deck.

The many fatalities and injuries sustained on board the African Star were due to the rapid spread of fire and heavy smoke in living spaces, and burning oil surrounding the vessel, precluding personnel from jumping overboard.
