PROCEEDINGS

M/V THERESA F CAPSIZING IN GULF OF MEXICO ON 9 JANUARY 1969

MARINE BOARD OF INVESTIGATION FINDINGS OF FACT

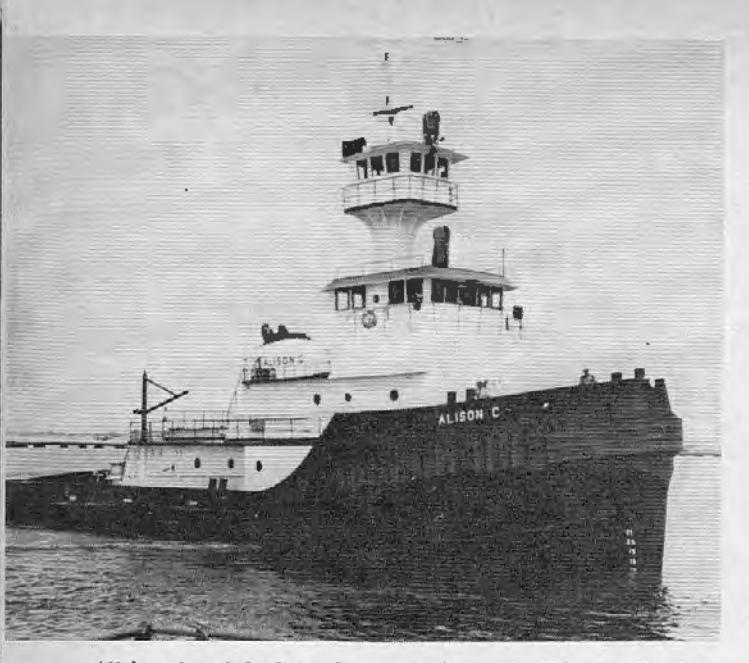
All hands might have been lost from the Theresa F, sister tug of the Alison C shown here, had the towing vessel not been equipped with an inflatable liferaft.

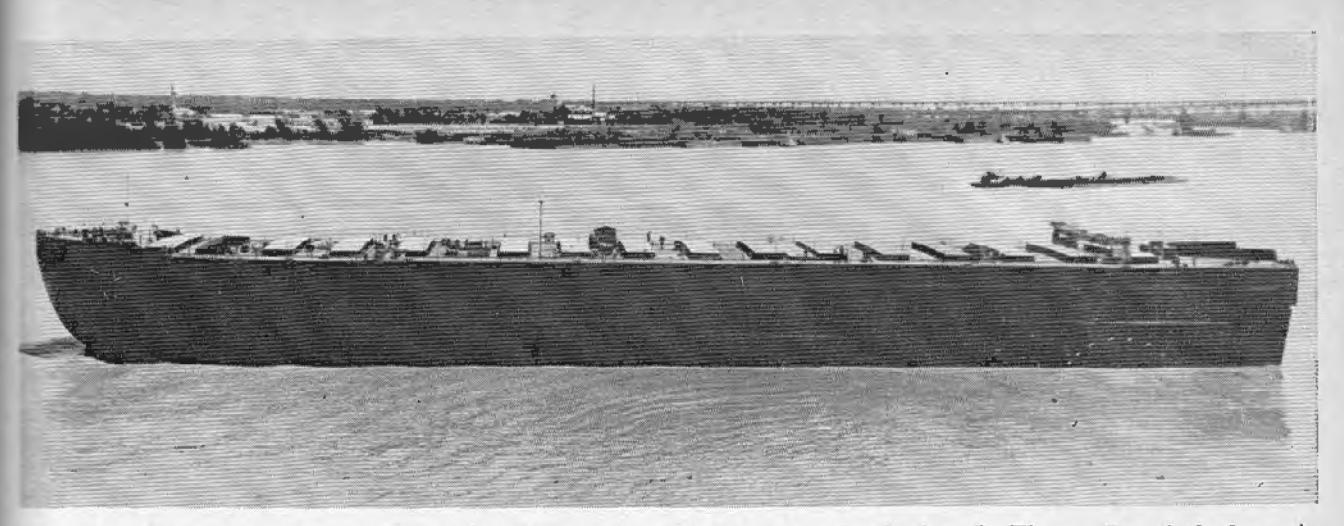
The skegs on the barge Freeport I were positioned inboard for pushing ahead when the Theresa F took the barge in tow astern. This action led to the barge's ultimately running wild and tripping the towing vessel.

The cause of the casualty was the heeling moment imposed by the towing pendant leading over the starboard quarter of the Theresa F while the barge Freeport I was on a sheer to starboard while running erratically from side to side on a shortened hawser. The primary cause of the sheering (running from side to side) of the barge was the improper positioning of the adjustable portion of the twin skegs of the Freeport I accentuated by the shortened hawser. The reduction in speed, the prevailing wind, and the confused seas were contributing factors since the barge had been trailing behind the tug better on other courses and speeds. These factors, however, should not have caused problems if the vessels had been operated properly. Other contributory factors were the failure of the Master to keep track of the position of the barge which was sheering from side to side; his lack of awareness of the effect of the heeling moment imposed by a tow of such great size on his quarter on a short hawser; and his failure to maneuver the Theresa F in such a manner as to reduce the heeling moment after the barge got on the starboard quarter. There is no evidence that the Theresa F suffered any impairment in stability before she was tripped by the towing line to the barge. There is no evidence that the Theresa F had insufficient stability for normal towing operations. There are no established criteria or stability standards for towing vessels that would prevent tripping by large tows being towed on a hawser under any and all conditions. Proper operation continues to be an important consideration in the safe navigation of towing vessels, especially those with large tows.

Concurring with the Marine Board of Investigation, it is considered that the cause of this casualty was the heeling moment imposed on the *Theresa* F by the towing pendant leading over her starboard quarter after the barge *Freeport I* took a sheer due to improperly positioned skegs which allowed the barge to yaw.

That a study of vessels engaged in towing operations be conducted to determine the adequacy of existing practices and requirements. In the interim the dissemination and publication of this report should alert the operators of towing vessels to the inherent dangers involved, with particular reference to, (a) the positioning of skegs where adjustable type skegs are employed on barges, (b) the condition of generators and essential machinery, and, (c)an alert watch to detect sheers that might result in the tripping of vessels towing large barges astern.

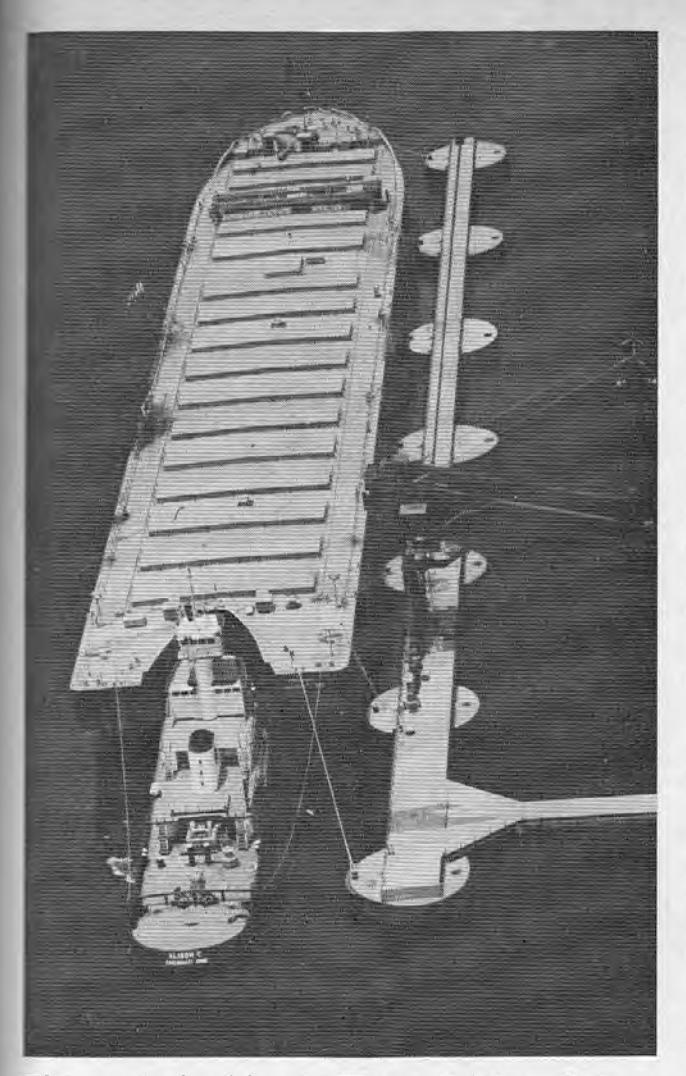
The casualty involving the Theresa F (Alison C shown in this photograph) and the Freeport I prompted the National Transportation Safety Board to call for an "operational analysis of towing vessel operations, and development of operating manuals for guidance of seagoing personnel".
