## **PROCEEDINGS** OF THE MARINE SAFETY COUNCIL

Vol. 28, No. 9

September 1971

# THE TRAGEDY OF THE M/V MARJORIE McALLISTER

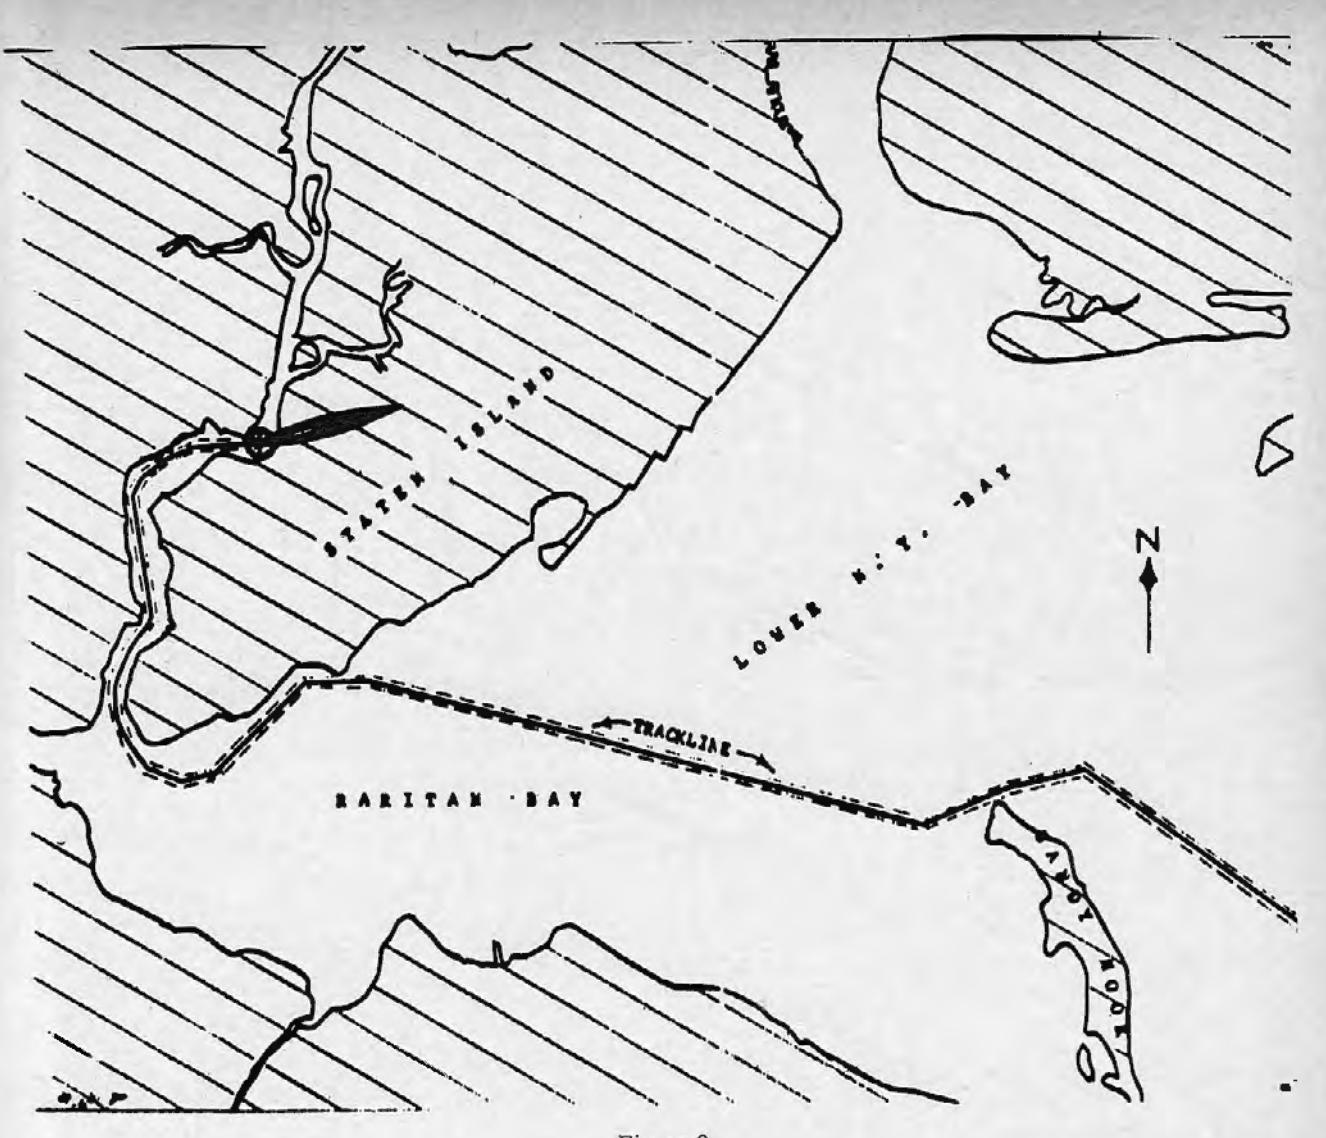
In Figure 2, the LNG tanker has collided with an outbound vessel in Port Reading Reach, near Smoking Point, Staten Island, and one tank has been breached, releasing 24,000 m<sup>3</sup> of liquefied natural gas onto the water. The cross sectional area of the spill has been drawn in, plus the vapor plume. The shaded area in the plume represents the explosive range, 5.3-14.3% methane in air. Figure 2 represents the vapor plume characteristic which would evolve from vaporization from a quiescent liquidmethane interface as determined ex-

perimentally. This would be a "minimum" size vapor plume. The plume shown in Figure 2 was based upon a continuous vaporization of the LNG at a rate of 2,000 m<sup>3</sup>/min or a 12 minute duration. The plume as a result of instantaneous vaporization would appear as indicated in Figure 3. The plume in Figure 3 illustrates plume length. "maximum" the Actually the plume, for the conditions anticipated, would lie between the plumes shown. Vaporization would be accelerated by wave action or chop which would tend to increase heat transfer area and prevent the formation of ice.

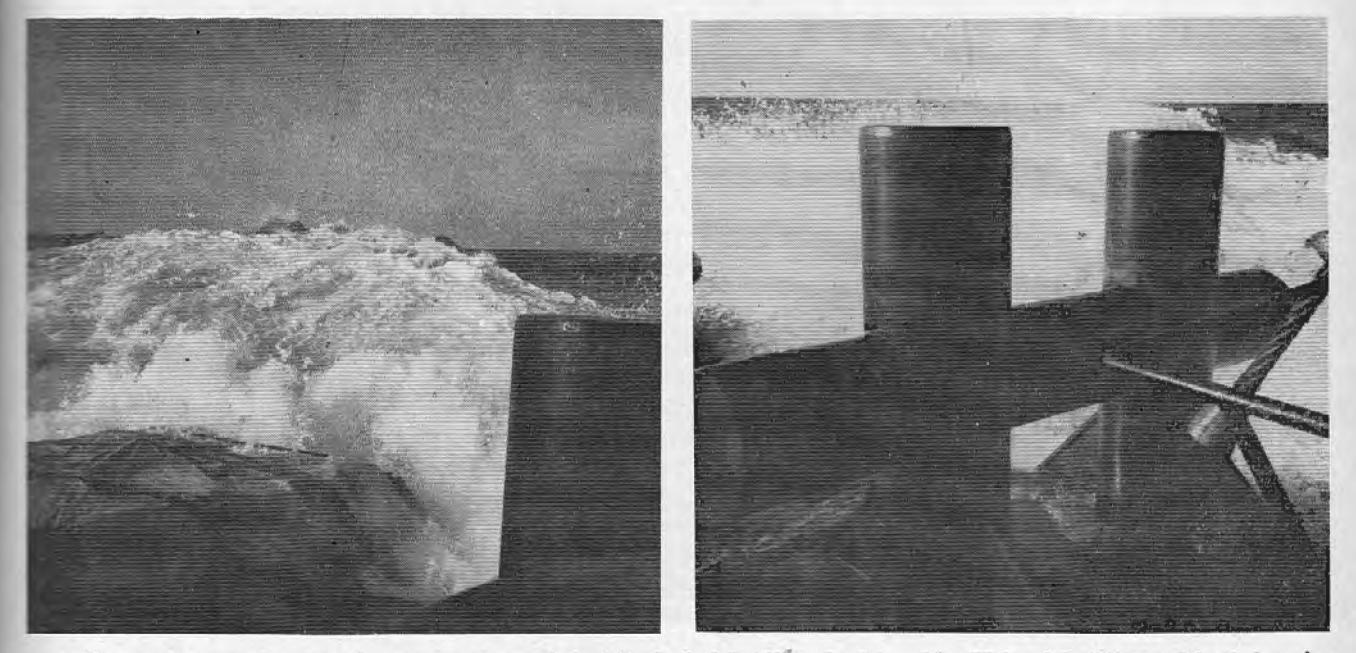
Green water pours over the port quarter of the Marjorie McAllister's sister ship, Helen McAllister. Much heavier seas than these 6 footers inundated the stern of the Marjorie McAllister on the night of the casualty.

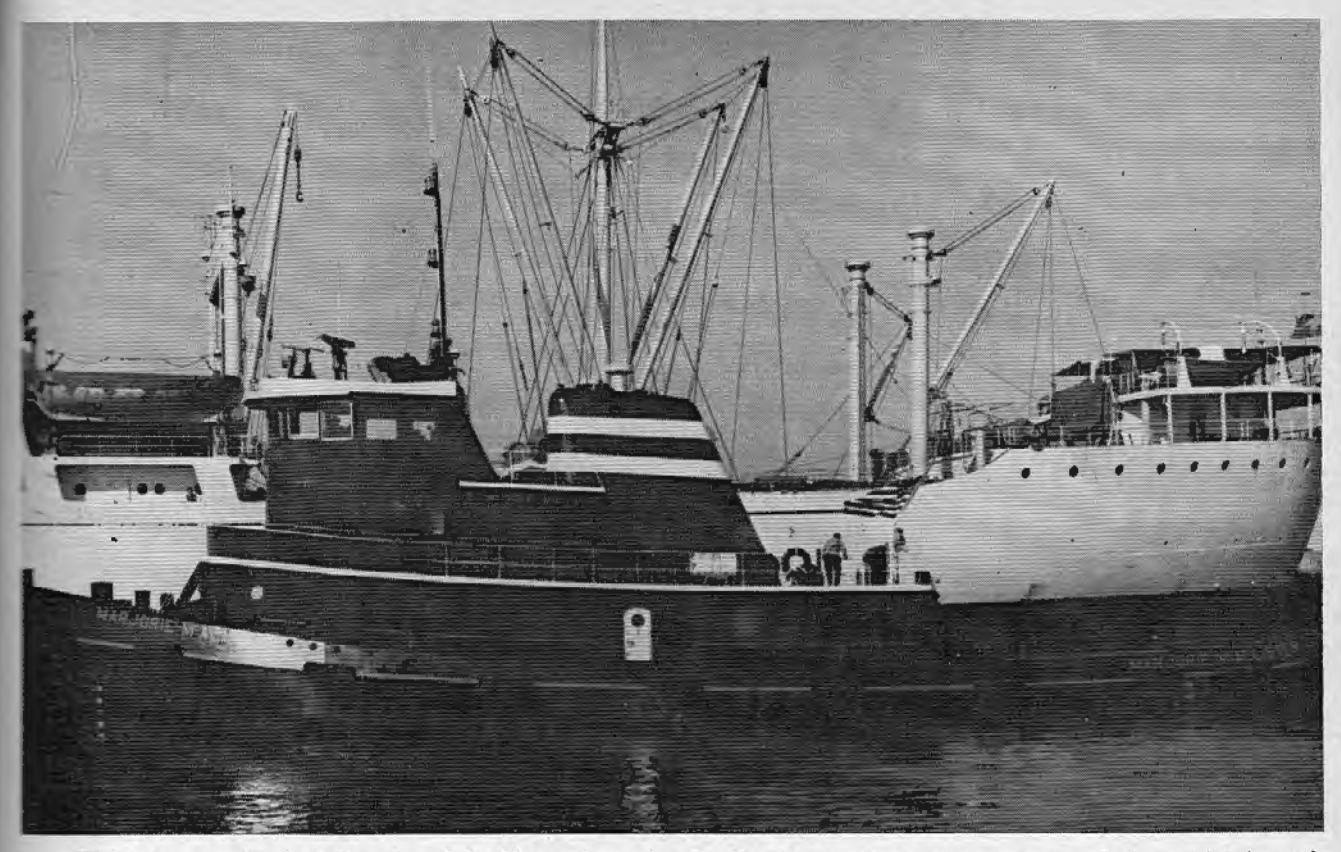
This photograph of the Marjorie McAllister shows her low freeboard aft, an element of her design which investigators determined to have contributed to her sinking off Point Lookout, N.C., on 2 November 1969.

> The National Transportation Safety Board finds that the probable cause of the loss of this vessel was foundering. Extremely adverse weather, flooding of the engineroom, and the sudden capsizing of the vessel were the causes of the foundering and the loss of all hands. Other contributing factors were:

The Marjorie McAllister, being a diesel-propelled towing vessel of under 300 gross tons, was not subject to U.S. Coast Guard inspection and certification. The Coast Guard Marine Board of Investigation recommended that action be taken to require licensing by the Coast Guard of Masters of towing vessels and that the Coast Guard seek legislation for the inspection of all towing vessels operating in Ocean or Goastwise Service. The National Transportation Safety Board concurred in these recommendations. They also recommended that the Coast Guard, in its special study of towing vessels, also analyze the casualties involving towing vessels operating in Inland Waters to determine whether there is a need for legislation requiring inspection of all towing vessels. The Safety Board was able to cite six casualties to this type of vessel which have occurred since 9 January 1969, and they stated, "This casualty is only one of several which have occurred within the past 2 years, and further illustrates the need for safety regulations specifically directed to this type of vessel." (See "M/V Southern Cities Disappearance," "Proceedings" of the Merchant Marine Council, Vol. 25, No. 8, p. 155 (August 1968) and "Marine Through Casualties-Prevention Legislation," "Proceedings", Vol. 28, No. 1, p. 3 (January 1971).)
