## **PROCEEDINGS** of the marine safety council

Vol. 29, No. 1

January 1972

# TOWBOAT FOUNDERING KILLS TWO

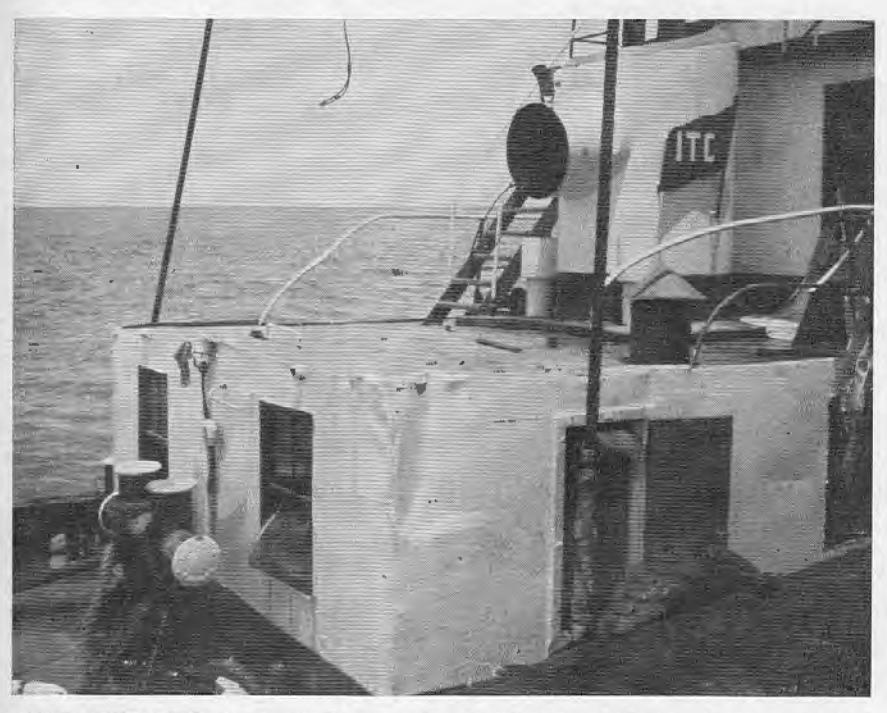
WITH A FREEBOARD aft of only 5 or 6 inches and 9 inch combings under the open door to the galley (lower right), the vessel's stern had to settle less than a foot and a half before water would flood the galley.

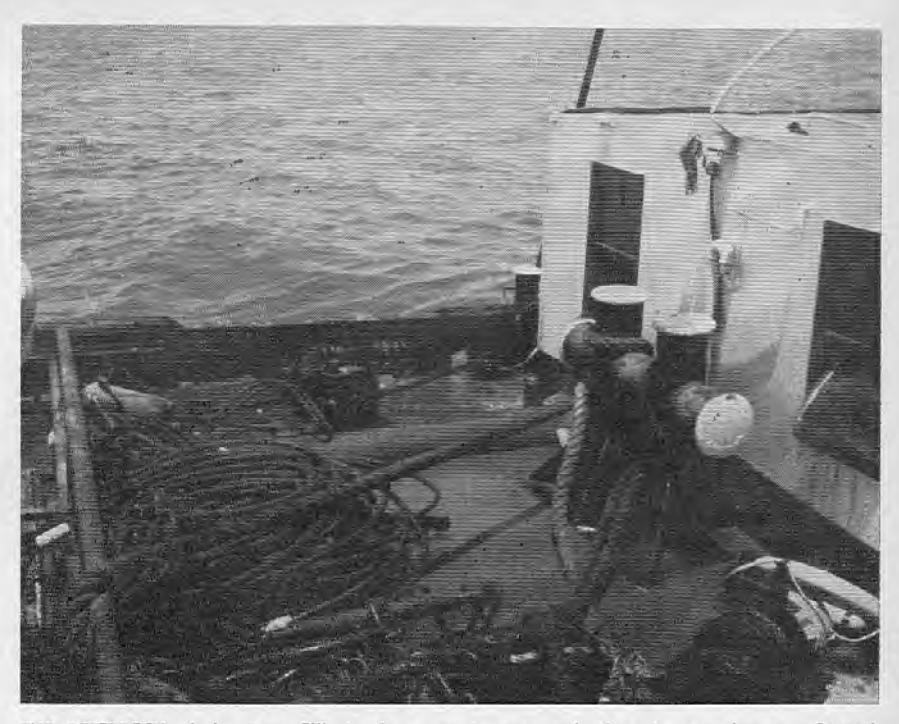
THE AFTERDECK of the Joan Ellis is shown as it appeared after the vessel was refloated. At the far left, the bitter end of the towing hawser is shown where it snagged. The other end of the hawser lies on deck, frayed and broken where it parted under the strain of the vessel's maneuvers and the tow.

The NTSB found that a sudden heeling moment was imposed by the hawser as it fetched up and jammed while still on the bitt after having been allowed to run. Large quantities of water poured through the open engineroom door and the vessel, assuming an extreme starboard list, sank suddenly by the stern.

The investigators found evidence to support these conclusions when the Joan Ellis was raised to the surface. A part of the 7-inch towing hawser was parted about 5 feet from the turn on the bitt. Several strands appeared to have been severed and the remainder were frayed as though parted under strain. Bits of rope yarn were in the broken weld of the dislodged flat plate lighting fixture on the bulkhead above the towing bitt.

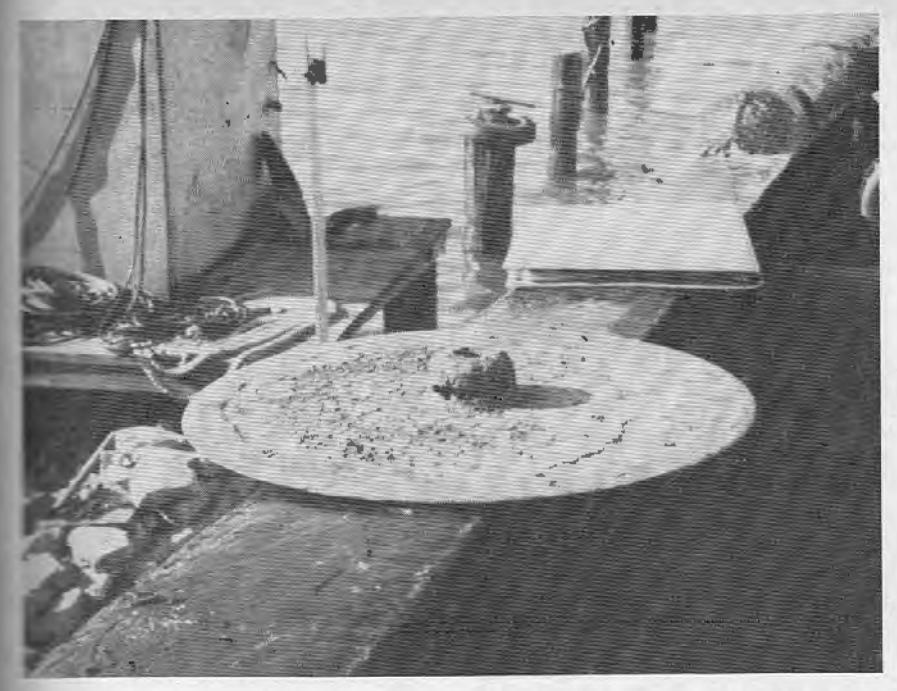
**ECODING OF** the Joan Ellis's water tank compartment was apparently the result of this manhole cover being wasted and holed. The NTSB was highly critical of the cover's meteriorated condition and concluded that the flooding of the tank compartment and of the entermost compartment of the vessel helped to cause the vessel's foundering.

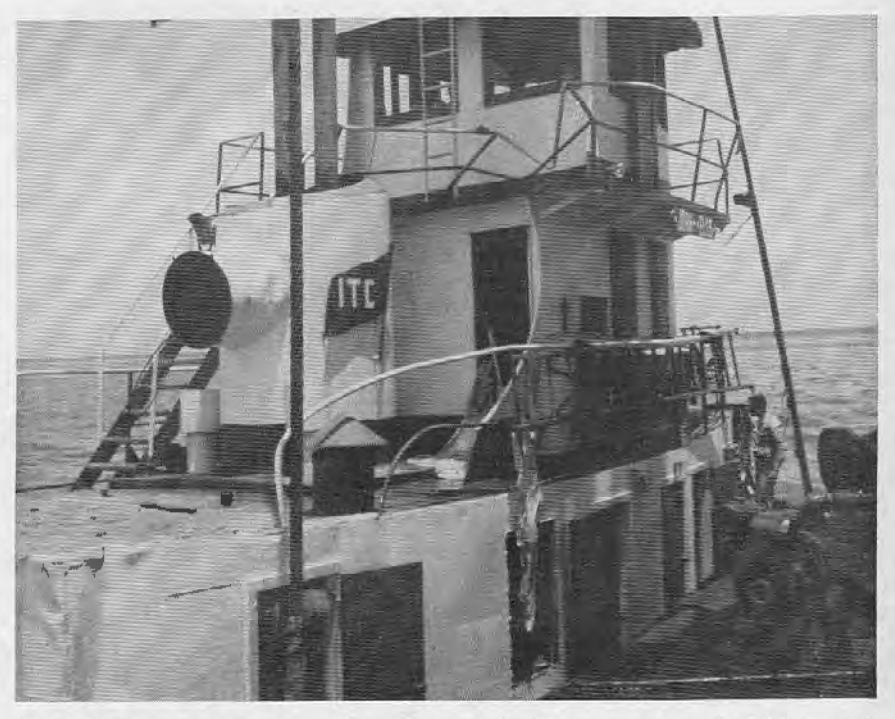
NONE OF THE crew of the Joan Ellis used any of the lifesaving devices aboard the vessel. Among the unused equipment were life preservers, life rings, and the skiff shown in this photograph still lashed in place behind the ladder and the rail on the second deck.

Investigators found that none of the survivors wore life preservers. One of the ring buoys fouled by its grab line on the rail outboard of the pilothouse door and the other floated away when the salvage team raised the vessel. Neither had been used by the crew.

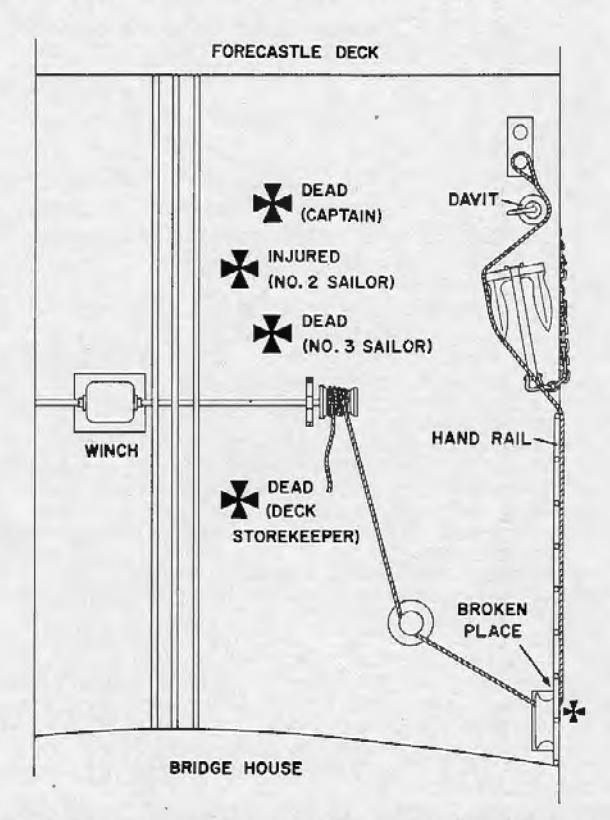
This shocking accident dramatizes the devastating forces unleashed from failure of a synthetic hawser under heavy strain. The illustration is copied from a hand-drawn sketch prepared by the tanker's Chief Mate. This is what reportedly happened:
