PROCEEDINGS OF THE MARINE SAFETY COUNCIL

VESSEL CAPSIZES IN DOCK

THE M/V Mercator, a 210-foot, 1258 gross ton vessel, was known as a very temperamental vessel while moored. She was rarely on an even kcel; and, when left as a dead ship with a few degrees list to one side in the evening, she would be found the next morning listing 5 to 8 degrees to the opposite side. Occasionally her Operations Manager would receive calls at home from personnel who had seen the vessel listing and who were concerned for her well-being.

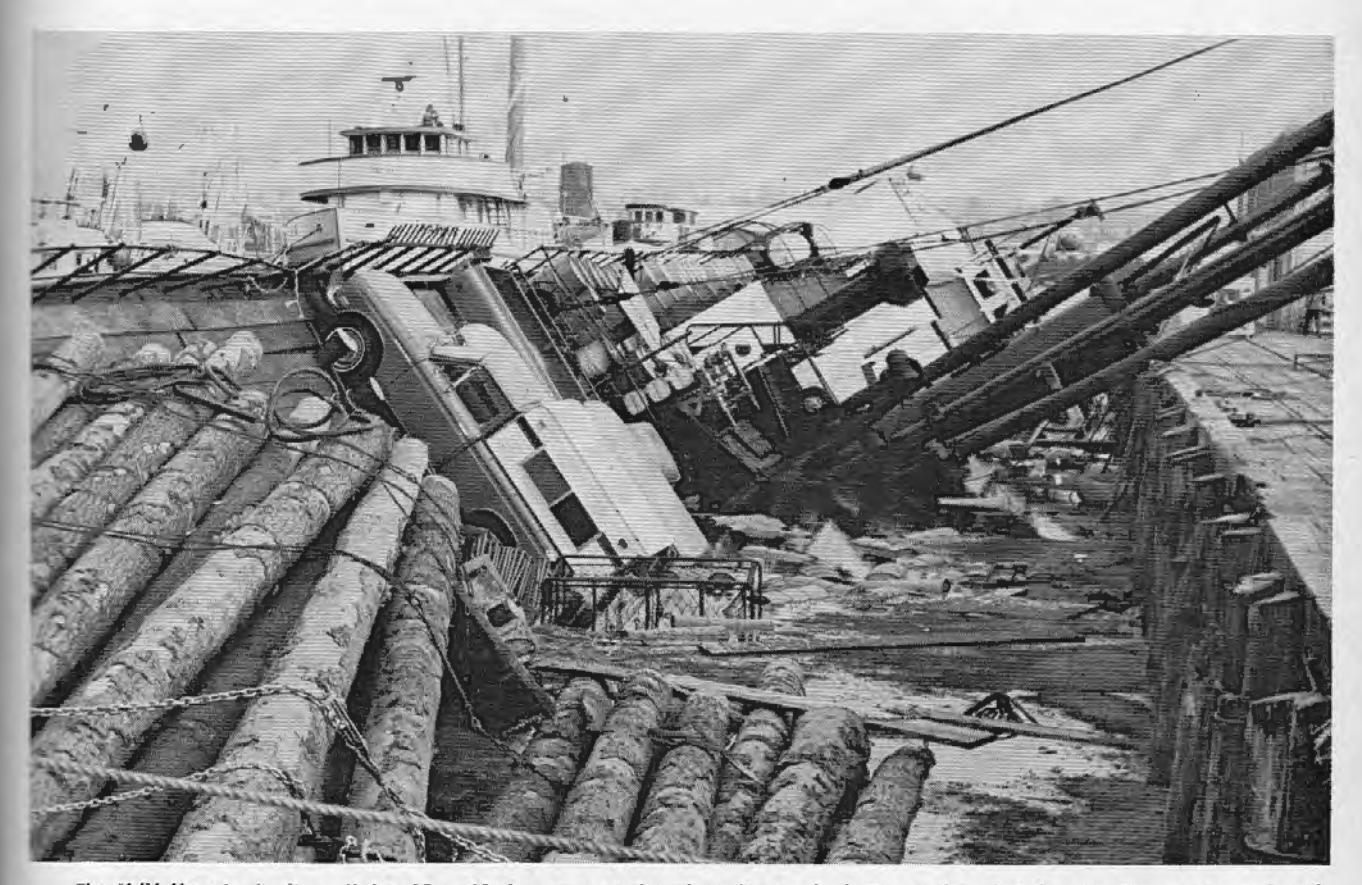
The M/V Mercator is shown listing 60 to 61 degrees to starboard, resting on the bottom and against the pier. The vessel was heavily loaded on the maindeck and above. Some of that cargo such as motor vehicles, steel round stock, and 55-gallon drums of oil can be seen above. Much of this cargo slid into the water as the vessel capsized.

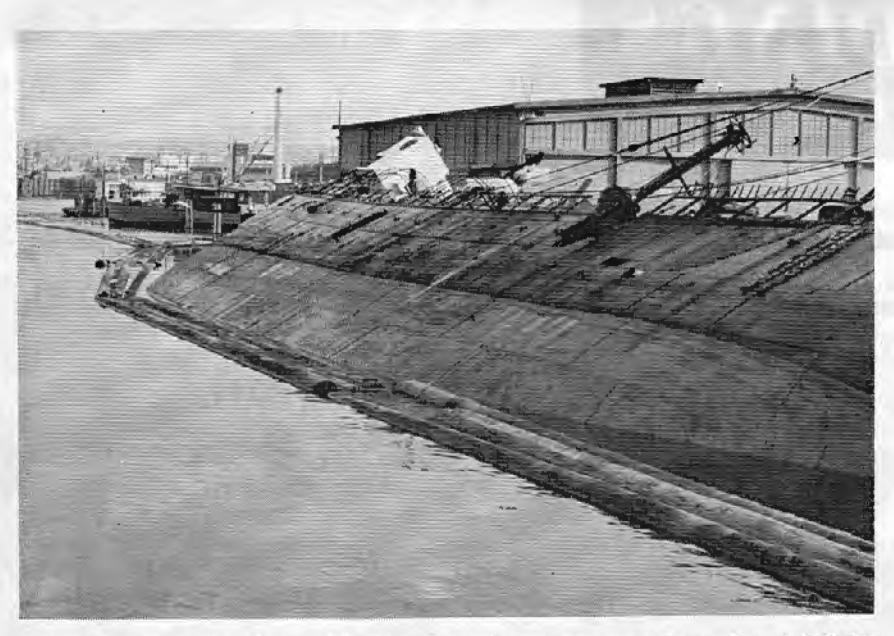
A log boom was rigged around the Mercator early on the morning she capsized. It failed to prevent some pollution which necessitated a major cleanup effort.

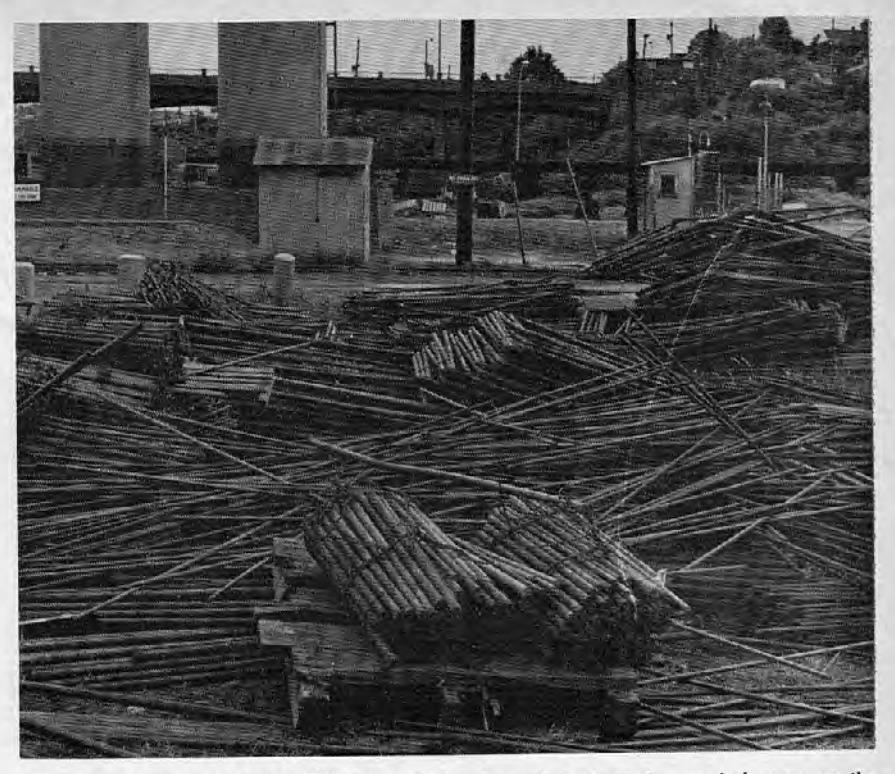
A view of most of the 154,511 pounds of steel round stock which was deck cargo on the weather deck of the Mercator at the time she capsized. Improper loading coupled with insufficient knowledge of the vessel's stability characteristics were primary causes of the casualty.

The distribution of the Mercator's cargo, with 62% by weight on the weatherdeck and 73% on, or above, the maindeck made the vessel very tender with a small righting arm. A stability test run after the capsizing with much cargo removed and the vessel drawing 13 feet, 3 inches forward and 11 feet, 7 inches aft approximated the metacentric height at between zero and 1 foot. The fact that two of the starboard fuel tanks were empty (down at least 7,000 gallons) while the port tanks were full, yet the vessel was on a relatively even keel prior to the evening of the casualty leads to the conclusion that cargo, most probably deck cargo, was not symmetrically loaded—more cargo being on the starboard than on the port side.

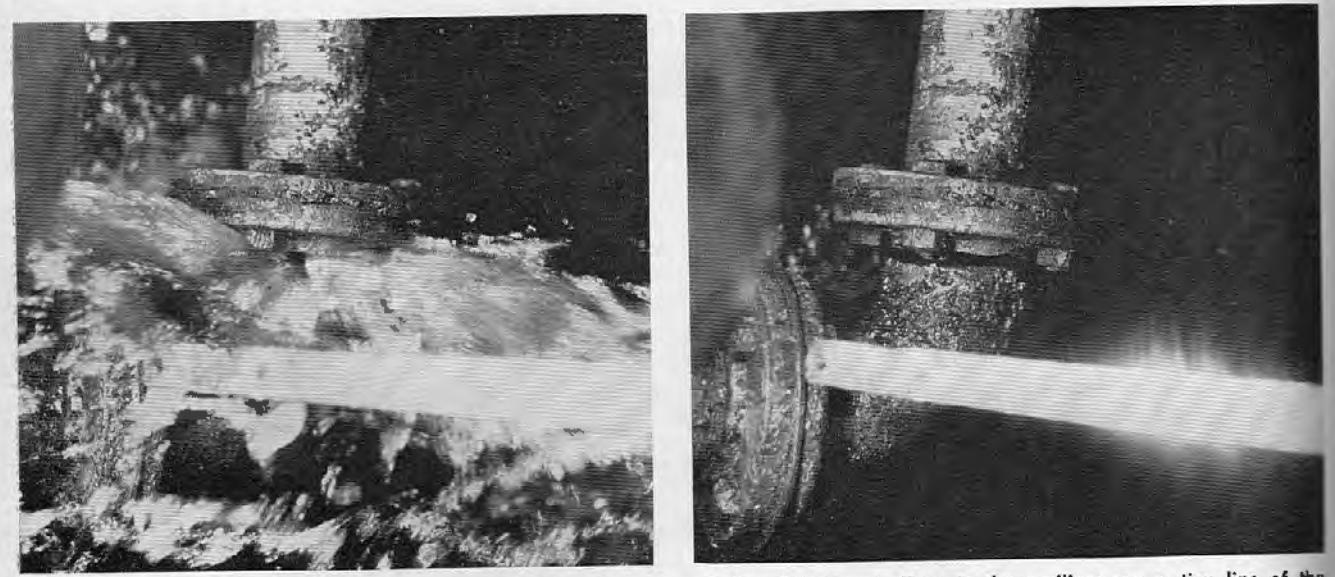
The two photos above are taken from above, looking down on a broken 3-inch cast elbow in the auxiliary sea suction line of the Mercator. The photo at the left was taken immediately after the vessel's engineroom was dewatered during salvage operations. The water leakage of less than 50 gallons per minute was considered a contributory cause of the casualty by the investigating officer. The photo at the right clearly shows the ½-inch gap left in the pipe by the fracture.

2. As the engineroom was dewatered, a 3-inch cast iron elbow in the auxiliary sea-suction line, located 15 inches above the bilge bottom on the portside of the longitudinal pipe tunnel, was found to be fractured. The elbow had separated 1/2 inch, allowing water to flow into the port engineroom bilge at a rate estimated to be less than 50 gallons per minute when the vessel was at 15-foot mean draft and when the fracture was above the bilge water level. Analysis of the cast elbow indicated that the fault had originated some years before and that the fracture area had undergone ferrite corroding, leaving the graphite intact. Hence the structure had become porous and had lost some mechanical strength. It was determined that the final fracture occurred within the time frame of the vessel's capsizing, but it could not be established whether it occurred before, during, or after the capsizing.

The changes in list on the evening of the casualty are also significant. The fact that the list increased to port between 6 and 10 p.m. causing the chief engineer to twice have fuel transferred to starboard is evidence of a shifting or addition of weight to the port side. The only likely source of this weight change is water entering through the fractured elbow in the auxiliary sea-suction line. It was concluded, therefore, that the fracture must have taken place in the early

evening hours prior to the capsizing. Because of the solid deck plating in the engineroom, the water thus entering the bilges was hidden from view; and the noise of the operating machinery hid the sound of the initial waterflow. Given these conclusions, water would have filled the port side of the engineroom bilge outboard of the longitudinal pipe tunnel. When the water level reached 15 inches and the fracture became submerged, the flow rate initially estimated at less than 50 gallons per minute would decrease. Water would begin to sluice to the center of the engineroom bilge through the 5-inch pipeway in the tunnel. If the flow from the fracture was greater than the rate of flow into the center of the bilge, the level of water in the port bilge would continue to rise and eventually water would flow over the pipe tunnel under the deck plates to the center of the engineroom bilges.

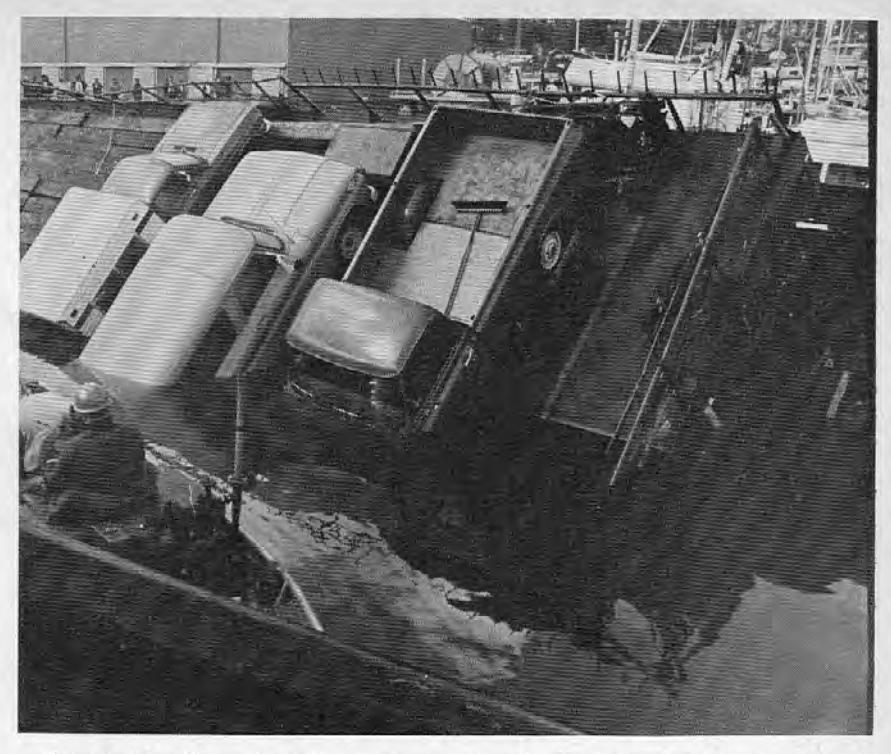
These motor vehicles were well enough secured on the Mercator's deck to escape complete destruction. The vessel itself was not so lucky. It was considered a total constructive loss.

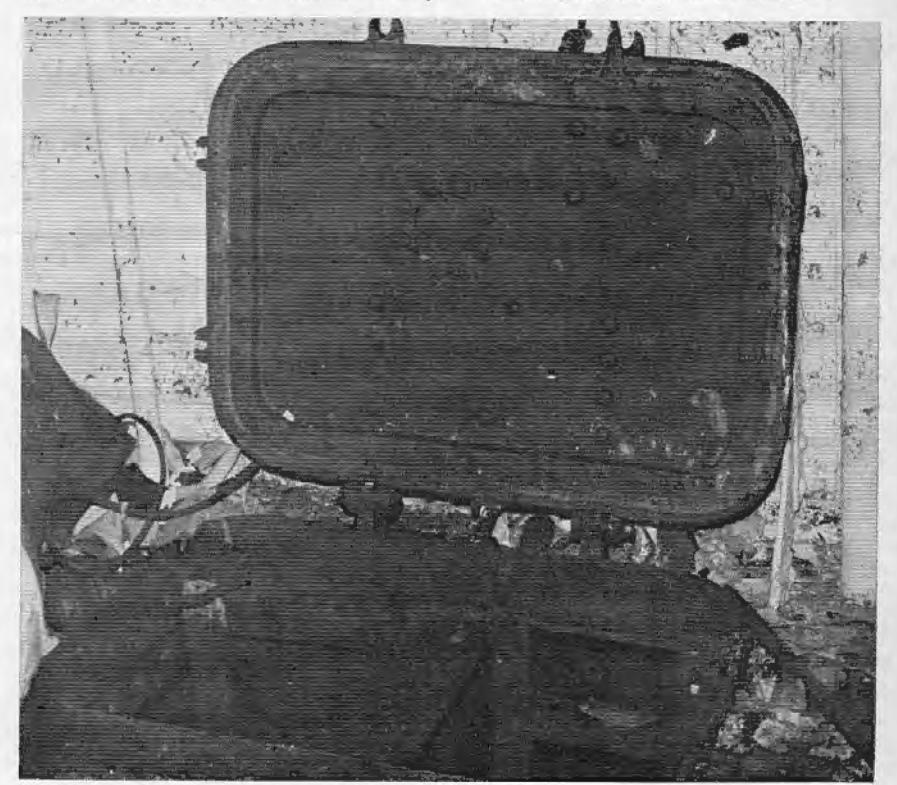
The starboard hatch cover to Nos. 1 and 2 starboard fuel oil tanks aboard the Mercator was open at the time of the capsizing. Water would flow over the hatch coaming when the vessel listed 12 or more degrees to starboard. Crewmembers saw water entering the hatch prior to abandoning ship.

7. Utilizing the Line Plans of the *Mercator*, it was determined that at a mean draft of 15 feet, approximately 5 degrees of list would place the main deck edge at water's edge (based on a 1 foot 6 inch freeboard at that draft). At approximately 12 degrees list water would flow over the hateh coaming to Nos. 1 and 2 fuel tanks.

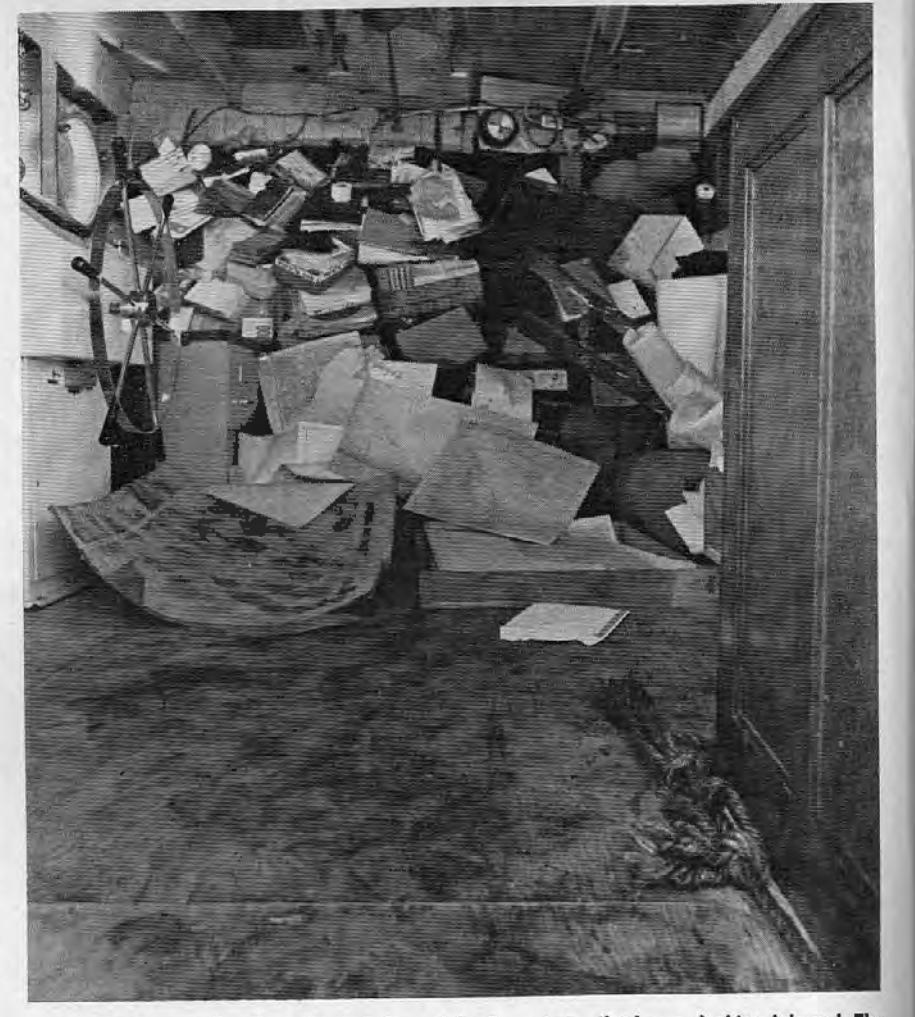
This photo was taken from the port door of the Mercator's pilot house, looking inboard. The vessel was listing to starboard some 55 degrees at the time, accounting for the buildup of debris on the far side.

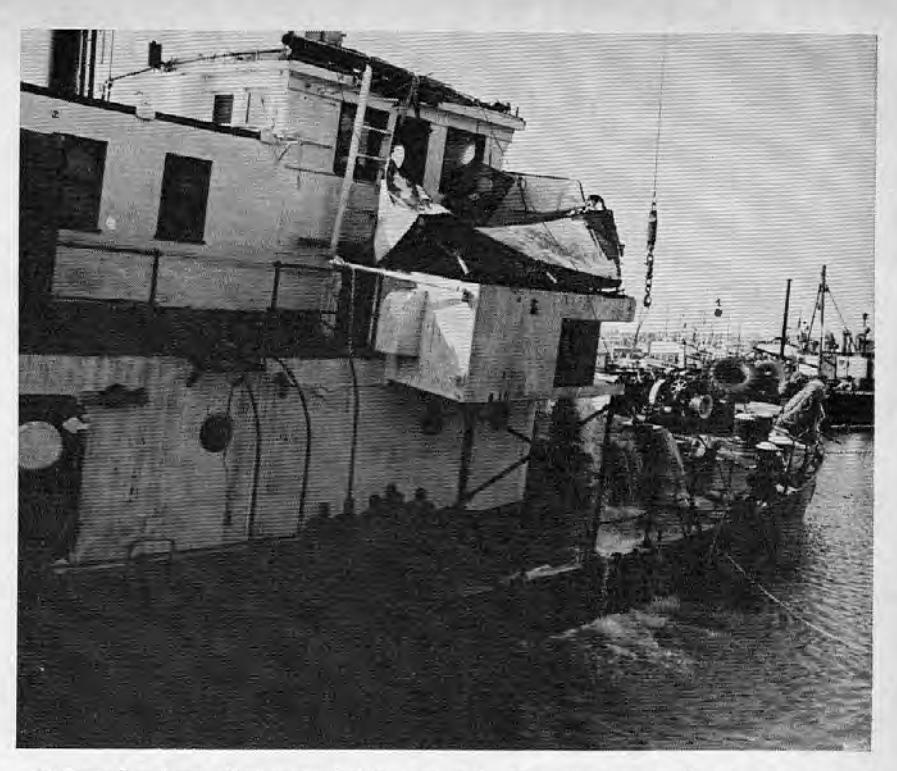
A 2-week salvage effort succeeded in righting the Mercator and refloating her. Here she is righted, but still sitting on the bottom. The damage done to the starboard wing of the bridge was caused by her coming to rest against the pier. Salvage water can be seen being pumped overboard.

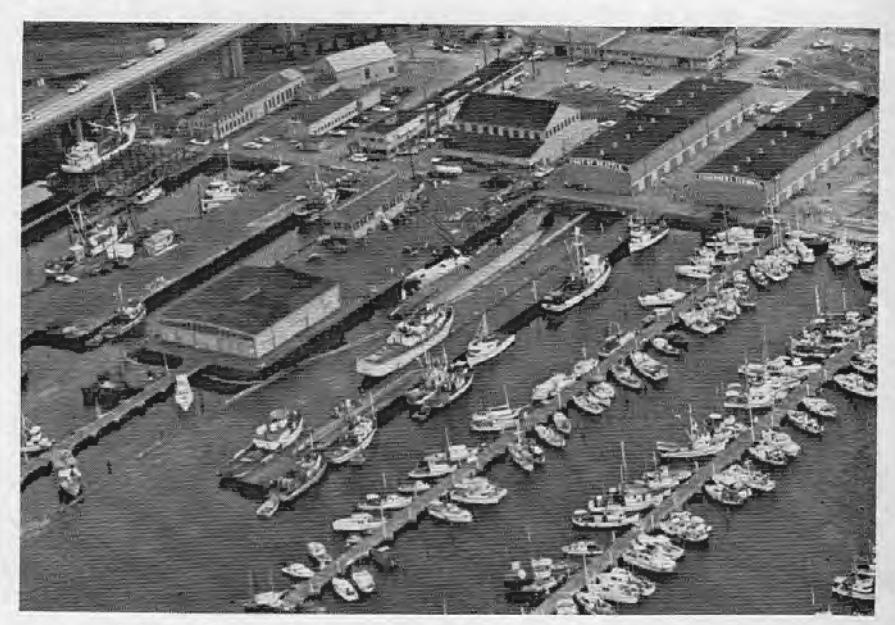
An aerial view of Fisherman's Terminal showing the capsized M/V Mercator.
