PROCEEDINGS OF THE MARINE SAFETY COUNCIL

Vol. 30, No. 9

September 1973

SHIP COLLIDES WITH BRIDGE

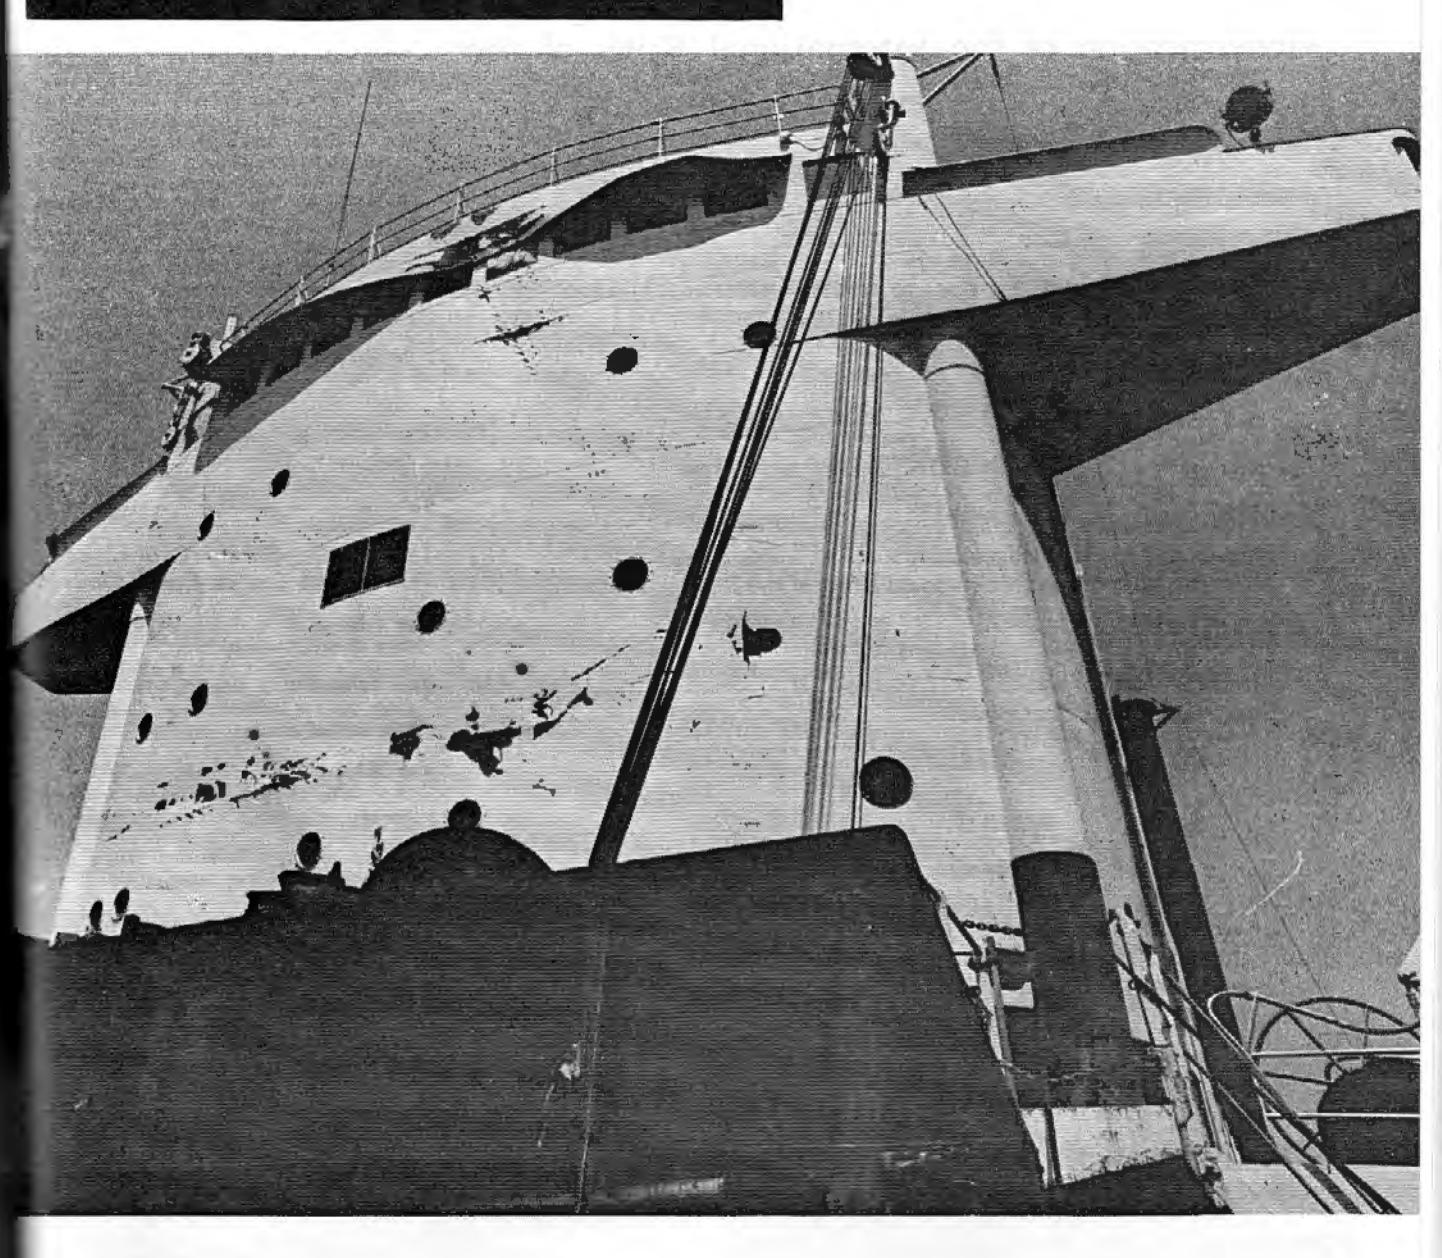
FRONT COVER: A poor job of ship maintenance? No. This is the wheelhouse of the SS Yorkmar after it met the lowered lift span of a vertical lift railroad bridge. The story of the casualty appears on page 183 of this issue.

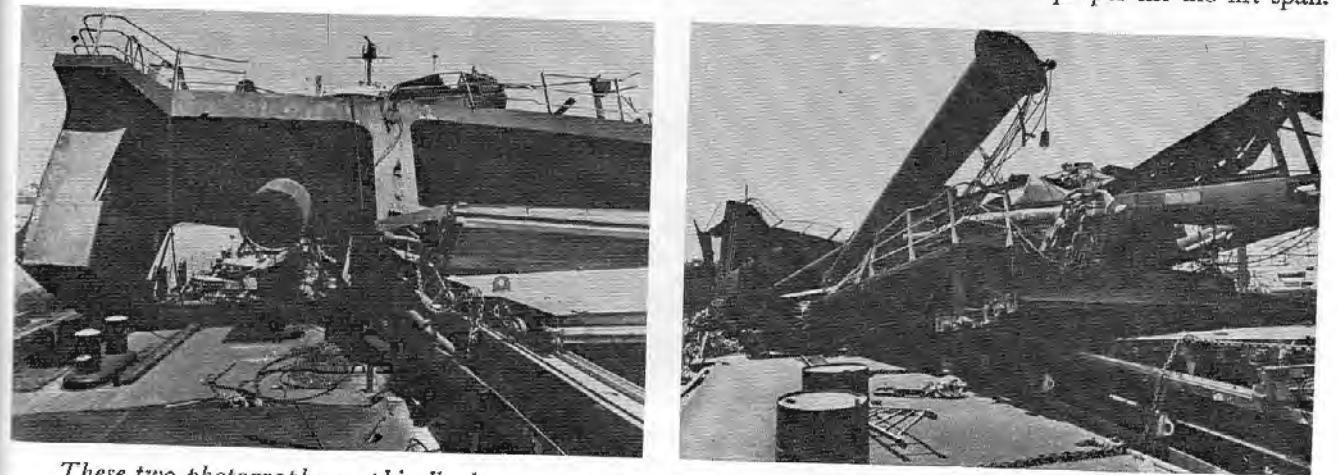
These two photographs graphically demonstrate the extensive damage suffered by the equipment and structural members on the Yorkmar's bow. The vessel remains in laid-up status.

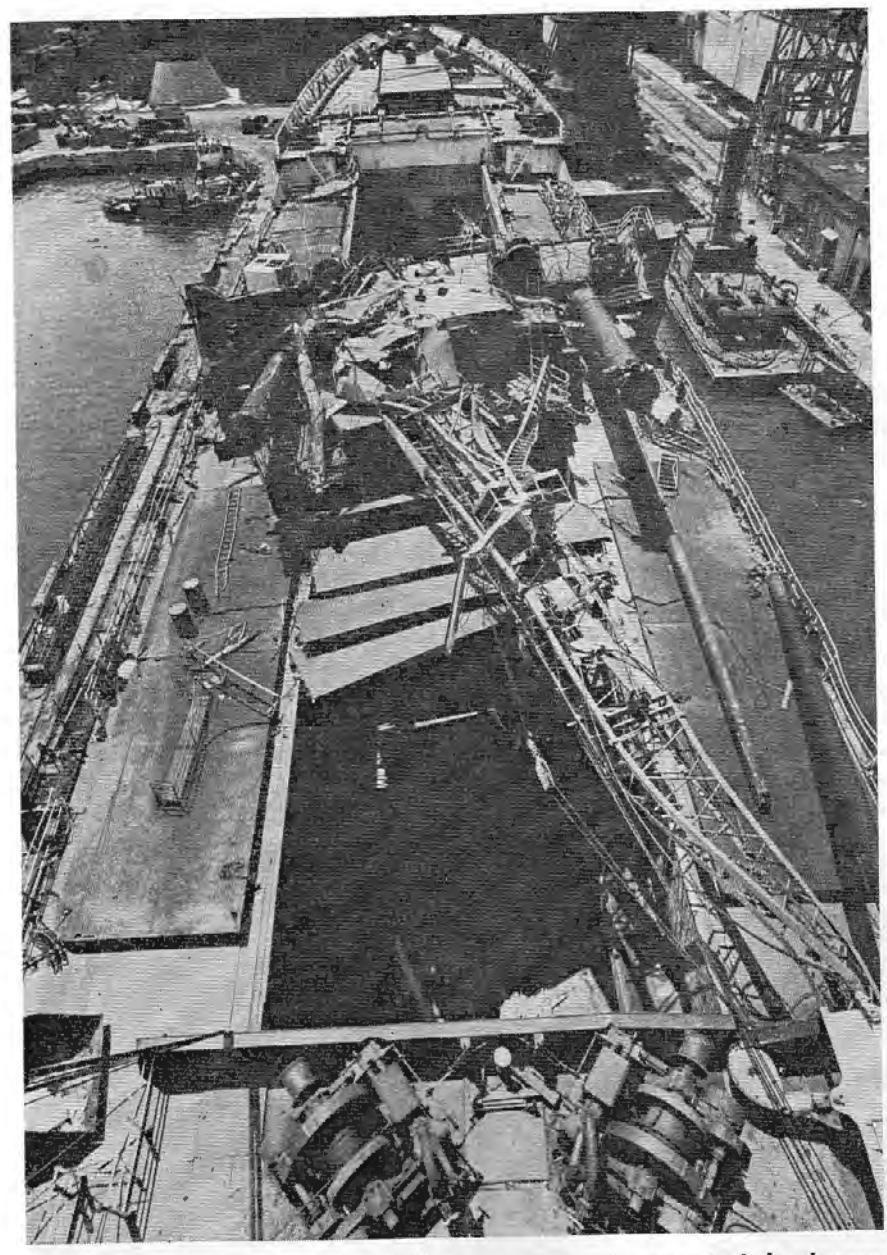
This view of the bow of the SS Yorkmar shows the extent of the damage incurred when the vessel struck the bridge. Plainly visible is the forecastle head under which the chief mate and the bosun sought shelter from harm. The bow lookout, not having such shelter, was crushed to death.
