## **PROCEEDINGS** OF THE MARINE SAFETY COUNCIL

Vol. 31, No. 10

October 1974

# 13 Minutes

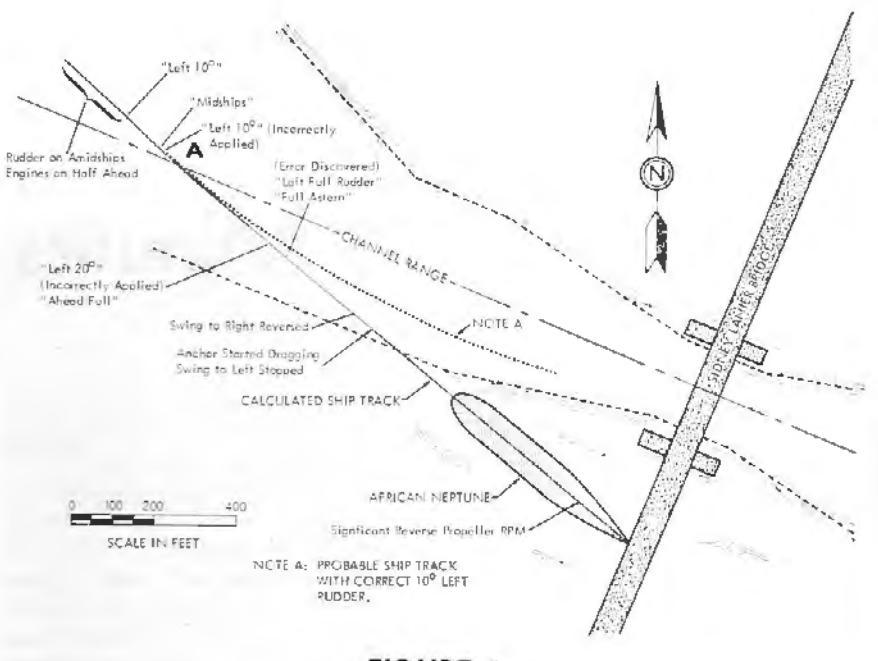
#### FIGURE 1

At about 9:44 the pilot again ordered the rudder, "LEFT,  $10^{\circ}$ ." (See fig. 1, point A) Each of the orders was audible in the pilot house. Each order was repeated by the helmsman as it was given, and each repeat was heard by personnel in the pilot house. Orders to the engine were similarly repeated by the mate on watch.

This illustration, taken from the National Transportation Safety Board's Action on the casualty, depicts the path of the African Neptune. The rudder order at Point A (near the beginning of the vessel's track) occurred at 9:44 p.m.

A Coast Guard Marine Board of Investigation convened to determine the cause of the casualty concluded that the helmsman's error in applying right rudder to a "left rudder" order was the primary cause of the collision. The lapse in time between the incorrect application of rudder and the time it was detected was also noted as a contributing cause. An additional contributing factor was the substantial speed required to maintain steerageway. This caused the *African Neptune* to pass the "point of no return" at a considerable distance from the bridge opening. The fact that the vessel had to approach the bridge in a continuous left turn maneuver was also viewed as contributing to the collision.

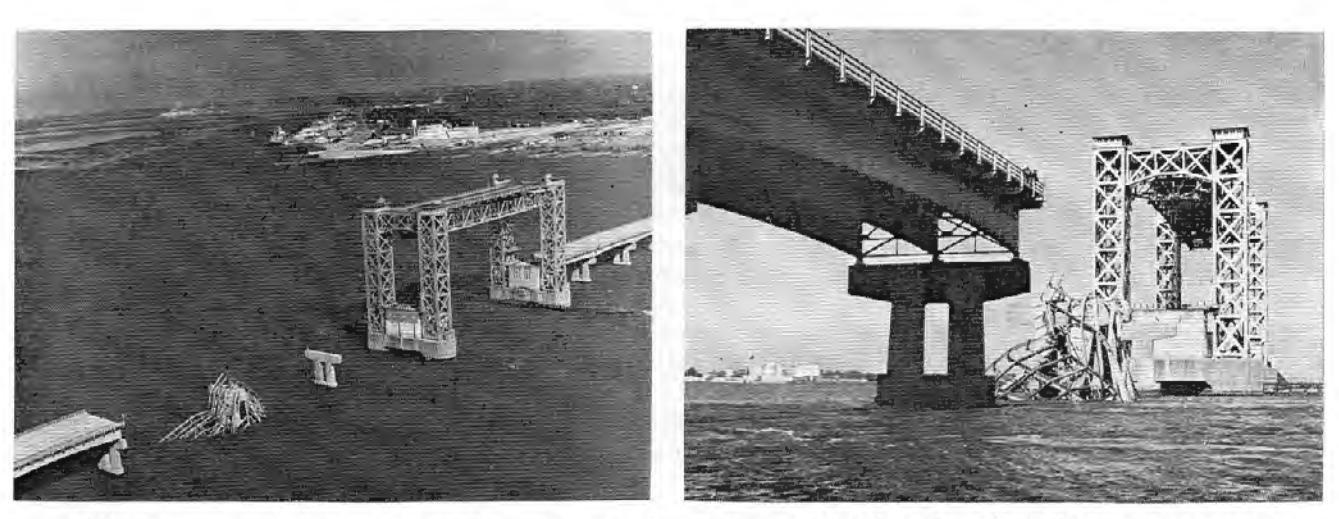
These two perspectives of the Sidney Lanier Bridge in Brunswick, Ga., show both the navigational complexities involved in a safe transit of the lift span and the height from which the vehicles plummeted as the bridge collapsed. Vessels heading out to sea from Oglethorpe Bay (channel, upper left in left hand photograph) have very little time in which to line up with the bridge opening. Ten vehicles which had stopped on the span to await the African Neptune's passage were plunged into the river's thirty-foot depths.

The Commandant's Action concurred with the Board's recommendation that the traffic control gates on the Sidney Lanier Bridge be relocated to prevent a similar occurrence. The National Transportation Safety Board also recommended that the Federal Highway Administration establish policies and standards to protect vehicles on bridges that might collapse if struck by a marine vessel. This recommendation

The Board of Pilotage Commissioners was provided a copy of the report with the recommendation that they adopt measures that would require large vessels to line up on the Sidney Lanier Bridge before passing a point of no return during outbound passage.

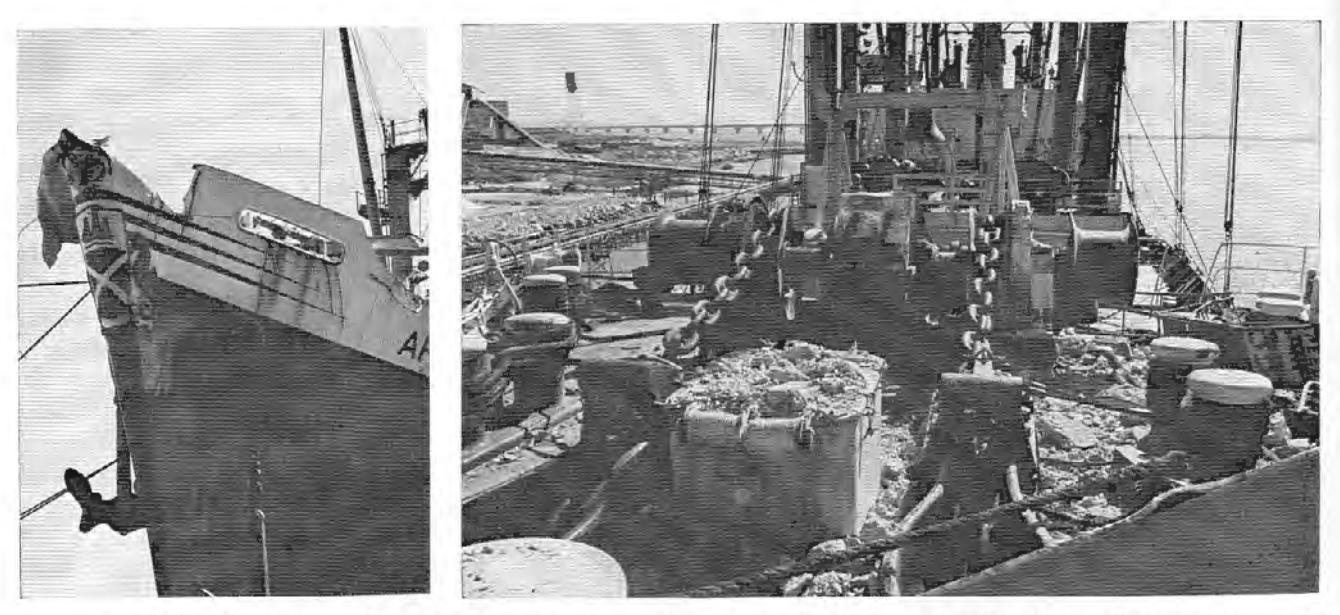
The African Neptune suffered only minor damage as a result of the casualty. After effecting temporary repairs in the Port of Brunswick the day following the casualty, she sailed for Savannah, Ga. Note the highway sign at the extreme right of the right-hand photograph.

The Port of Brunswick was closed to shipping overnight. With the assistance of two tugs, the African Neptune proceeded to the Lanier Berth in Brunswick to effect temporary repairs. The vessel then proceeded to Savannah, Ga., on November 8, 1972, to discharge cargo and complete permanent repairs to the minor damage she had sustained.
