PROCEEDINGS OF THE MARINE SAFETY COUNCIL

Vol. 31, No. 5

May 1974

TUG AND BARGE COLLIDE WITH BRIDGE

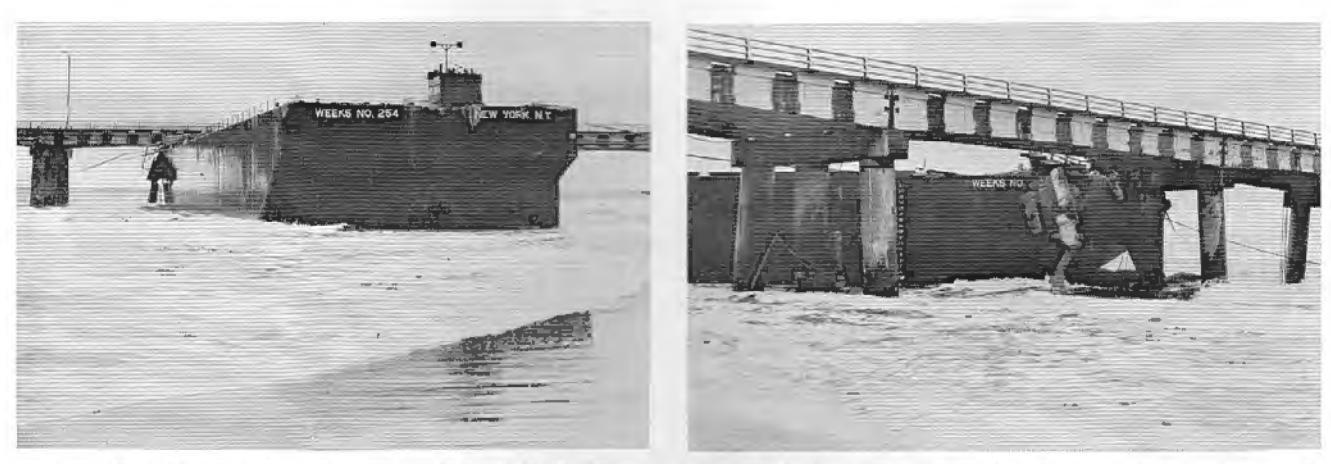
The barge Weeks No. 254, still attached to the Carolyn struck trestle A of the Chesapeake Bay Bridge and Tunnel some $2\frac{1}{2}$ miles from the shoreline. The barge drifted southward along the west side of the trestle, repeatedly striking the structure, until it finally fetched up approximately halfway through the bridge roadway. The photos above show the final position of the barge with respect to the bridge.

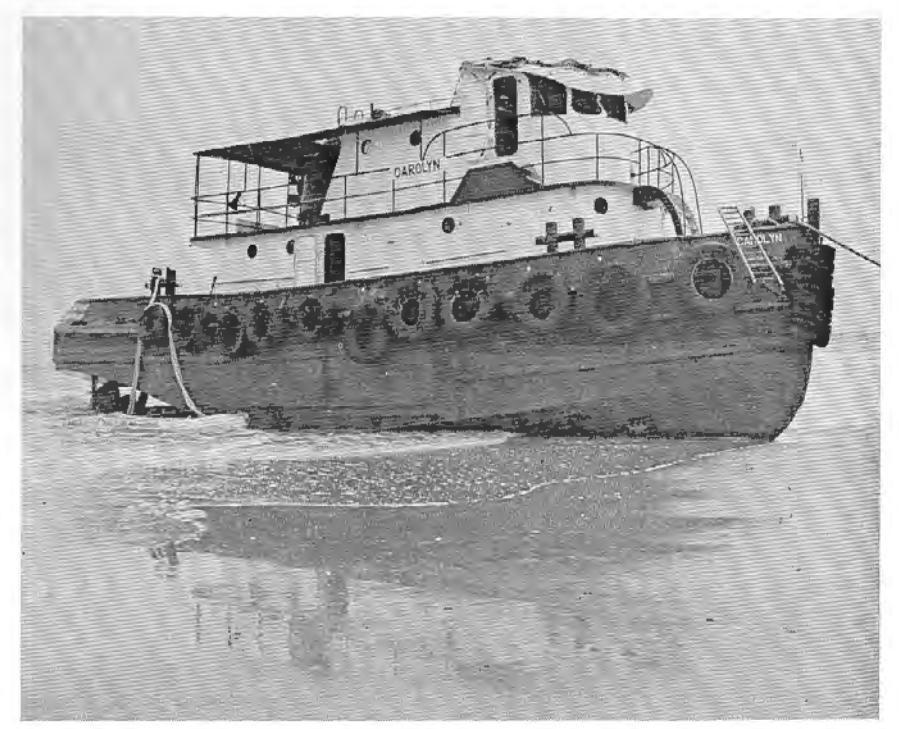
The Carolyn finally grounded on the beach east of the bridge. The top of her wheelhouse apparently sheared off when she passed under the bridge.

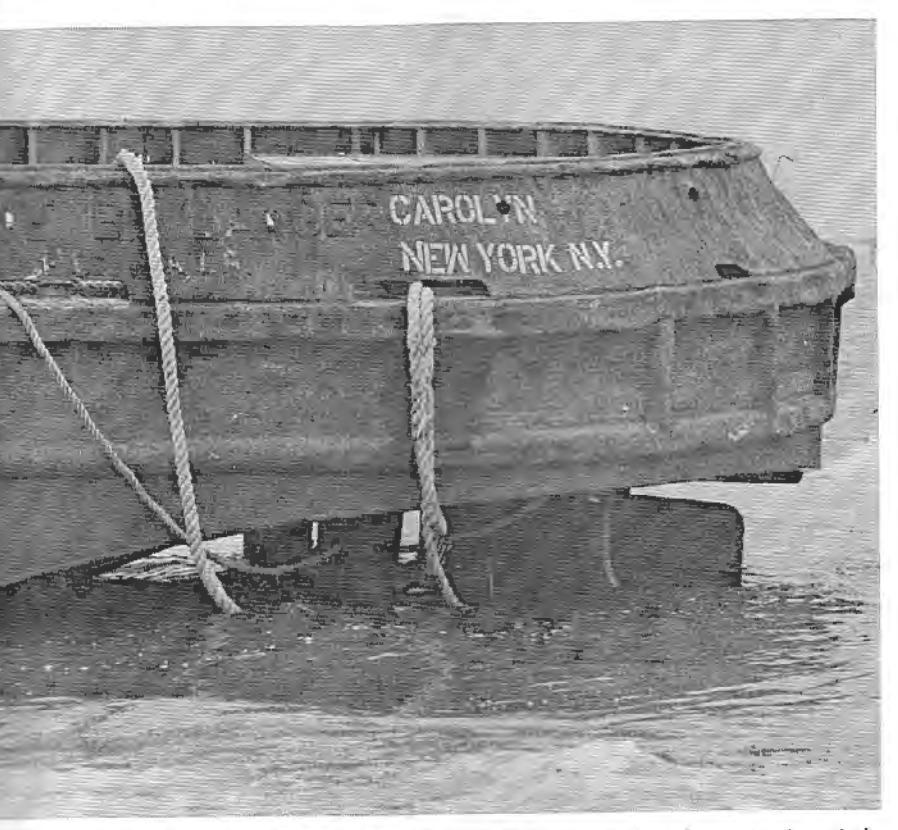
Much of the trouble with the Carolyn resulted from the fact that a portion of the towing hawser had slipped overboard and fouled in both screws. Additionally, another smaller line dangling out a freeing port was wrapped around the rudder. Both the hawser and the smaller line are visible above.
